**INVESTIGATION REPORT
OF THE
FIRE IN THE
WIDE BAND LABORATORY
AT
FERMI NATIONAL ACCELERATOR
LABORATORY
BATAVIA, ILLINOIS
OCTOBER 3, 1987**

**U.S. DEPARTMENT OF ENERGY
Chicago Operations Office**

FIRE IN THE WIDE BAND LABORATORY

OCTOBER 3, 1987

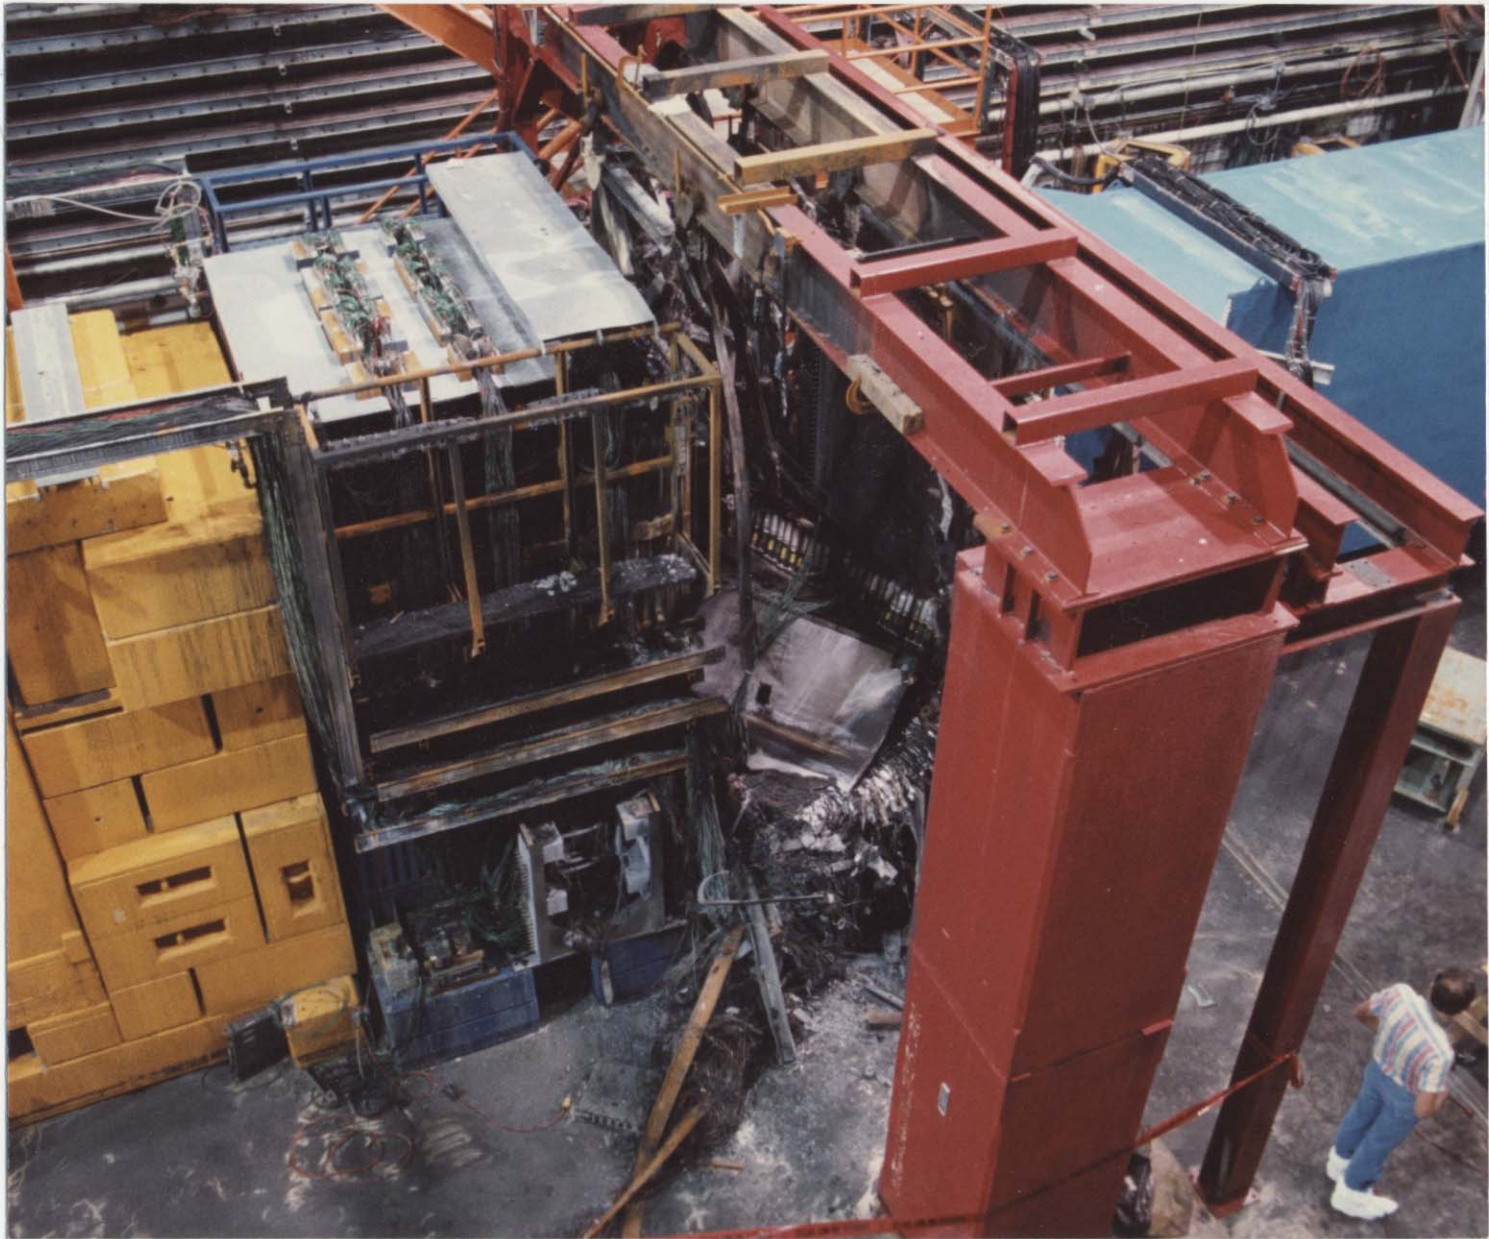
After the fire was extinguished and the situation stabilized, the first assessment of the damage was made. (See Figures 7-13.)

Figure 7. West side of beam line after fire.

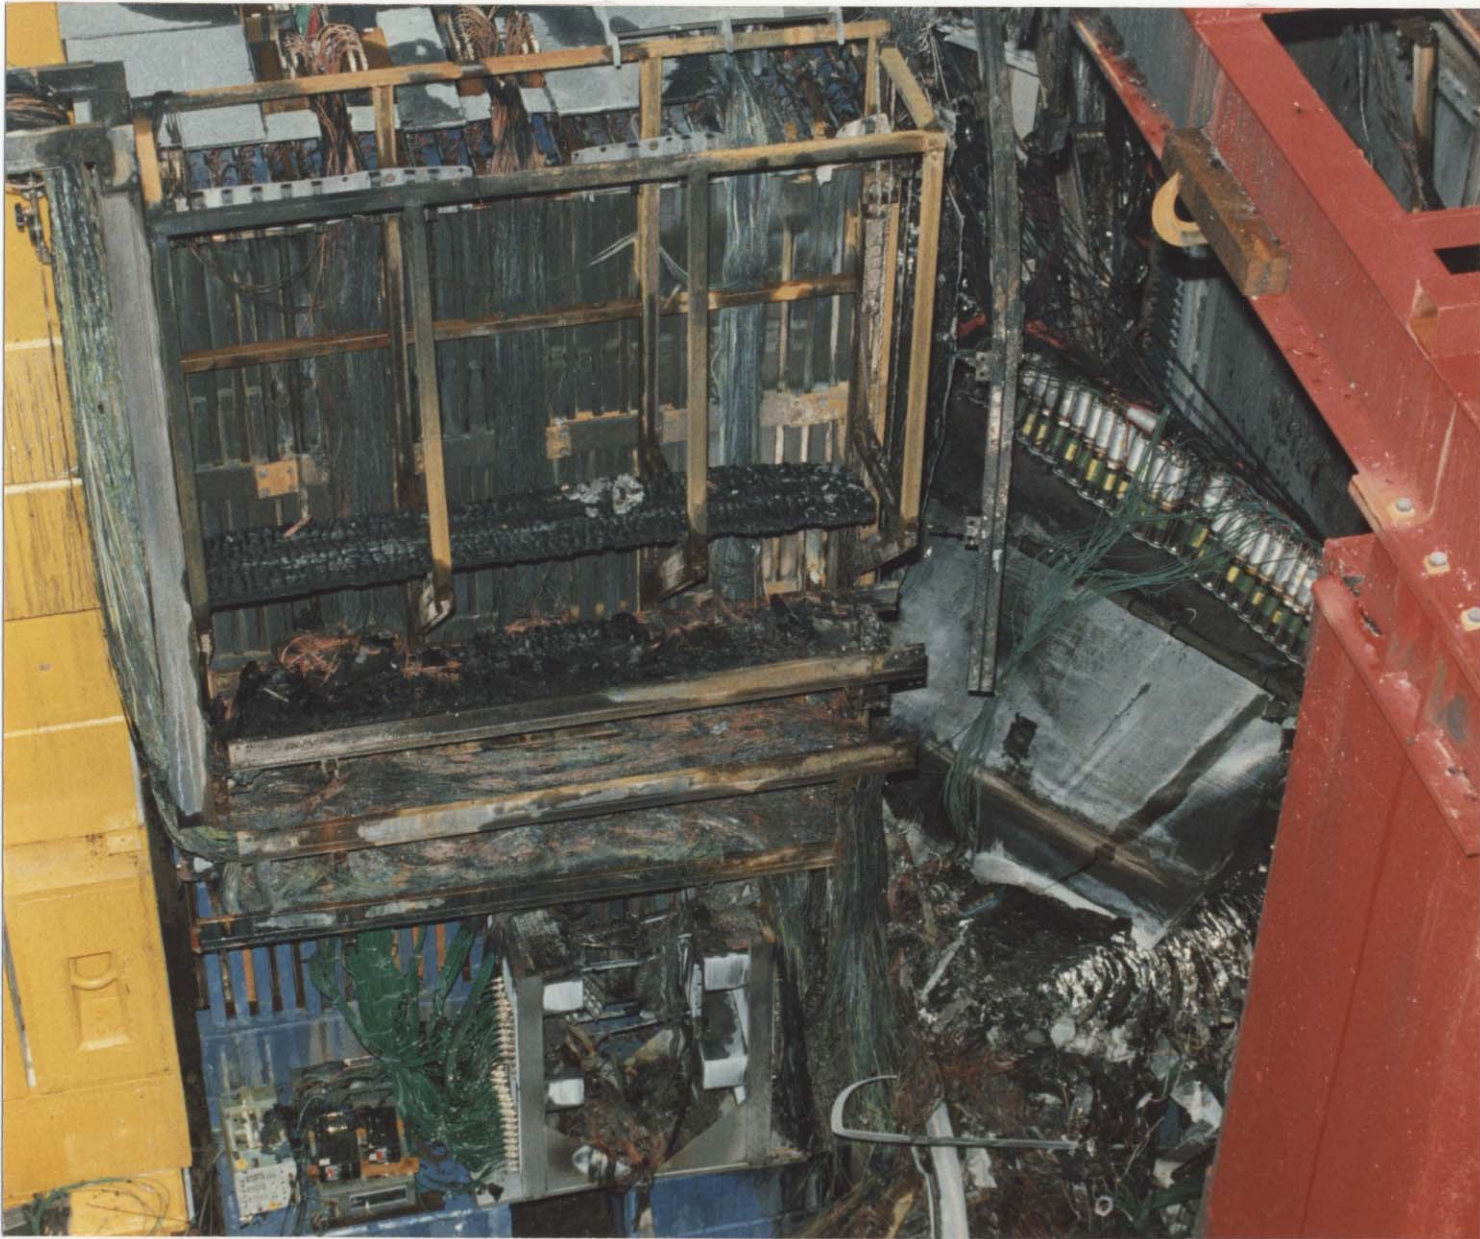
Figure 8. West side of beam line after fire. Note damage to HC, IEC, and dynode sum box.

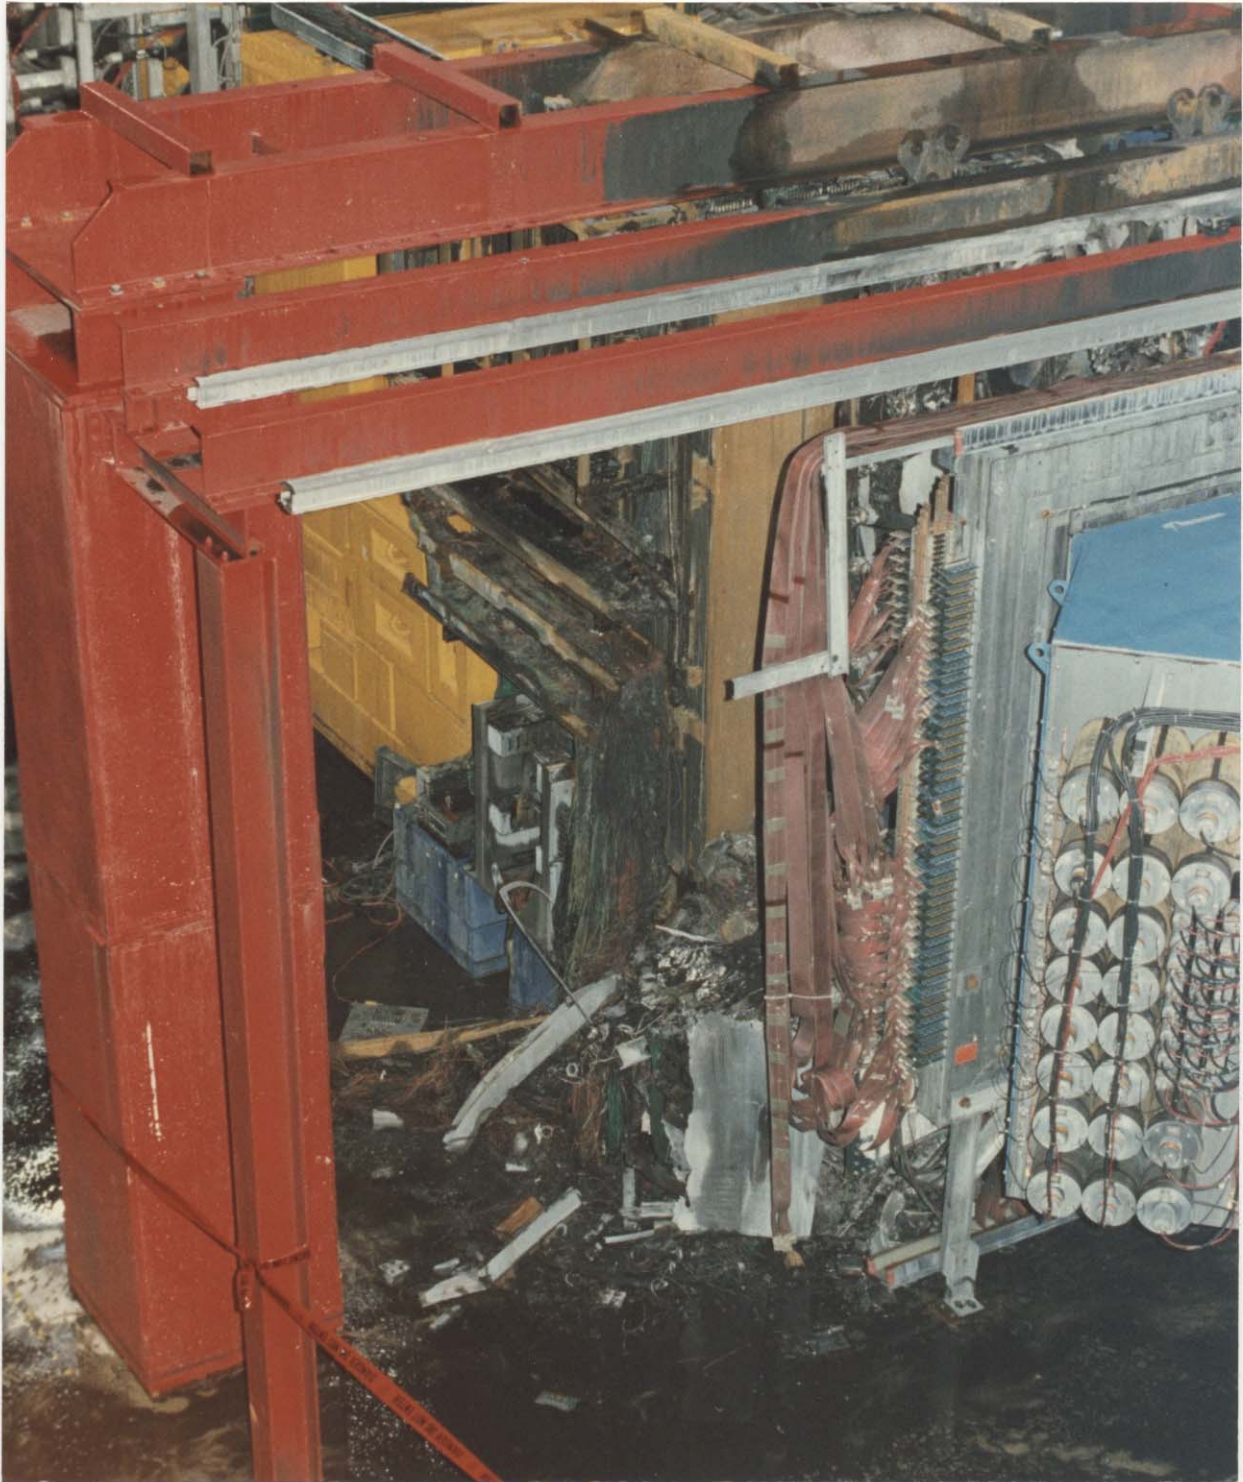
Figure 9. West side of beam line after fire. Note damage to HC, IEC, and support structure, and undamaged ribbon cable on P4.

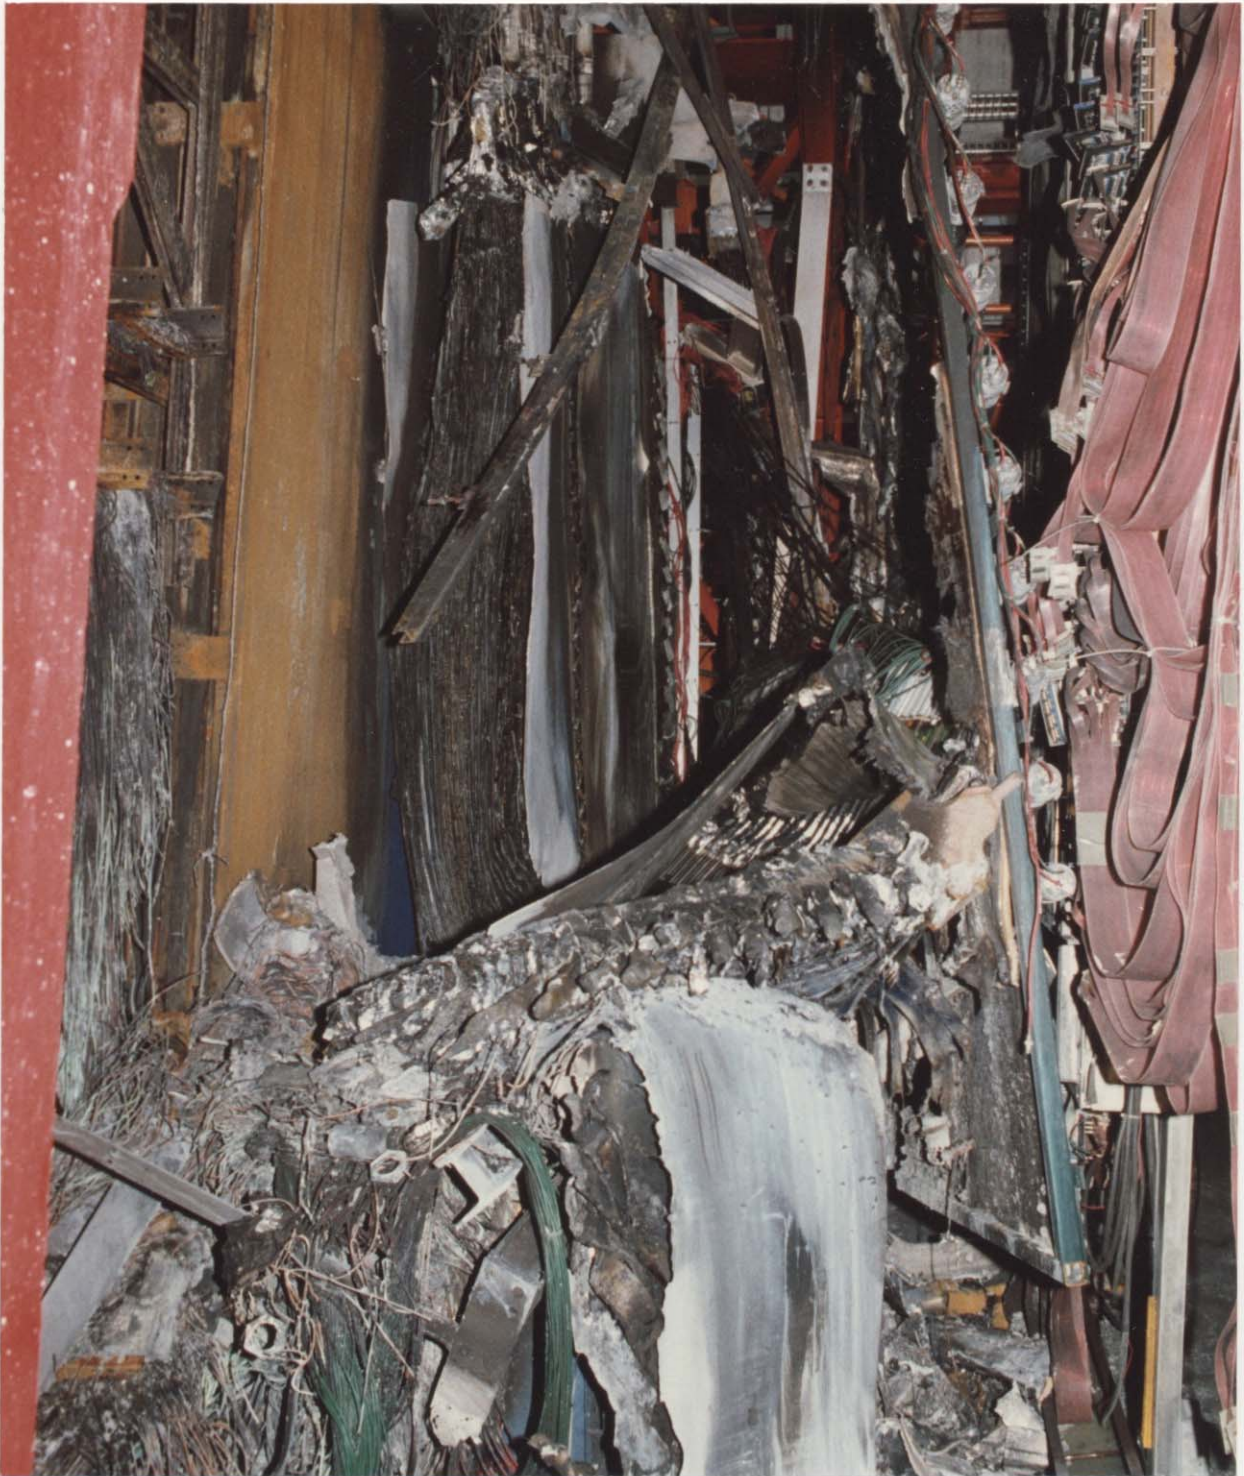
Figure 10. Damage to IEC and HxV. IEC third module and downstream tiebreaker are visible hanging from aluminum framework.

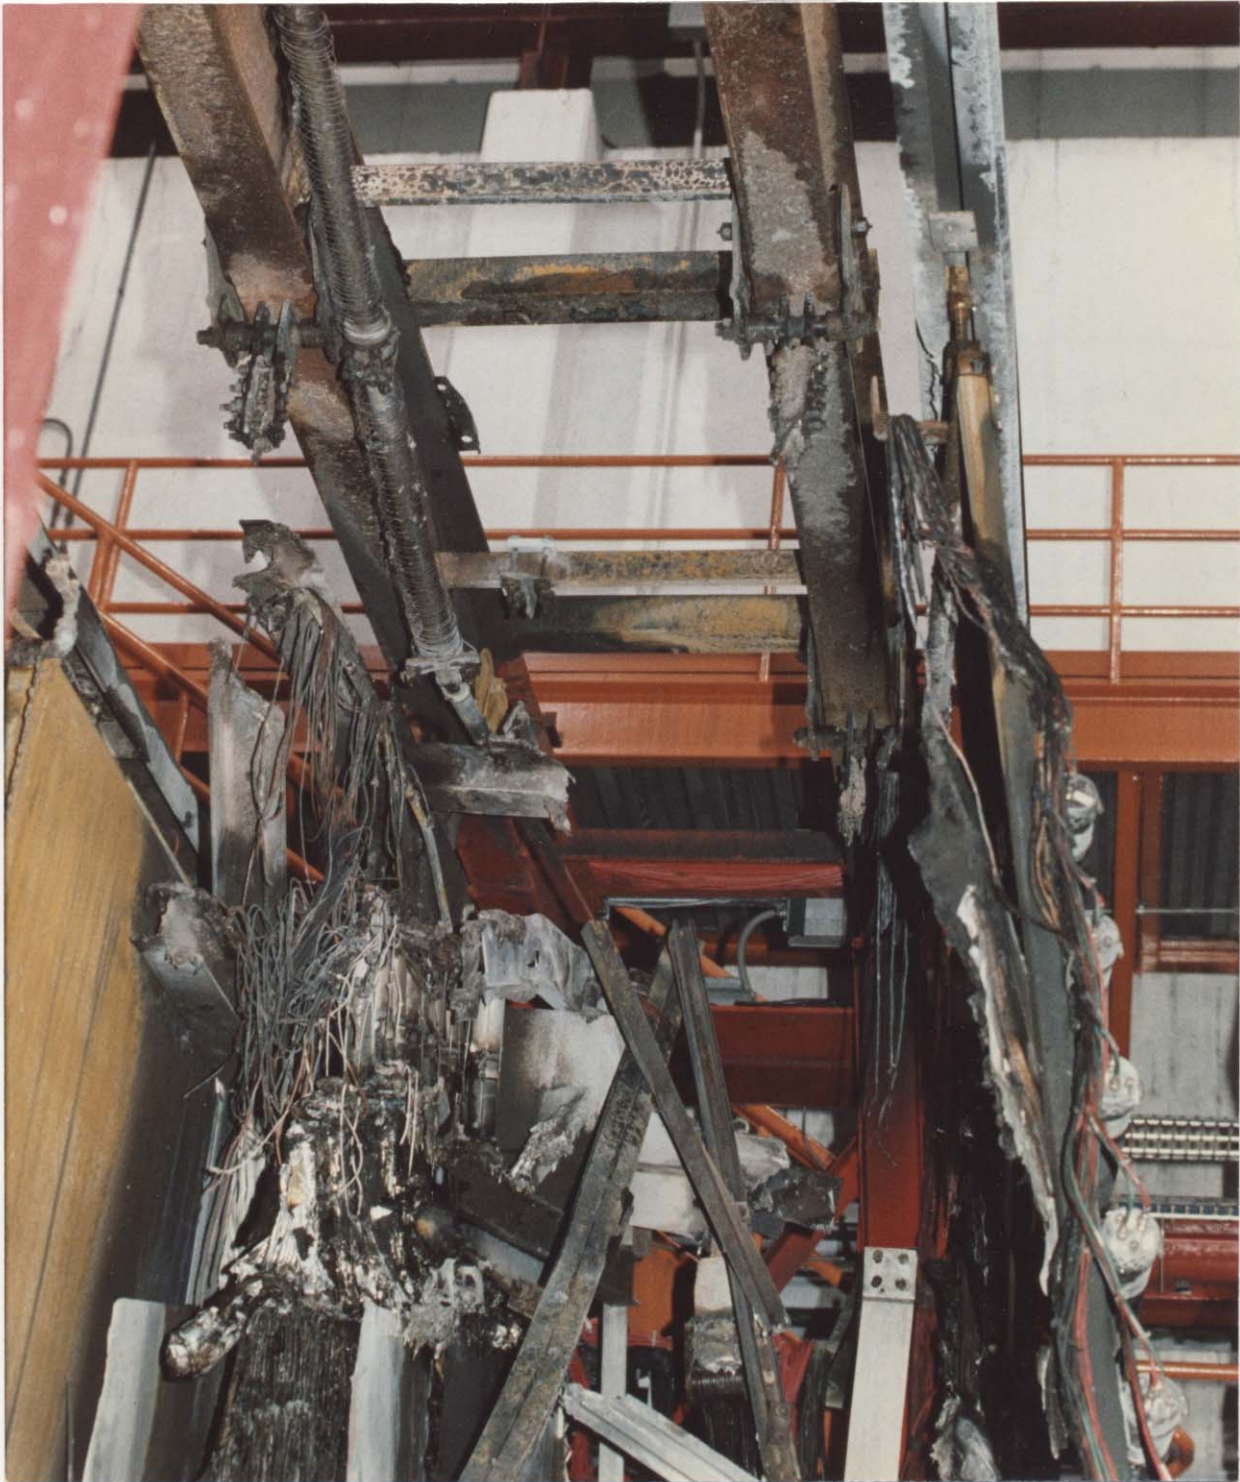
Figure 11. Damage to upper portion of IEC aluminum framework and support structure. Note remnants of HxV.

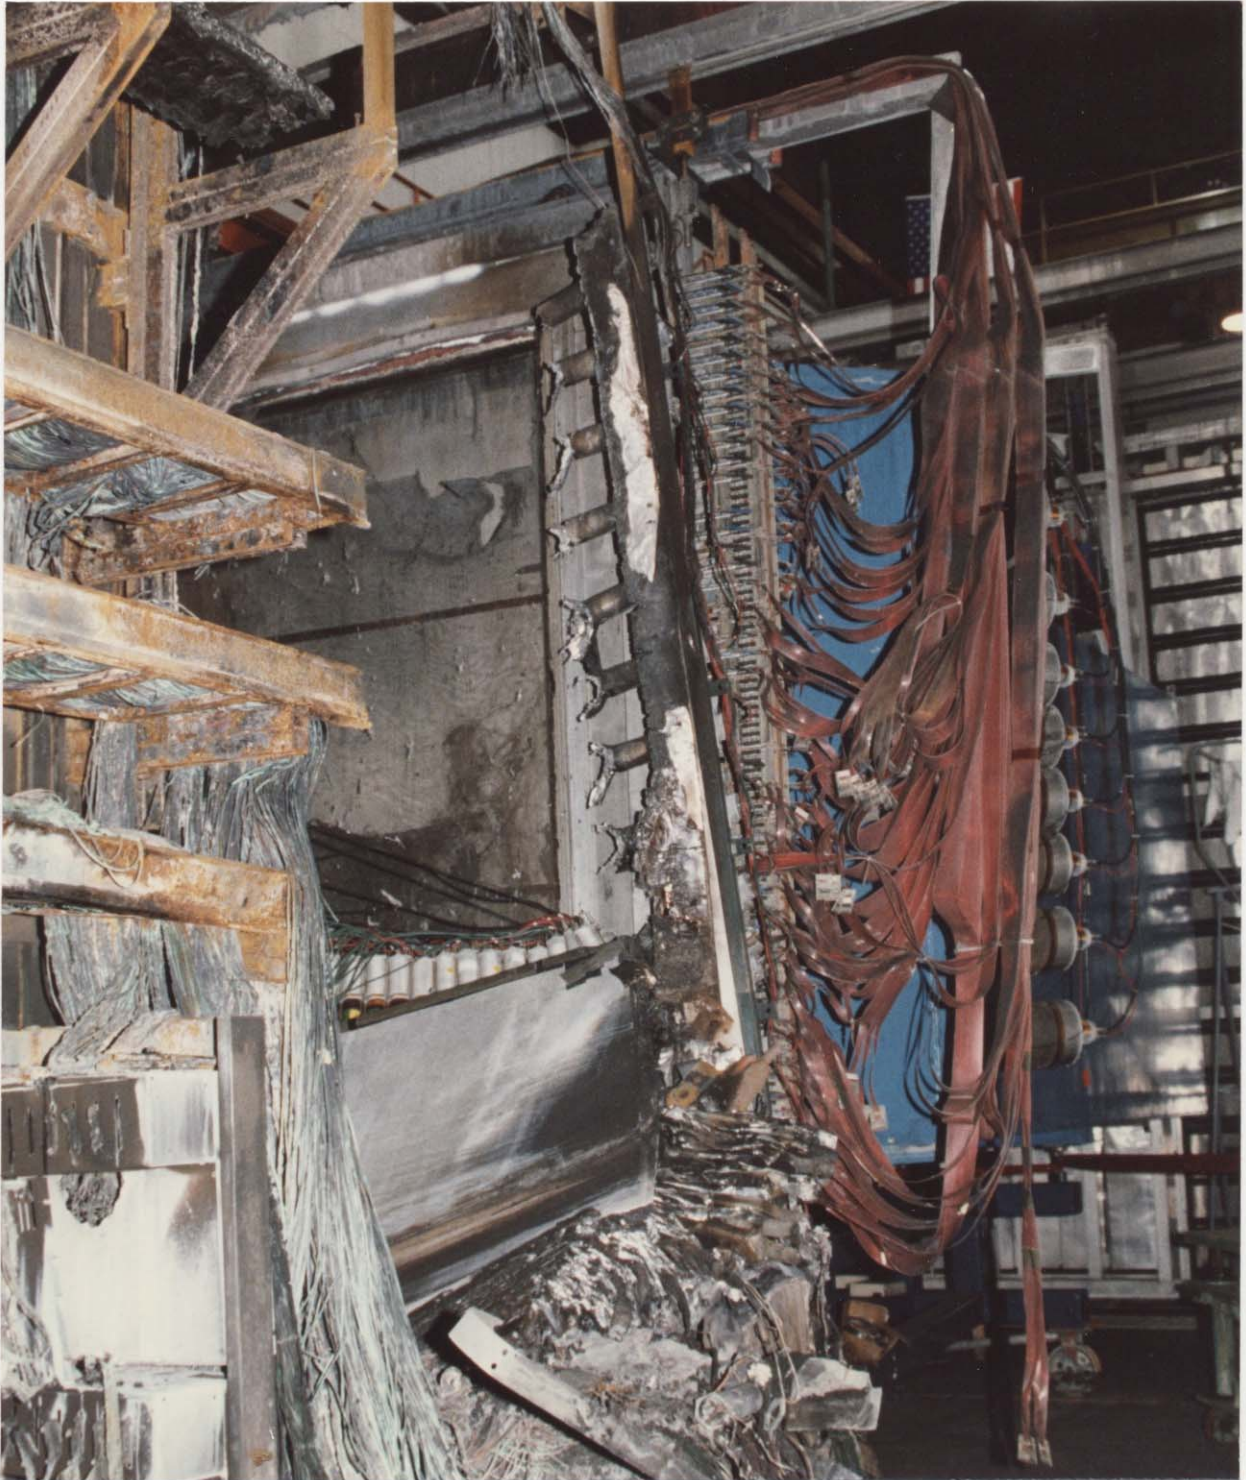
Figure 12. Damage to dynode sum box (with hole burnt through south panel) and IEC second module, remnants of west side of HxV, and damage to P4. Note minor damage to P4 ribbon cables.

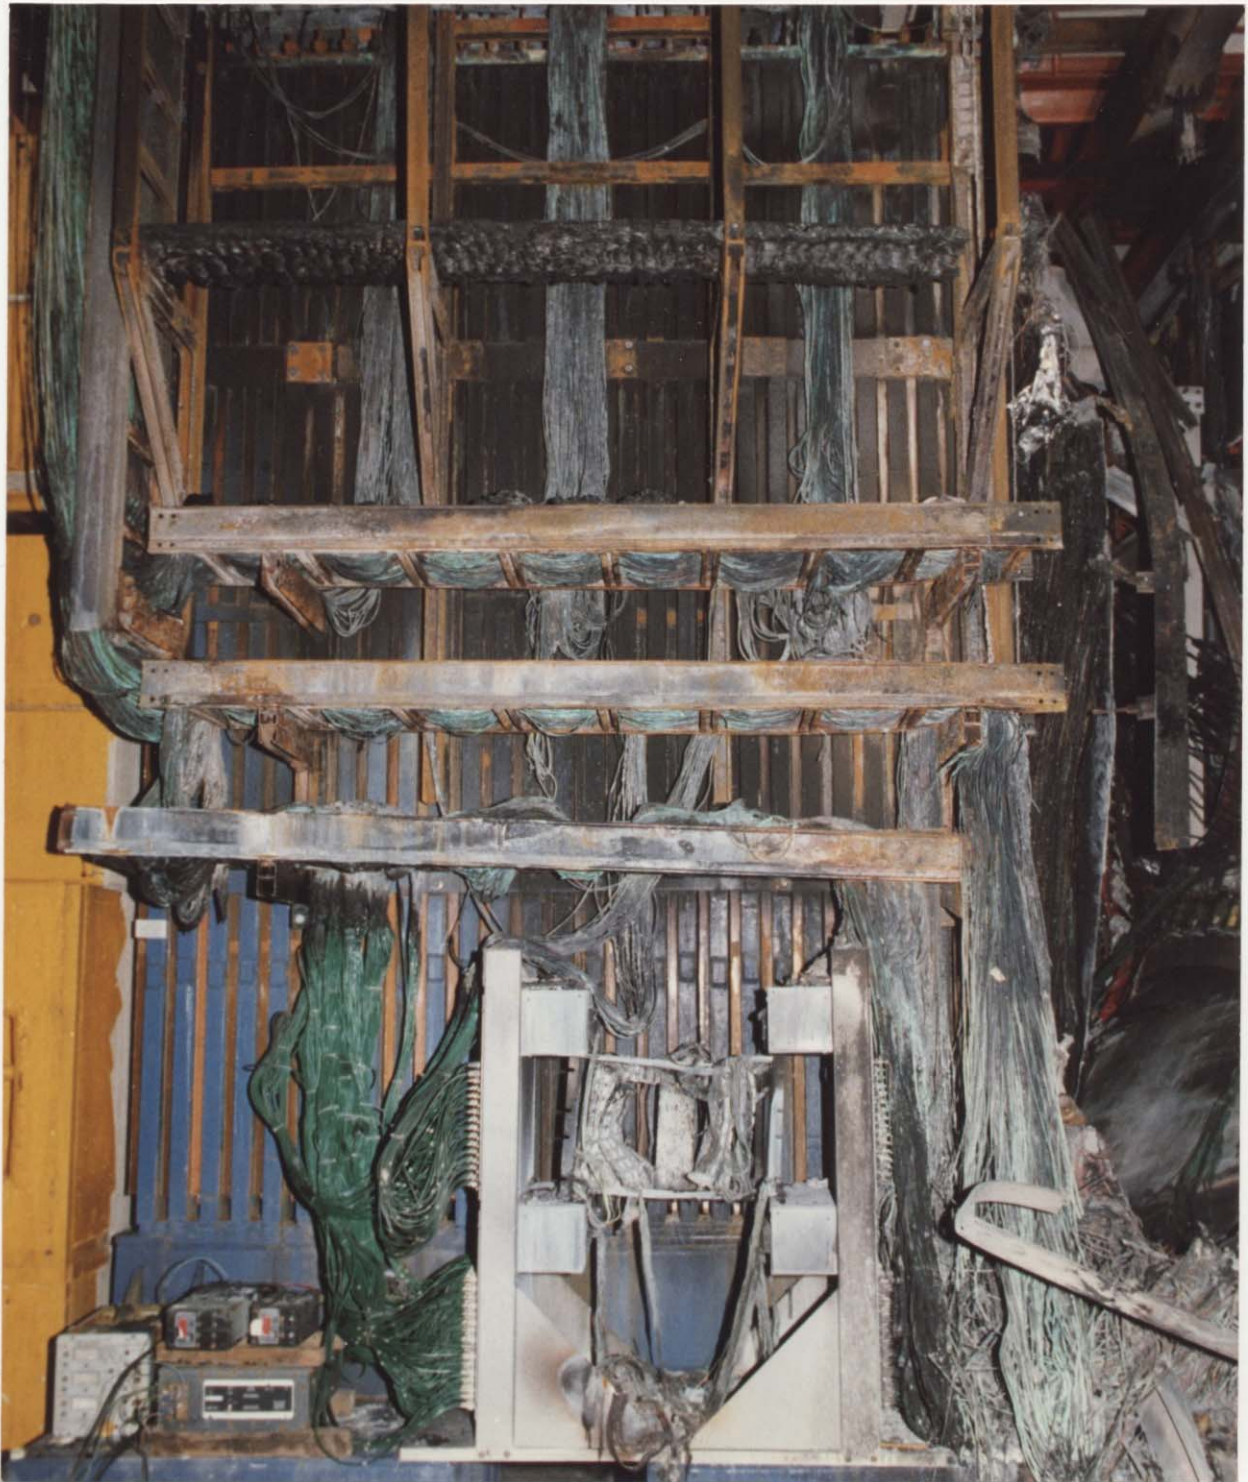
Figure 13. Damage to west side of HC and dynode sum box. Note almost complete destruction of cables on right side of sum box and mostly intact cables on the left.

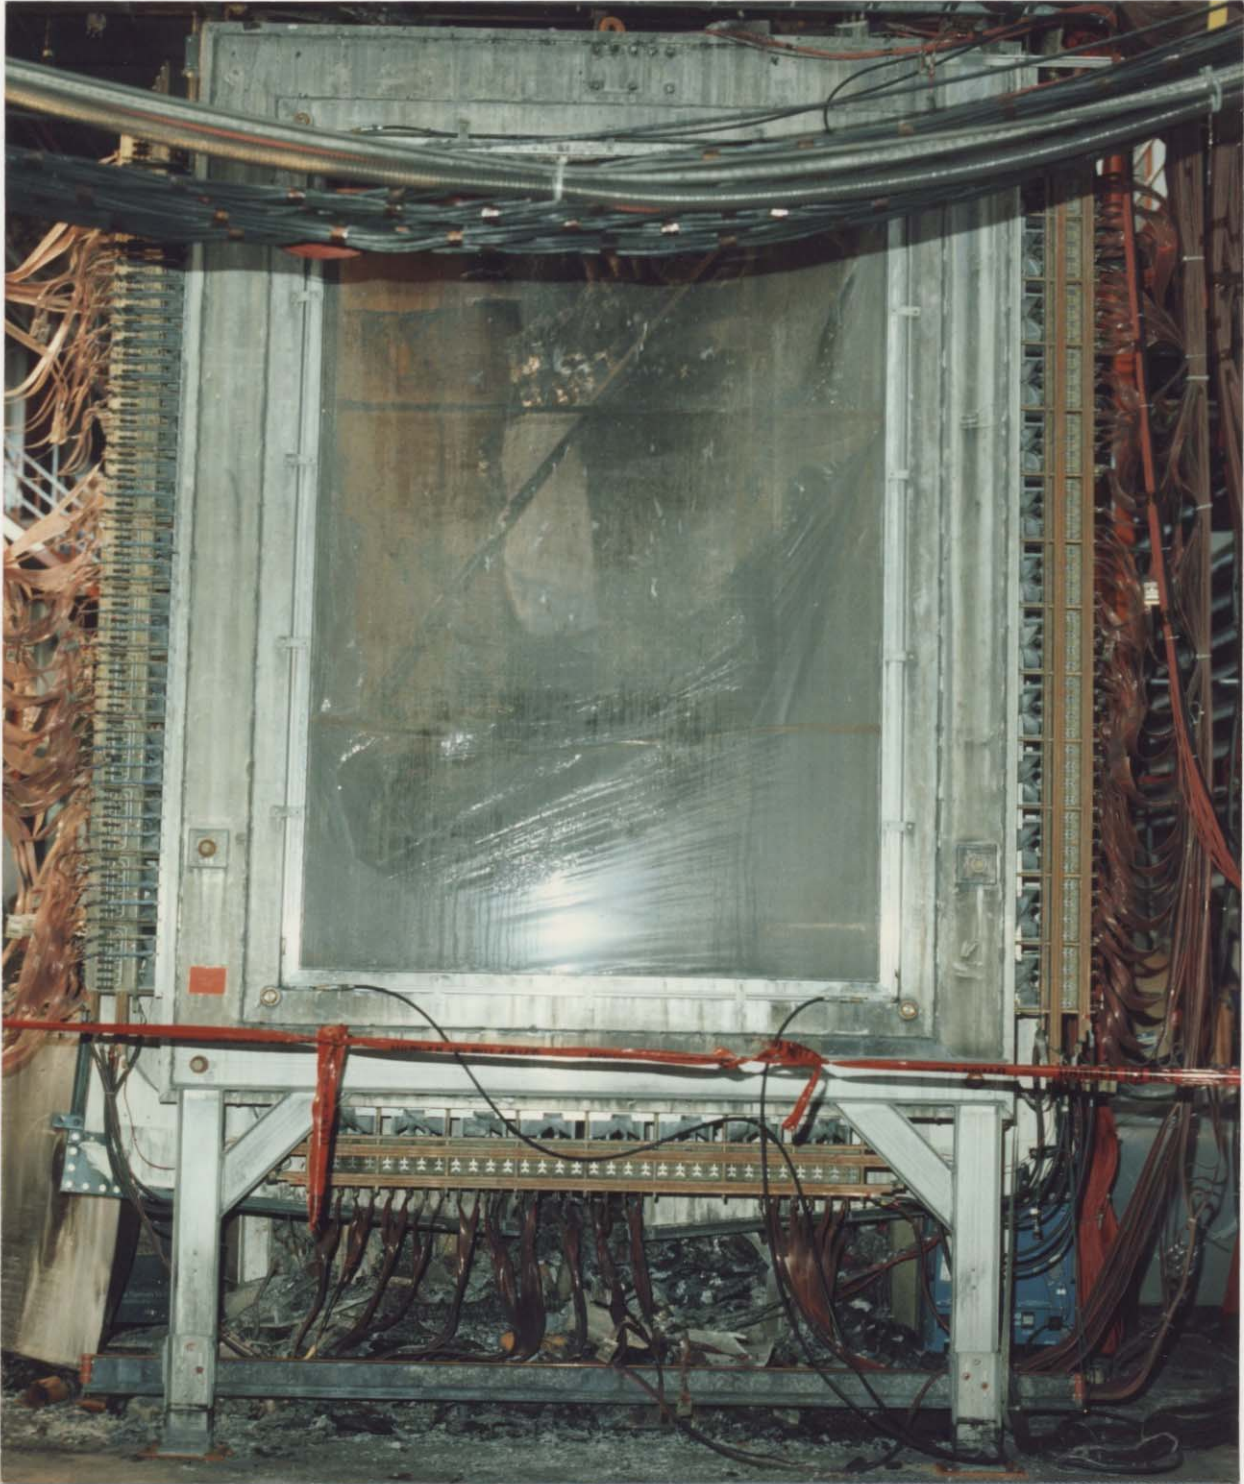
this detector. It had been originally thought that the damage to P4 could easily be repaired by rewiring and installing new mylar windows and gaskets. However, after removal and disassembly, the main circuit boards were observed to be extensively damaged, which will necessitate a major refabrication effort. An interesting observation was that in spite of the damage to HxV (immediately downstream of P4) the ribbon cables from the P4 preamplifier boards were hardly damaged (see Figure 14).

Figure 14. Upstream view of P4 after C3 was rolled aside. Note extensive damage to ribbon cable on bottom, but only minor damage to cables on west (left) and east sides.

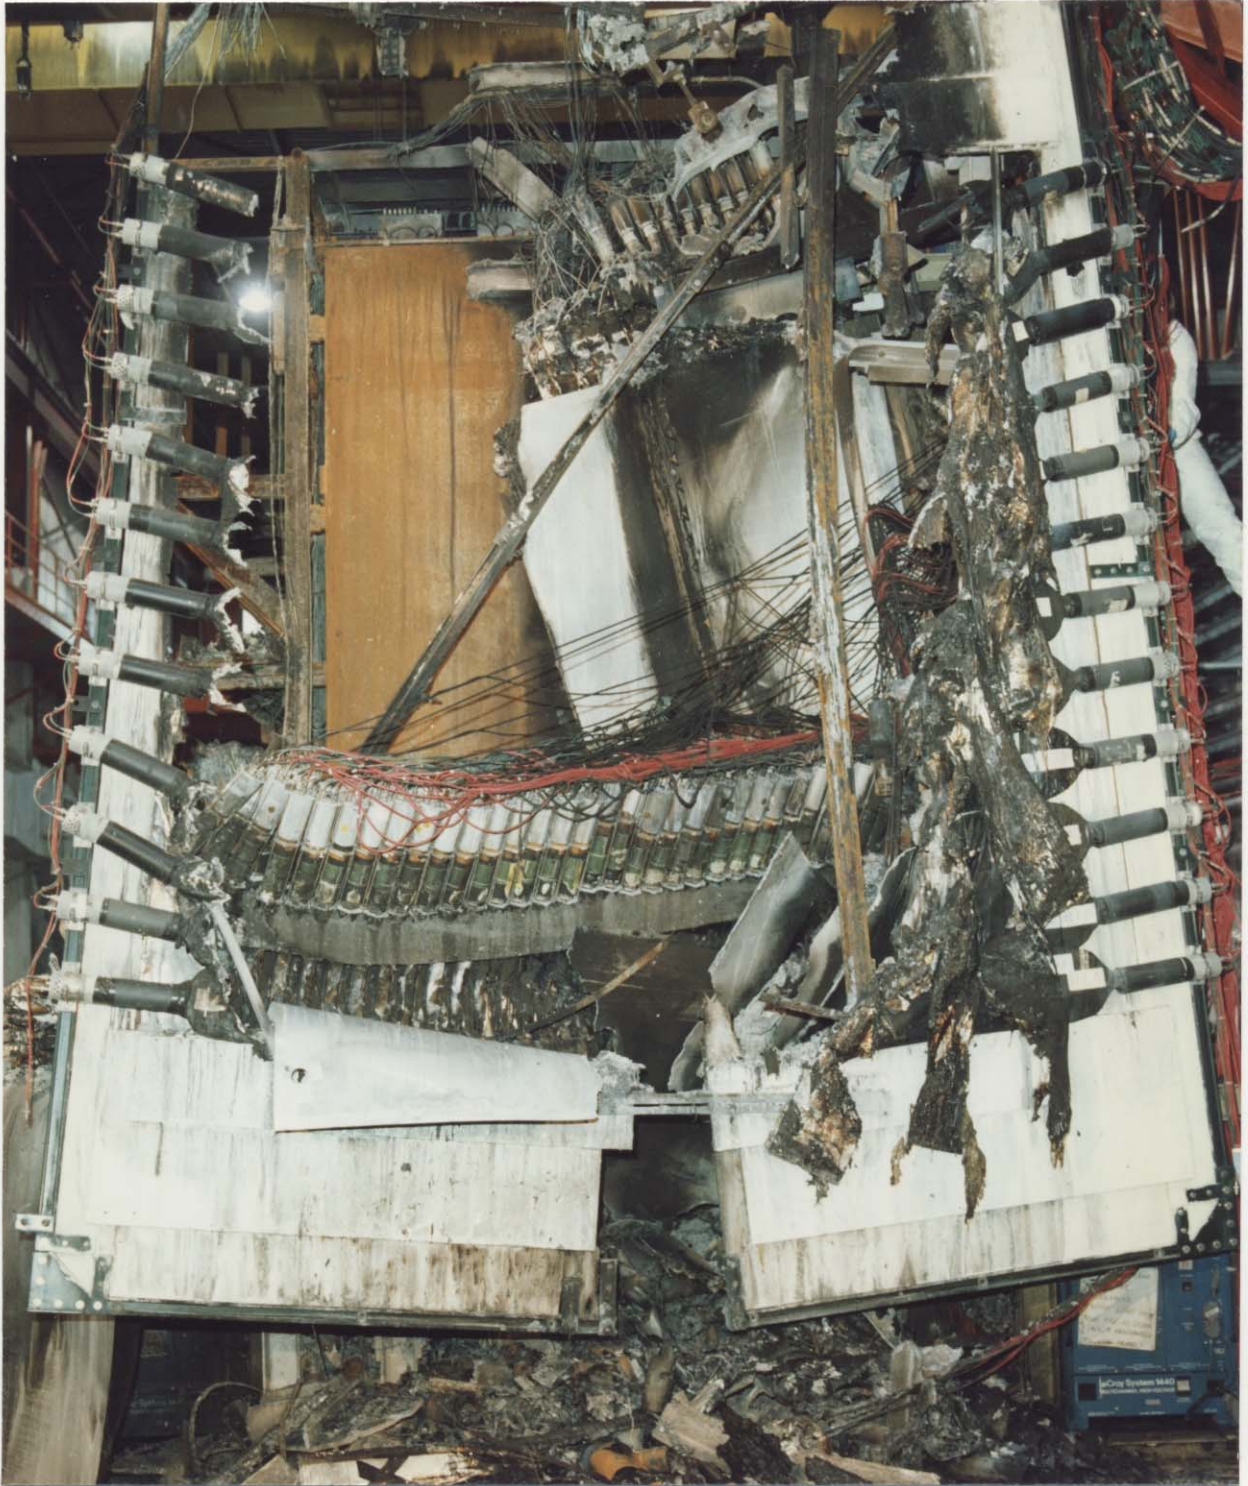
The HxV detector was nearly totally destroyed. Almost all of the plastic scintillator material was consumed. The burn pattern was "U" shaped with slightly more damage on the west side than the east (see Figure 15). The downstream side was completely charred while the upstream side still had some intumescent paint undamaged. This reinforced the theory that the fire and source were further downstream. The remnants of HxV were removed in two pieces to gain access to the IEC, which suffered the bulk of the fire damage.

Figure 15. Upstream view of HxV with P4 removed. Damage on west side is only slightly more severe than on east side.

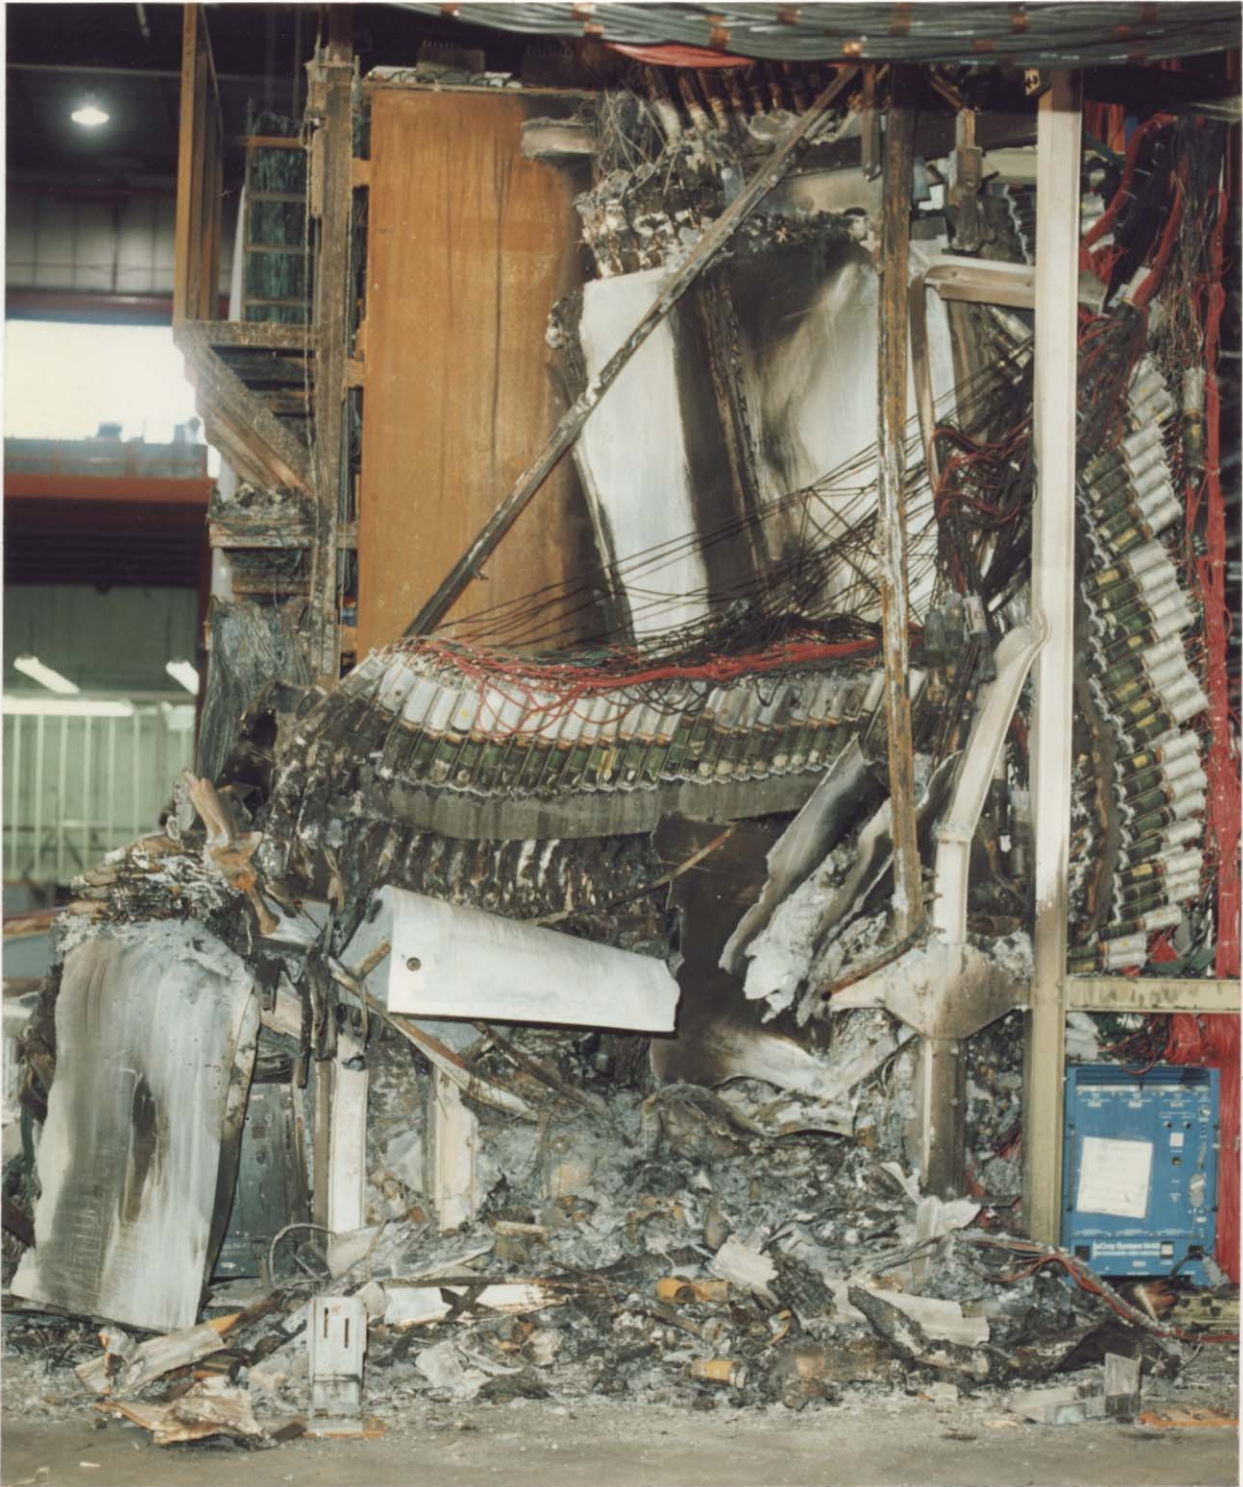
The third module of the IEC was partially resting on a downstream aluminum frame member and hanging from its east hanger (see Figures 16 and 17). Since it was estimated to weigh about 2 tons, great care was taken not to disturb it without adequate preparation. It was lifted out using the overhead crane and innovative rigging. The damage was found to be

Figure 16. Upstream view of IEC with HxV removed. MF6 is clearly visible on lower right while MF7 is buried under rubble at lower left. Note undamaged cables along east side.

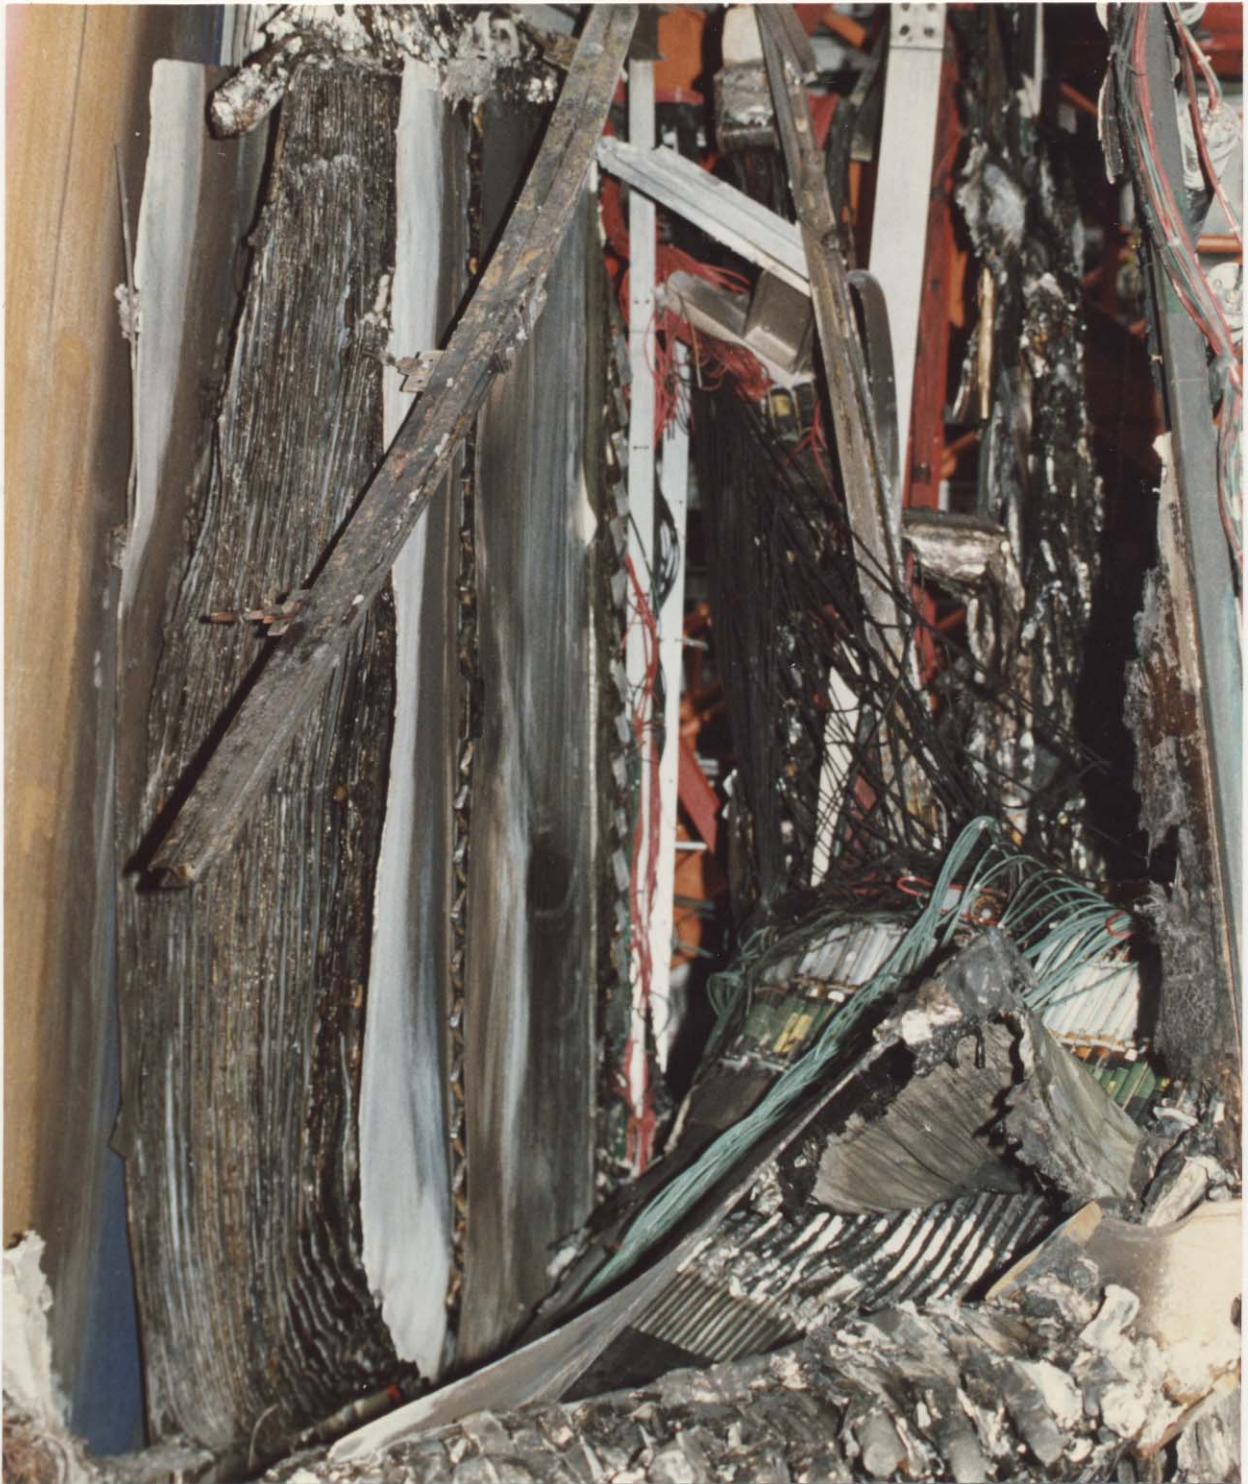
Figure 17. View of damage to IEC looking east prior to removal of HxV and P4. IEC third module is still hanging from aluminum framework and second module is in foreground.

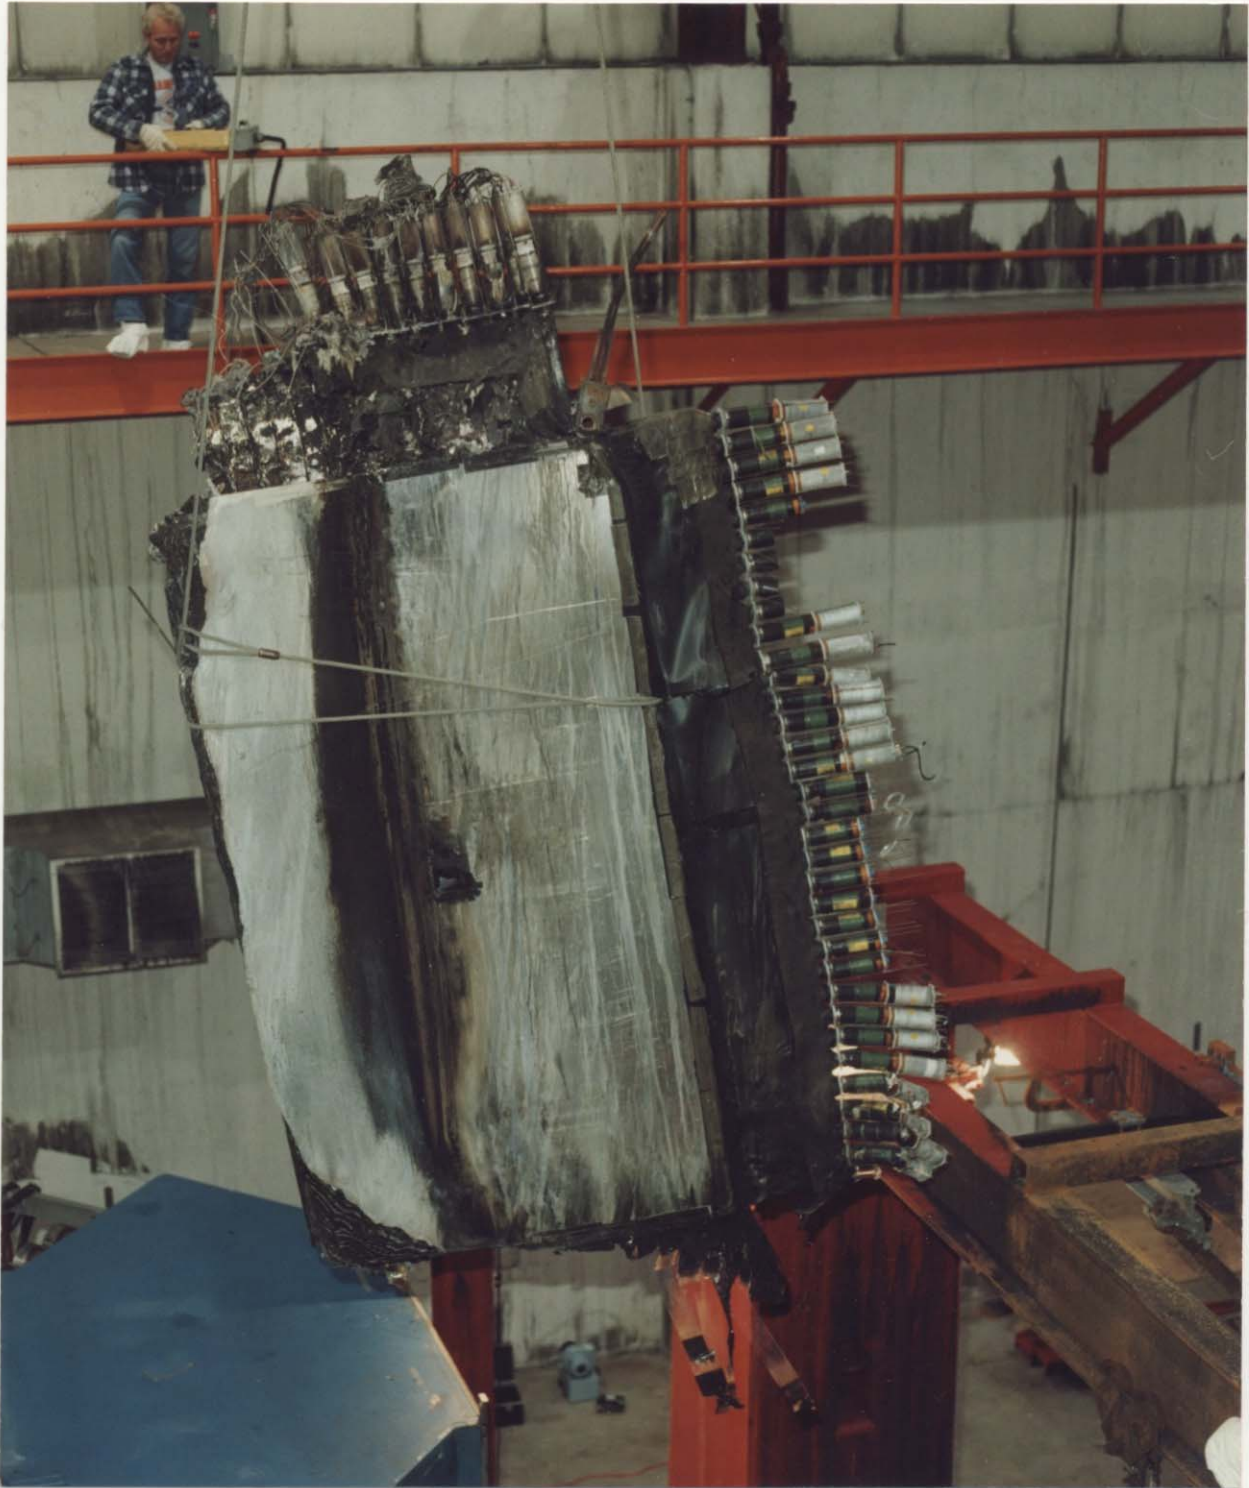
extensive on the west and bottom sides, with most of the PMTs and scintillator light guides burned off. The top received somewhat less severe damage. The east side of this module was undamaged and still had most of its PMTs and cables intact. (See Figure 18.) Thus, there was comparatively little fire on the east side of this module. A partial disassembly indicated that the majority of the internal scintillator material had remained unburned, apparently protected from heat by the lead sheets.

Figure 18. Upstream view of IEC third module after removal from fire scene. Note damage is greater on left (west) and bottom.
