**INVESTIGATION REPORT
OF THE
FIRE IN THE
WIDE BAND LABORATORY
AT
FERMI NATIONAL ACCELERATOR
LABORATORY
BATAVIA, ILLINOIS
OCTOBER 3, 1987**

**U.S. DEPARTMENT OF ENERGY
Chicago Operations Office**

FIRE IN THE WIDE BAND LABORATORY

OCTOBER 3, 1987

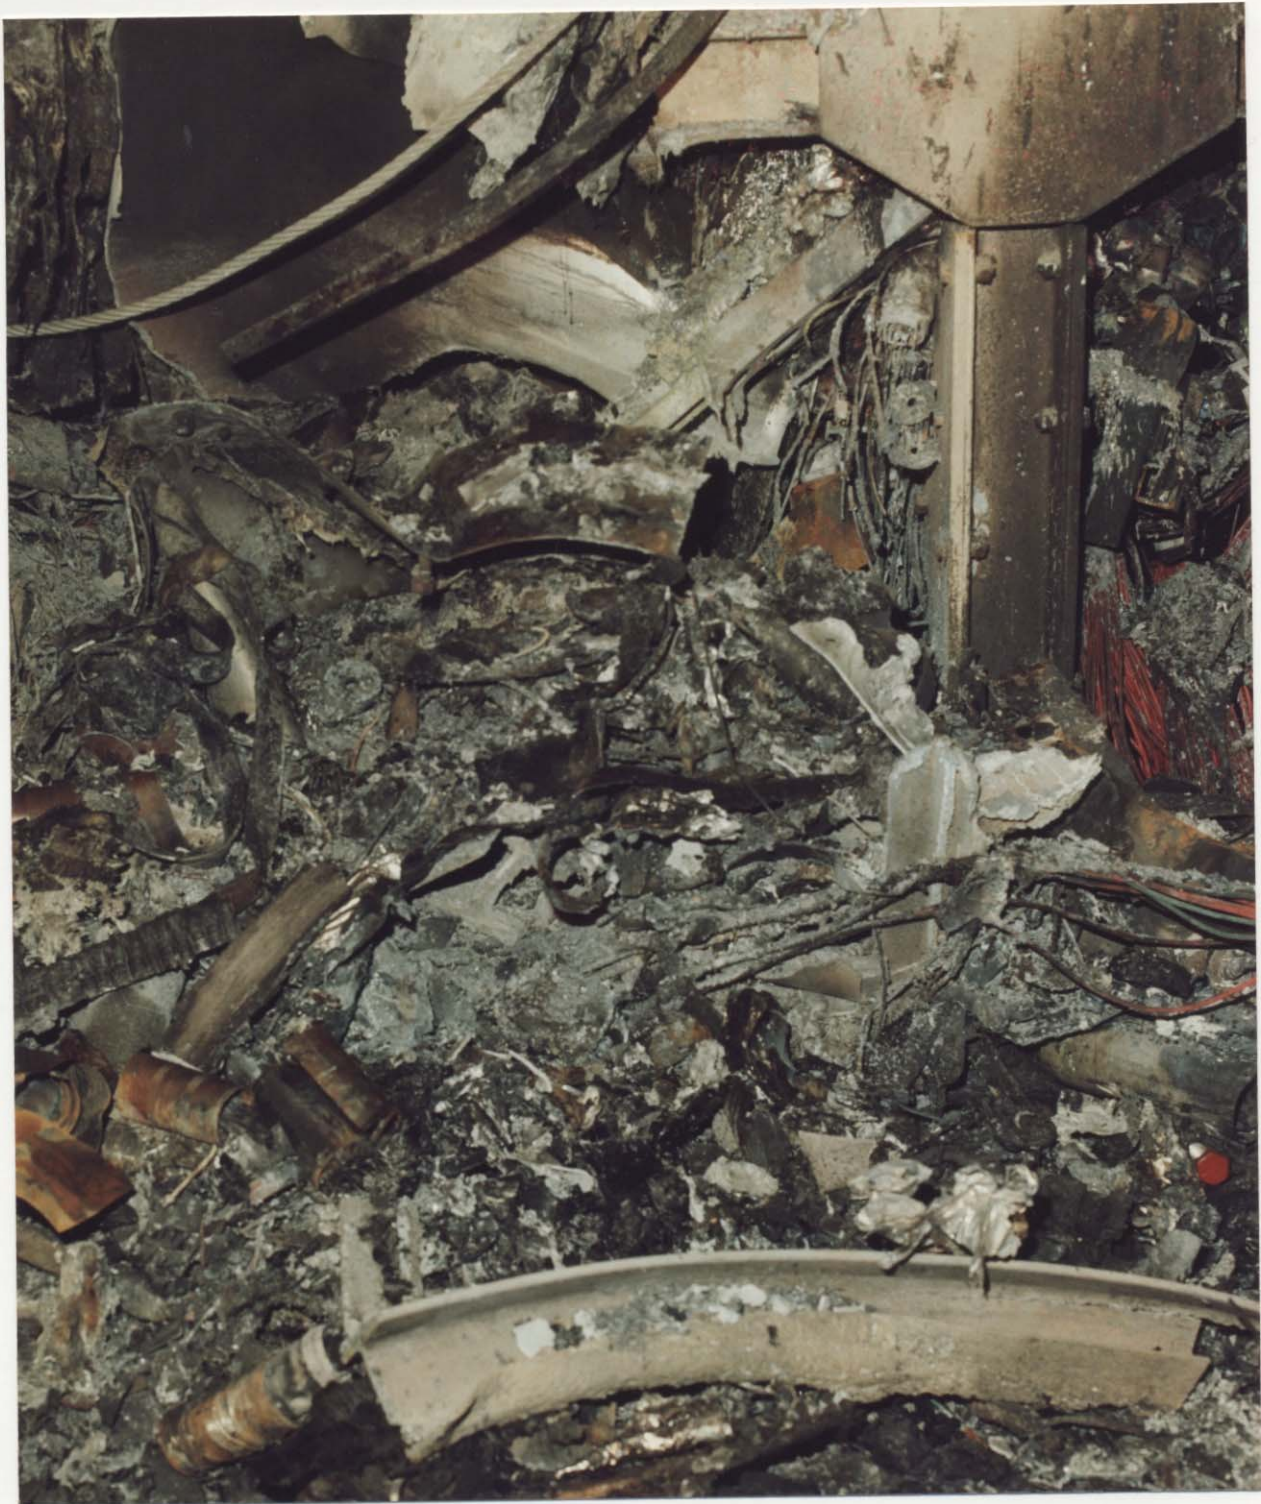
Figure 19. Rubble pile below the IEC containing damaged PMT parts, aluminum frame pieces, and burnt cables.

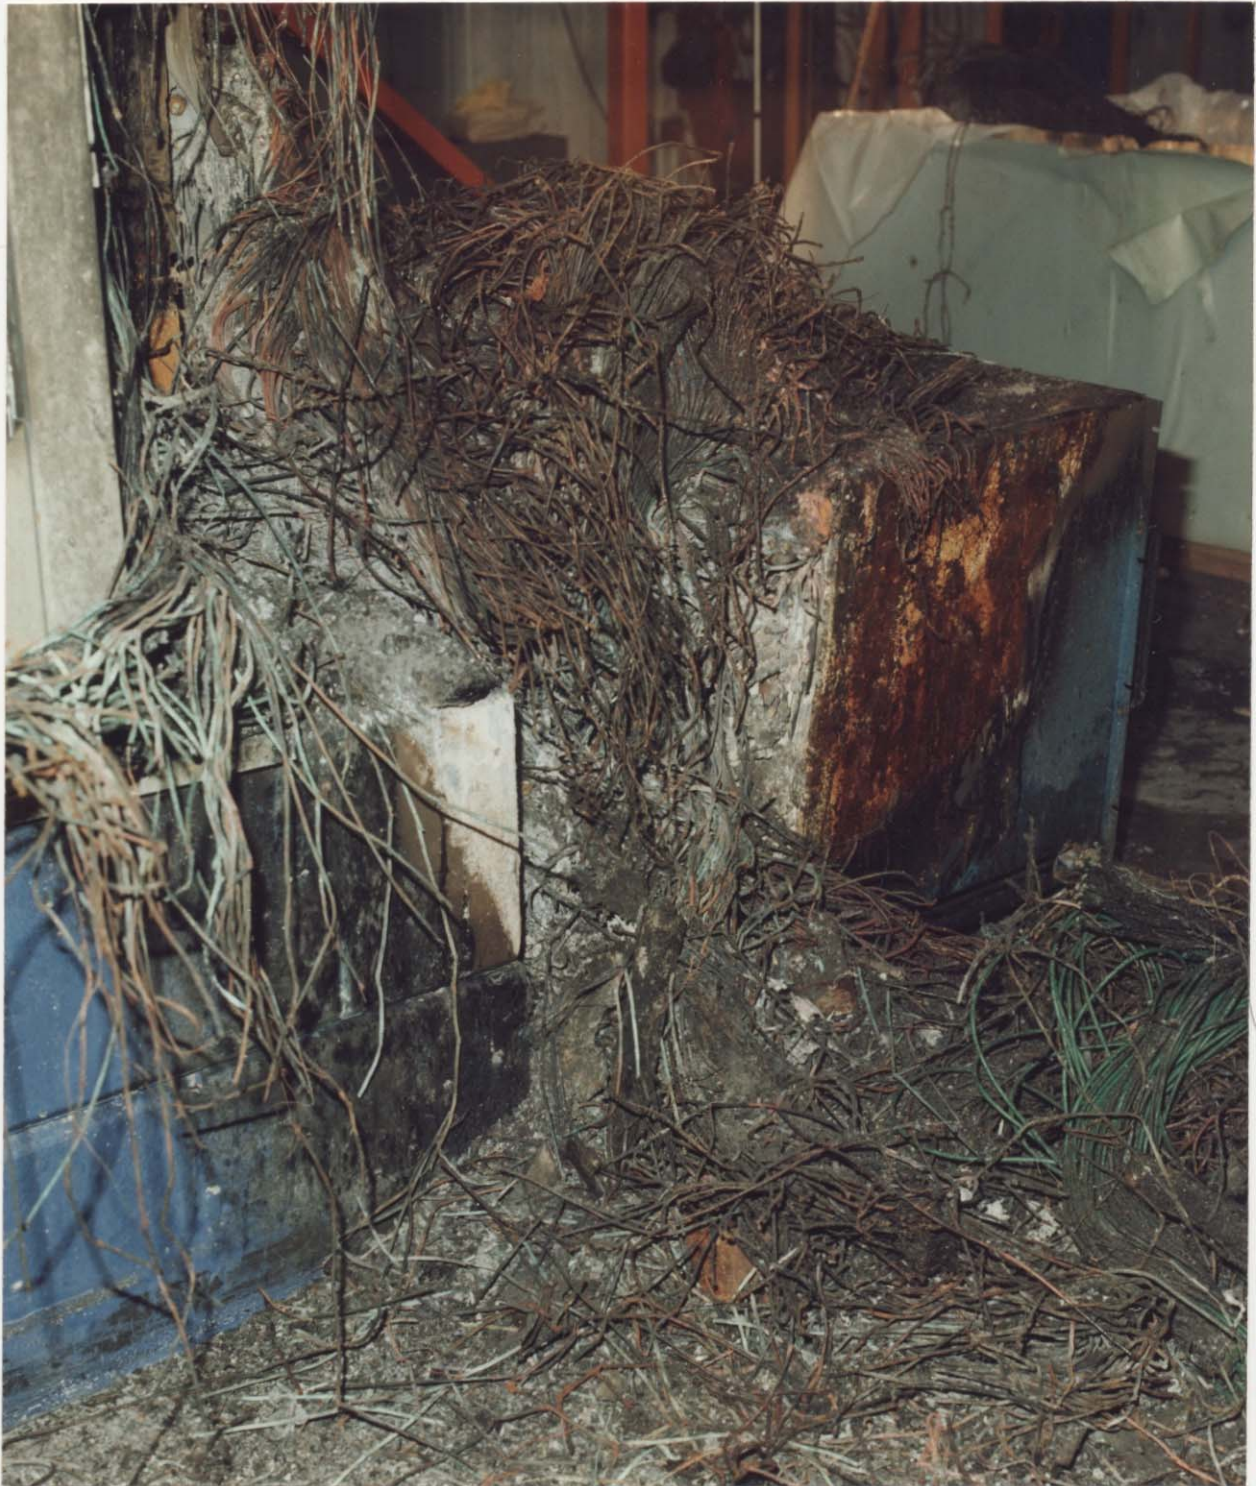
Figure 20. "V" pattern on southwest HC shielding block support and MF7 caused by burning cables.

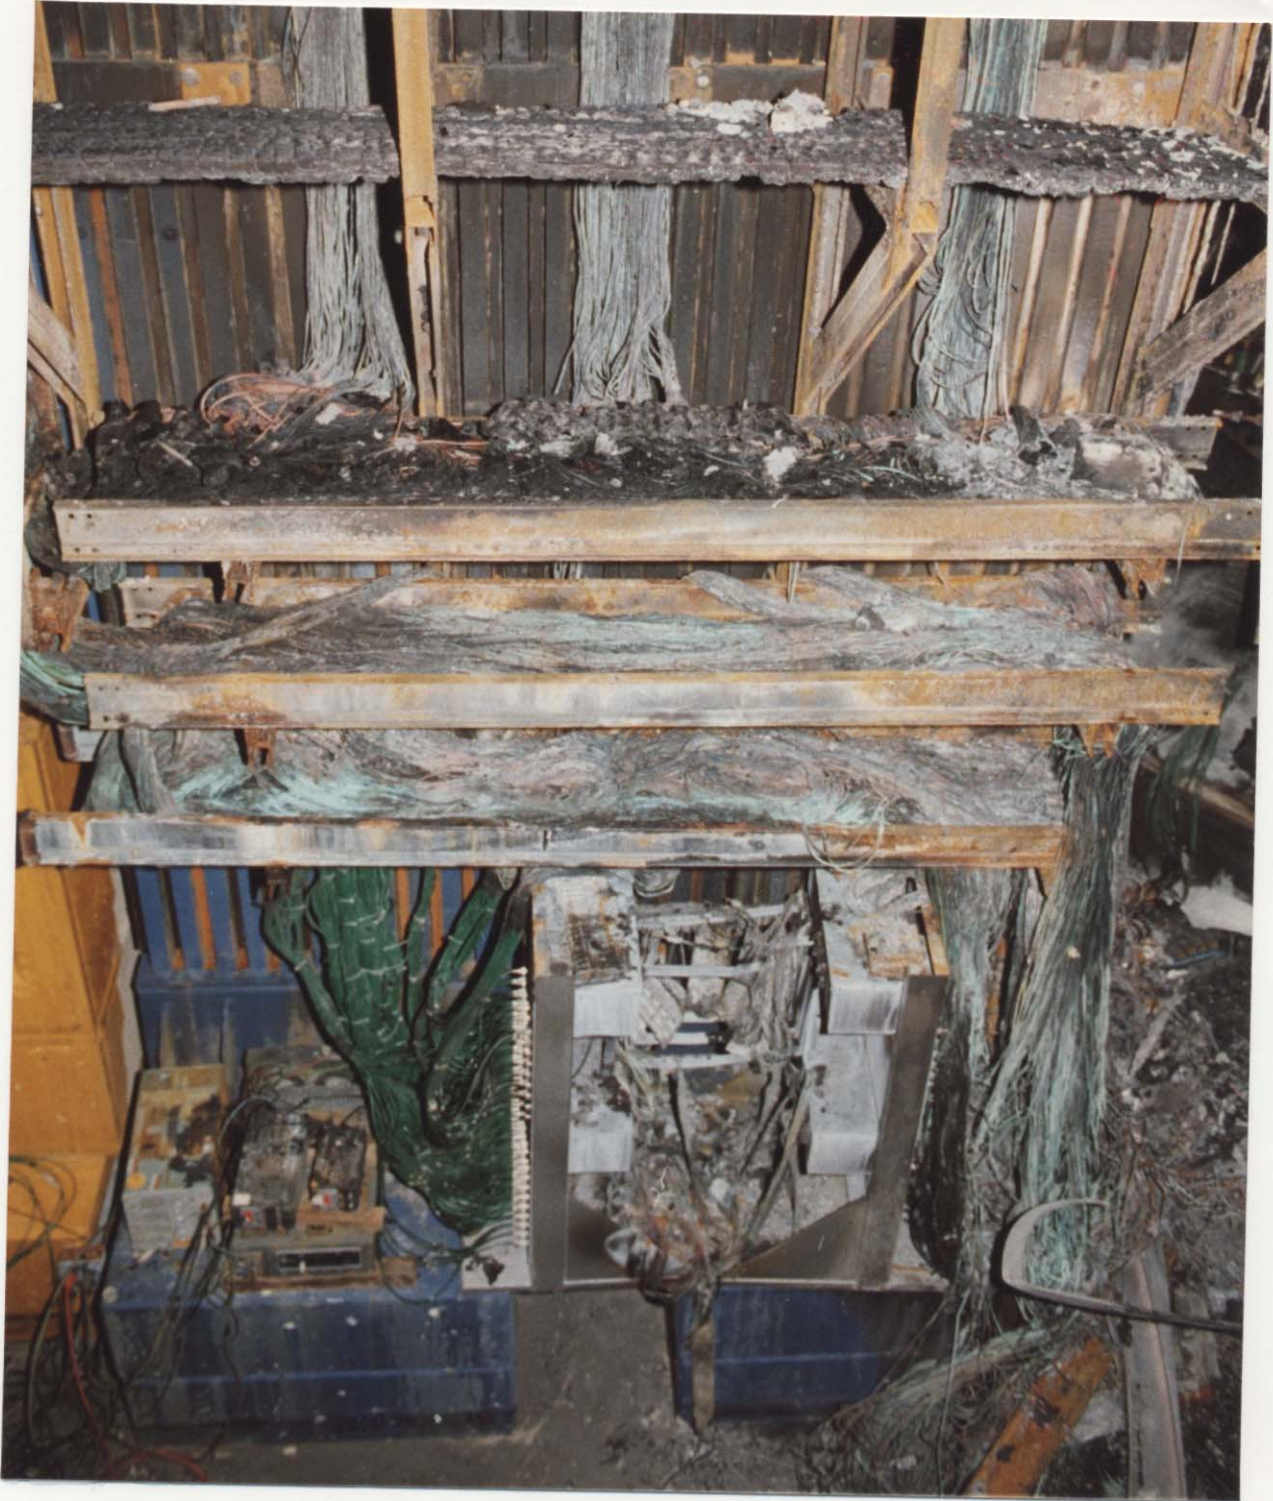
The examination then focused on the cable trays attached to the west side of the HC, as well as the dynode sum box and its associated cables. The cables in the horizontal trays were extensively damaged (see Figures 21 and 22), but for the most part, not as severely as the vertical runs. The dynode sum box was also badly damaged and was removed for further examination (see IV.B.5.). Most of the cables on the north side of the sum box were undamaged, while most of those on the south side were burned. This also suggested a fire origin near MF7.

Figure 21. Fire damage to west side of HC.

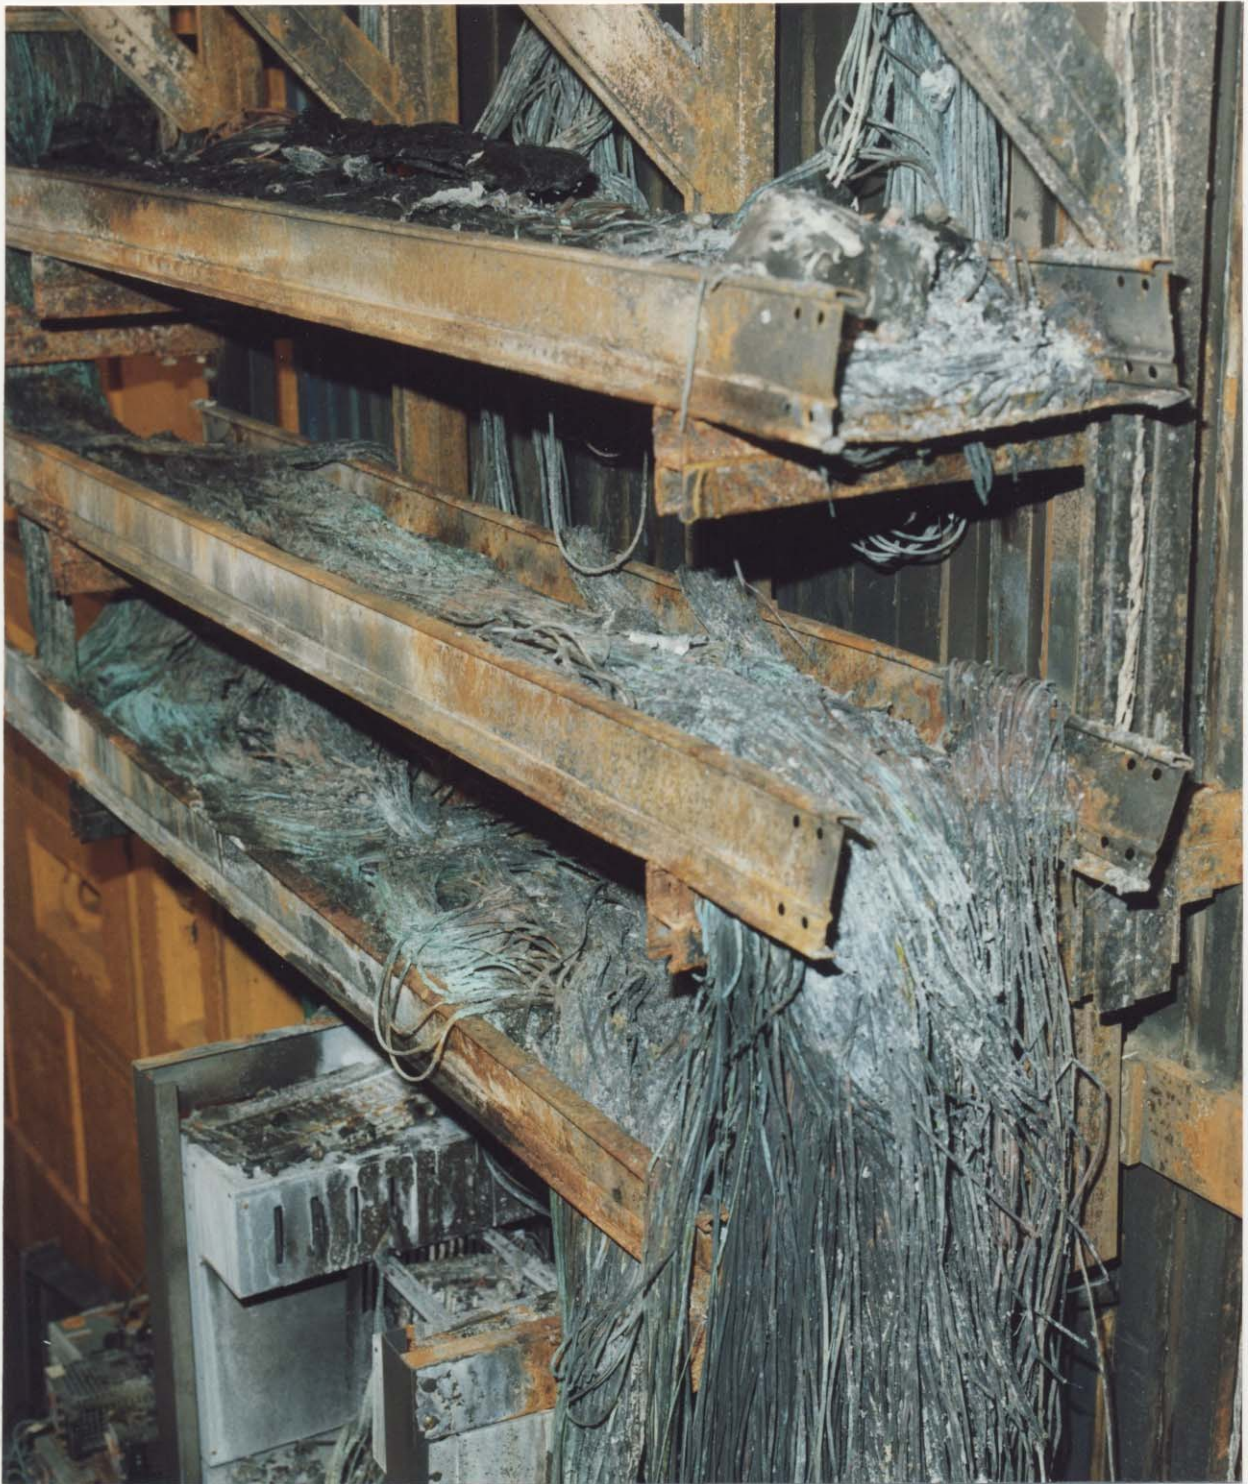
Figure 22. Fire damage to cables in trays on west side of HC.

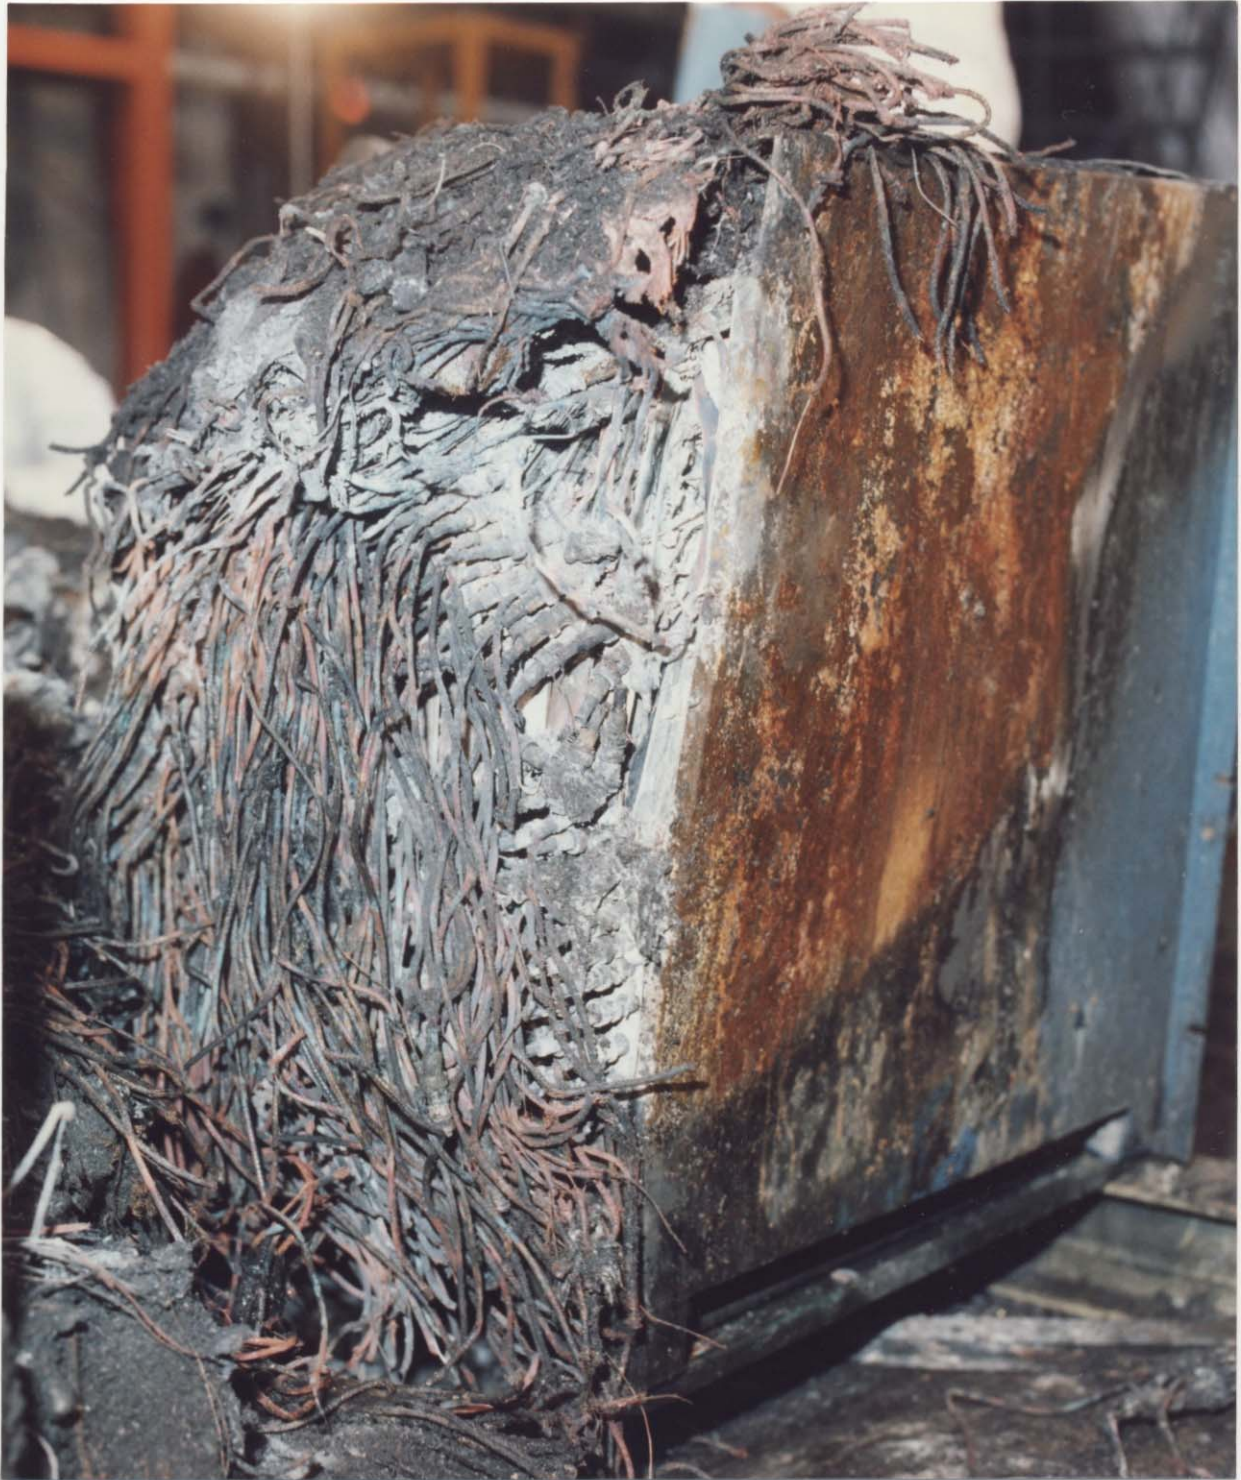
Extensive damage was observed both outside (see Figure 23) and inside the unit. The examination indicated that the damage was caused by external heat and mechanical stress. No evidence of internal failure that would have implicated MF7 as a source of the fire was observed.

Figure 23. Extensive fire damage to rear of MF7. The top has been mechanically damaged from weight of fallen cables.

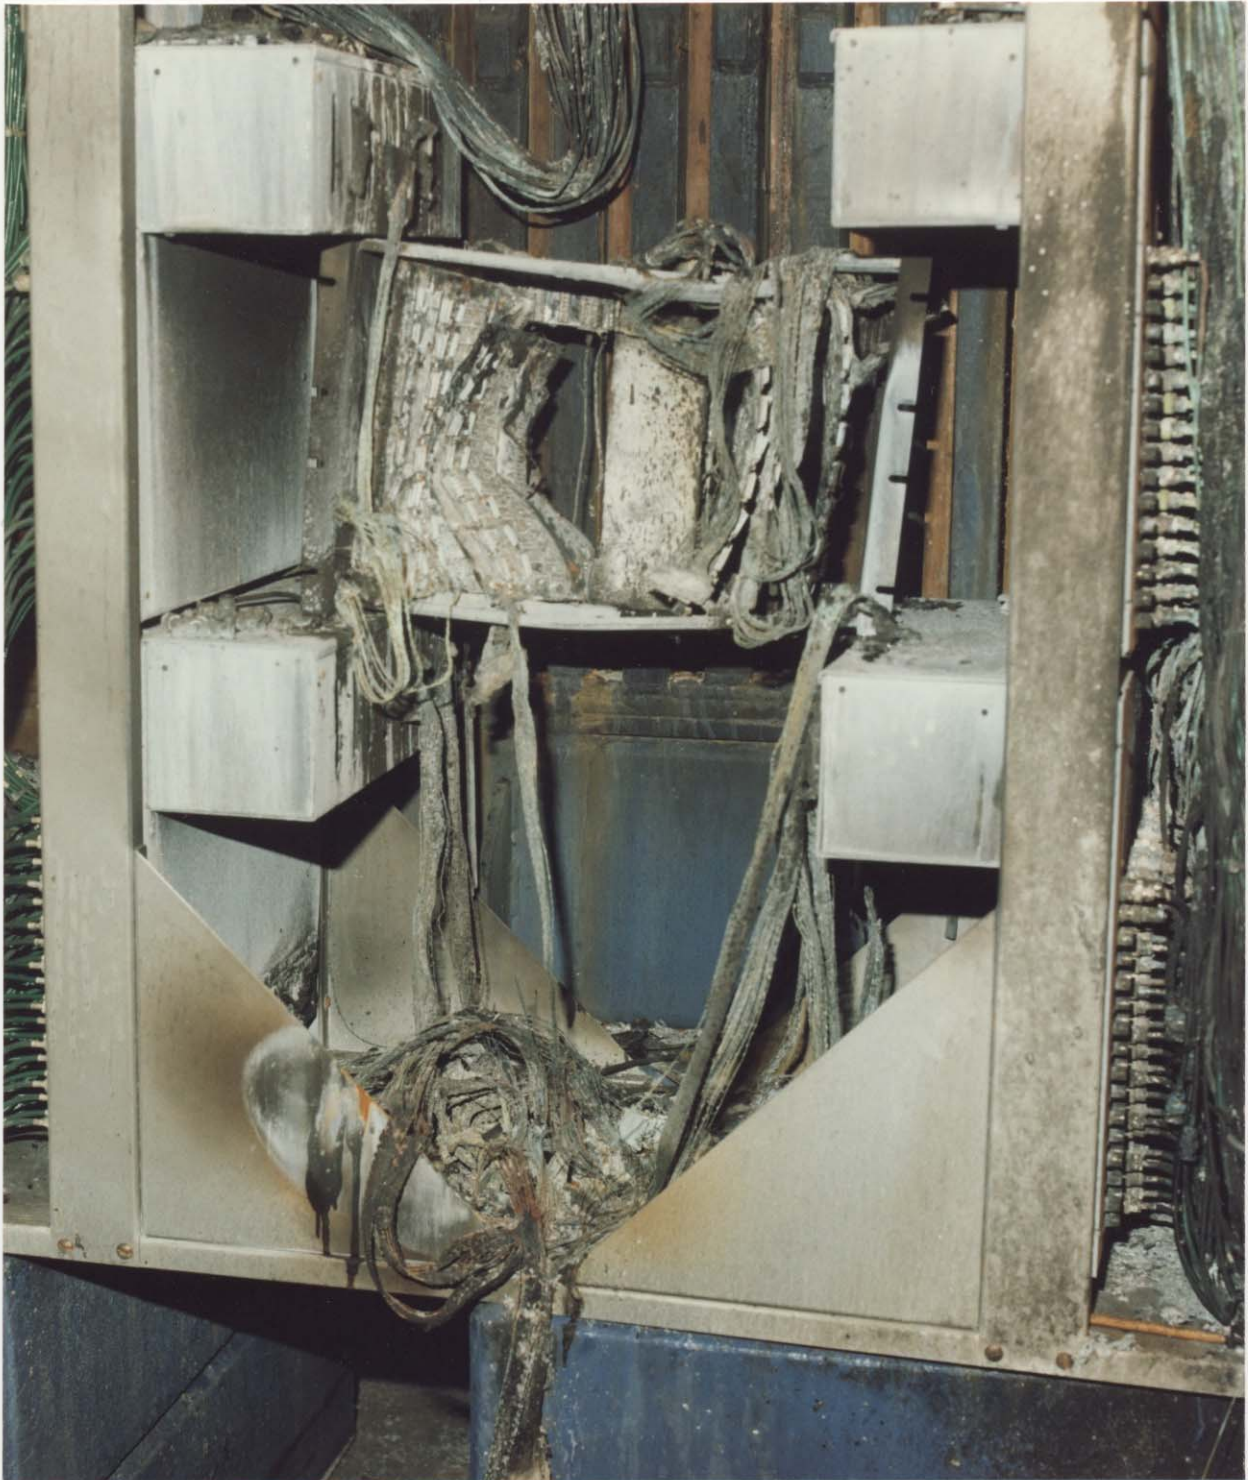
Figure 24. Fire damaged dynode sum box. Discriminator boards are in center of unit.

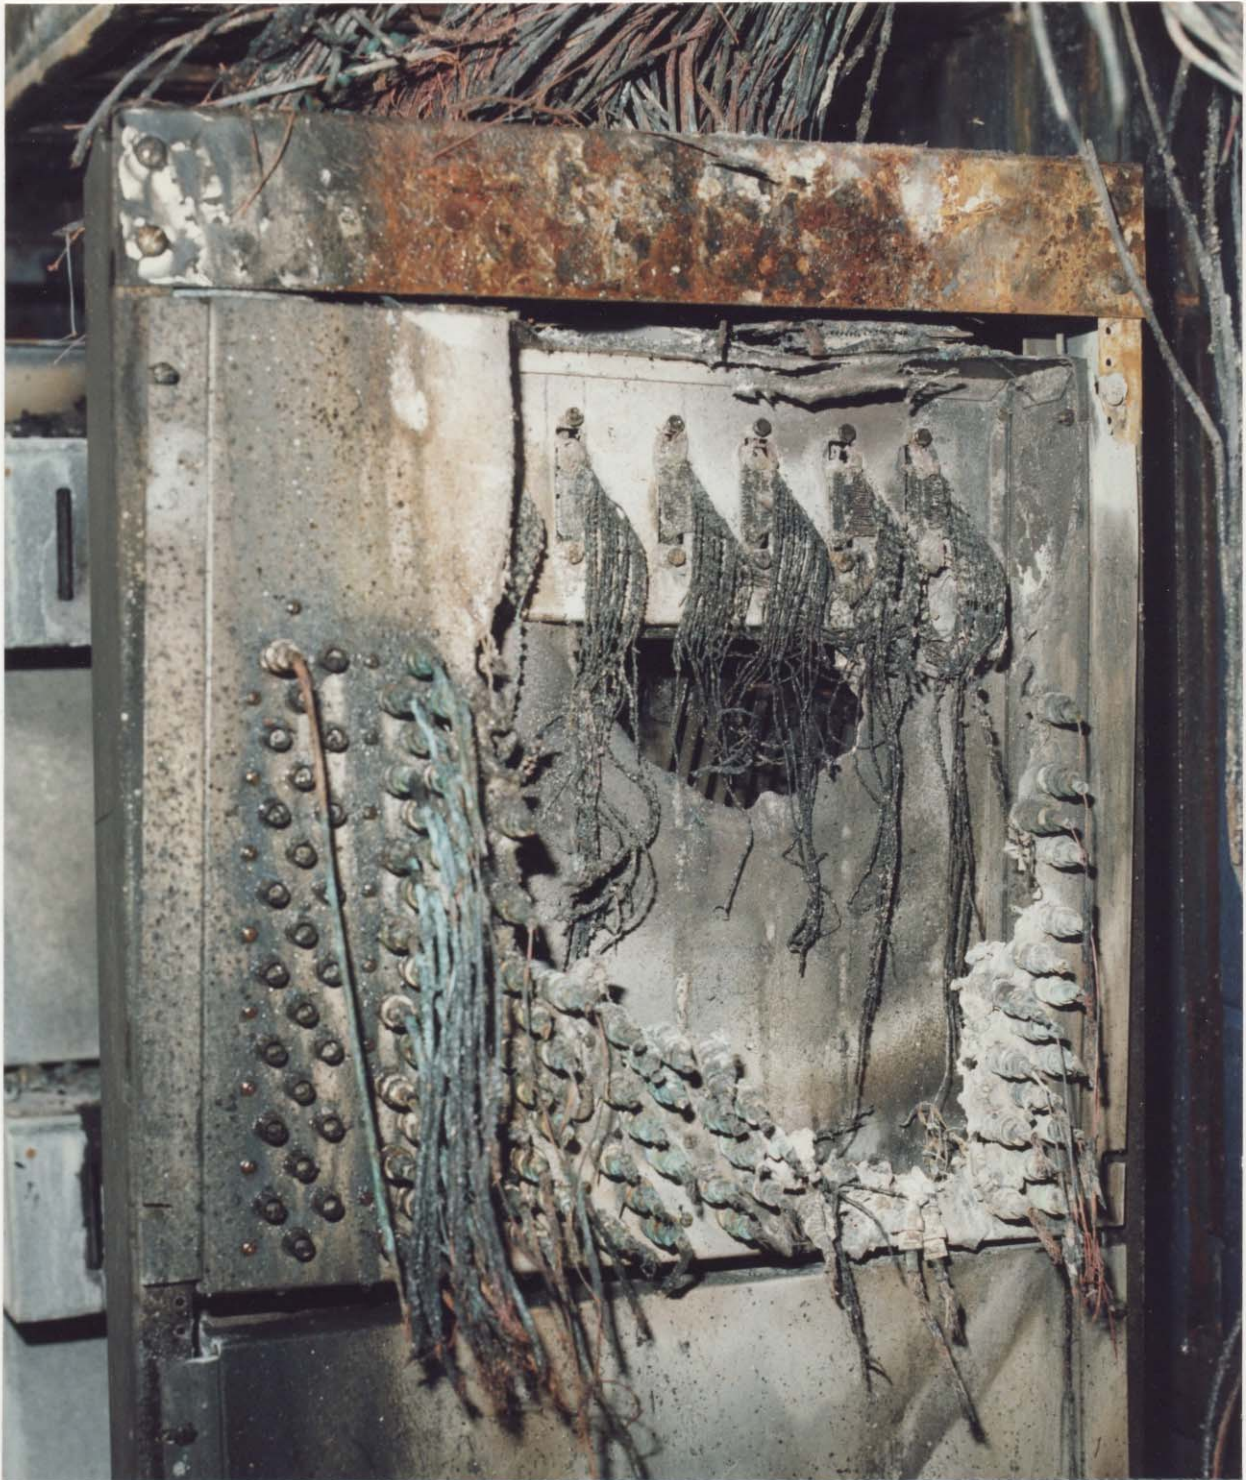
Figure 25. Upstream side of dynode sum box. Cable fire has melted exterior aluminum panel and a smaller portion of interior panel.

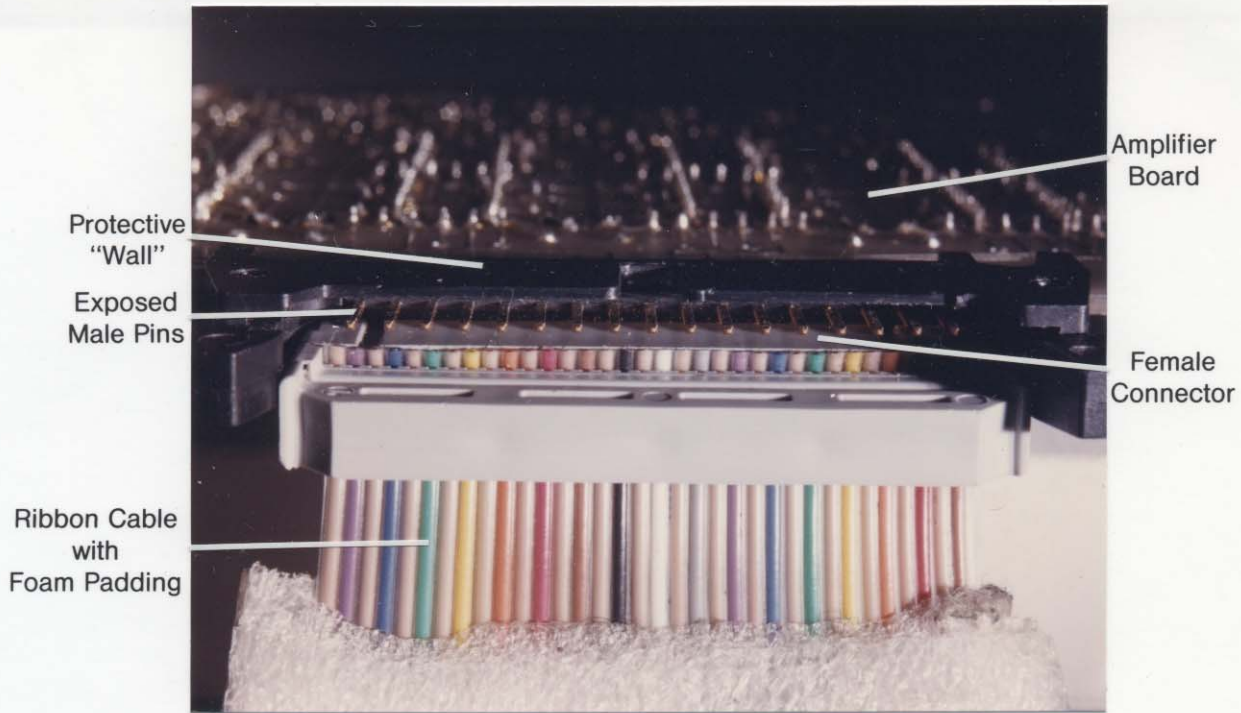
Figure 26a. Misregistered 34-pin connectors. Note row of exposed male pins. Cable and connectors are same type as those in dynode sum box.

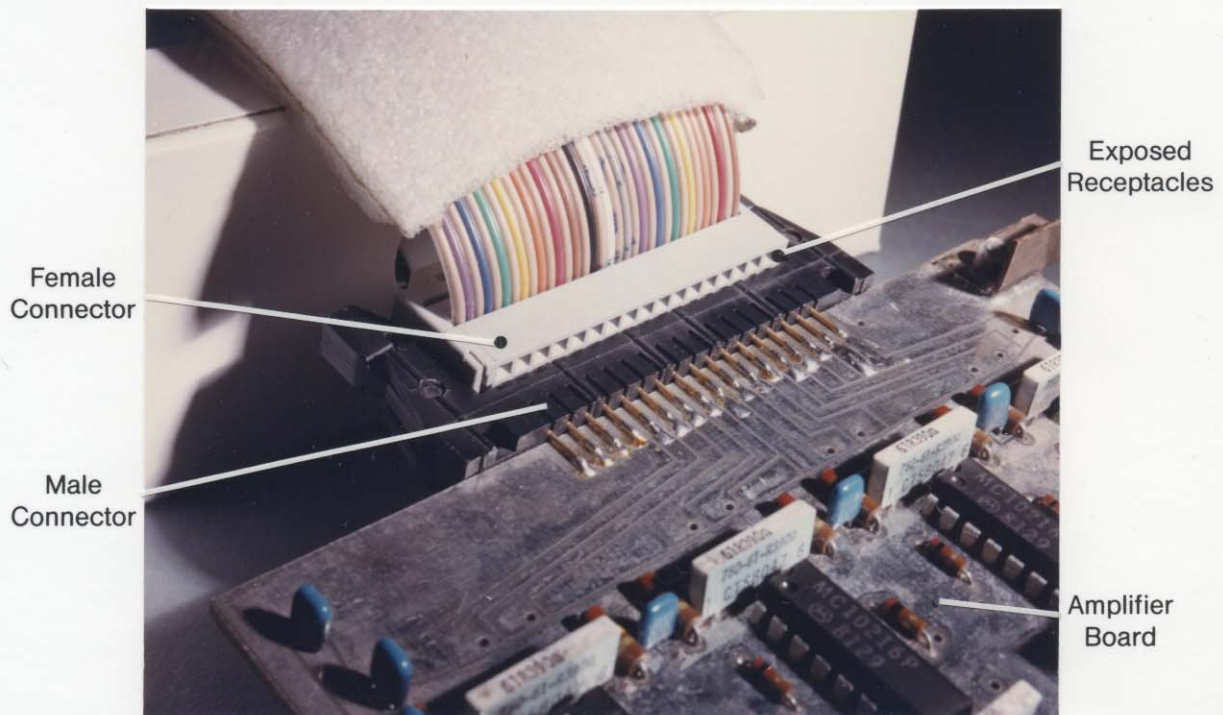
Fig. 26b. Misregistered 34-pin connectors. Note exposed female receptacles and absence of protective "wall" on male connector.

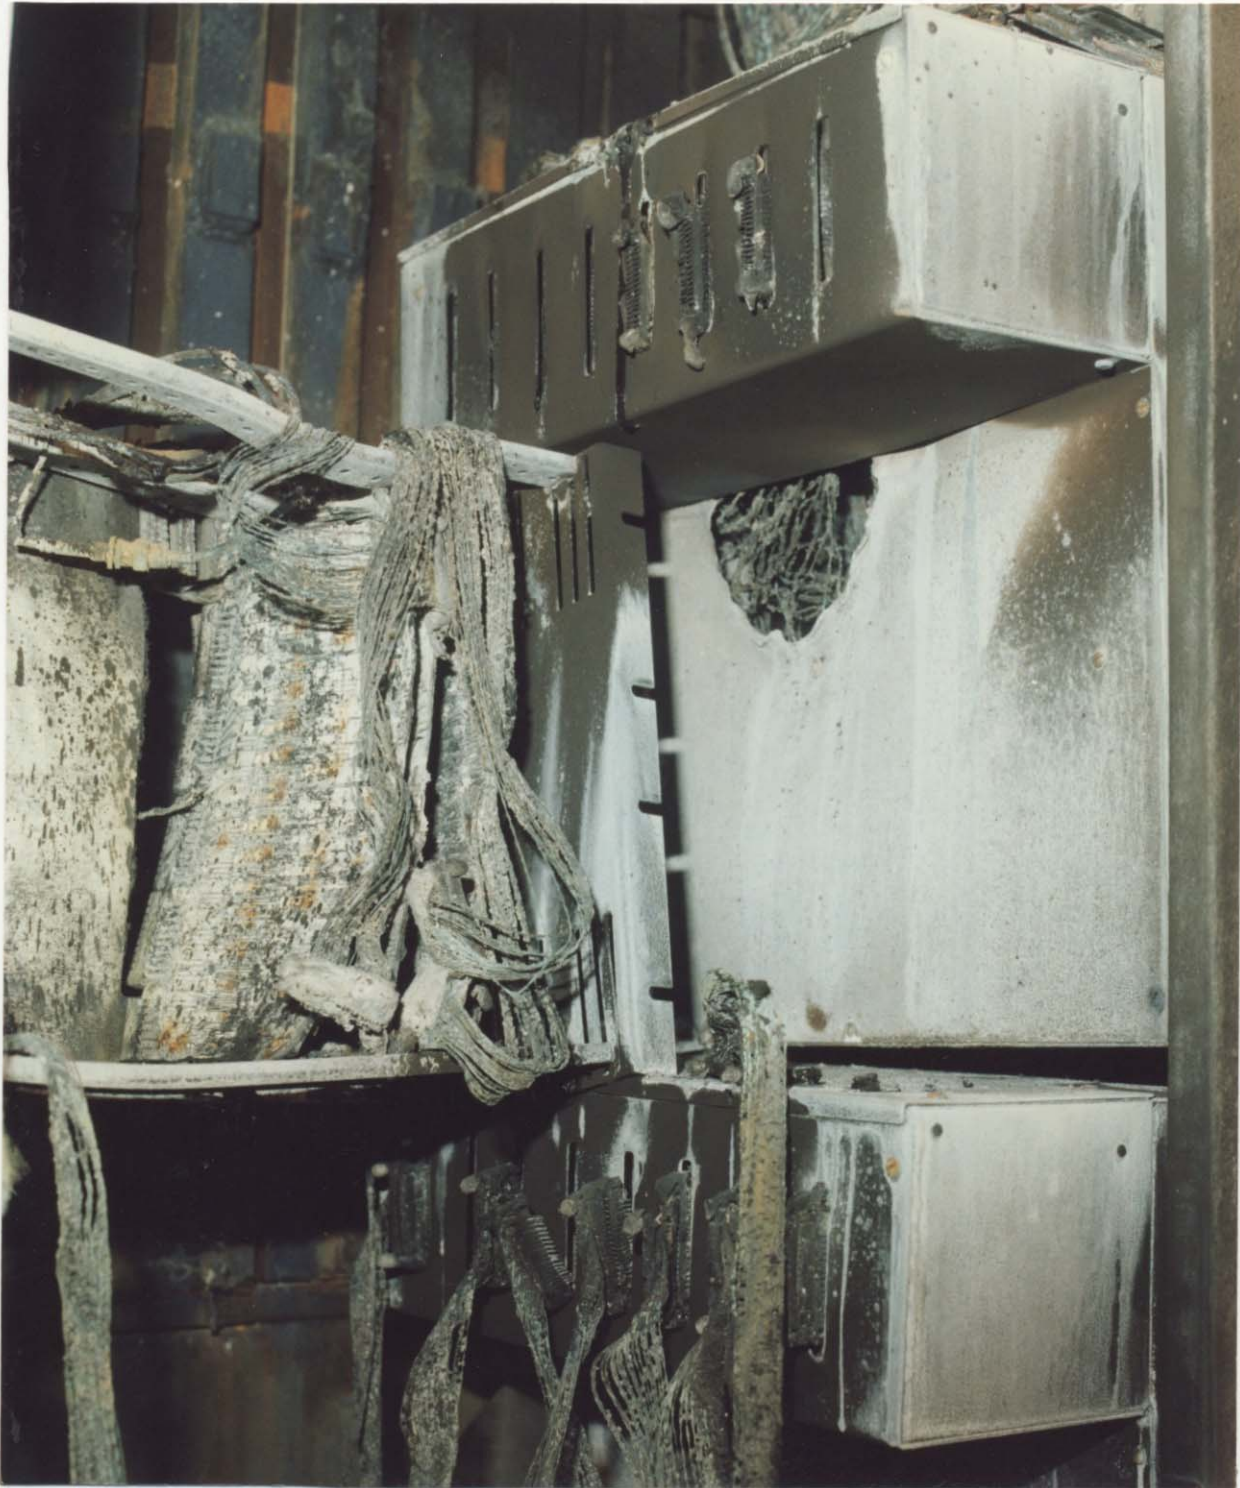
Figure 27. Interior of upstream side of dynode sum box. Connectors handled immediately prior to fire are on lower chassis box. Suspect connector is third from outside.

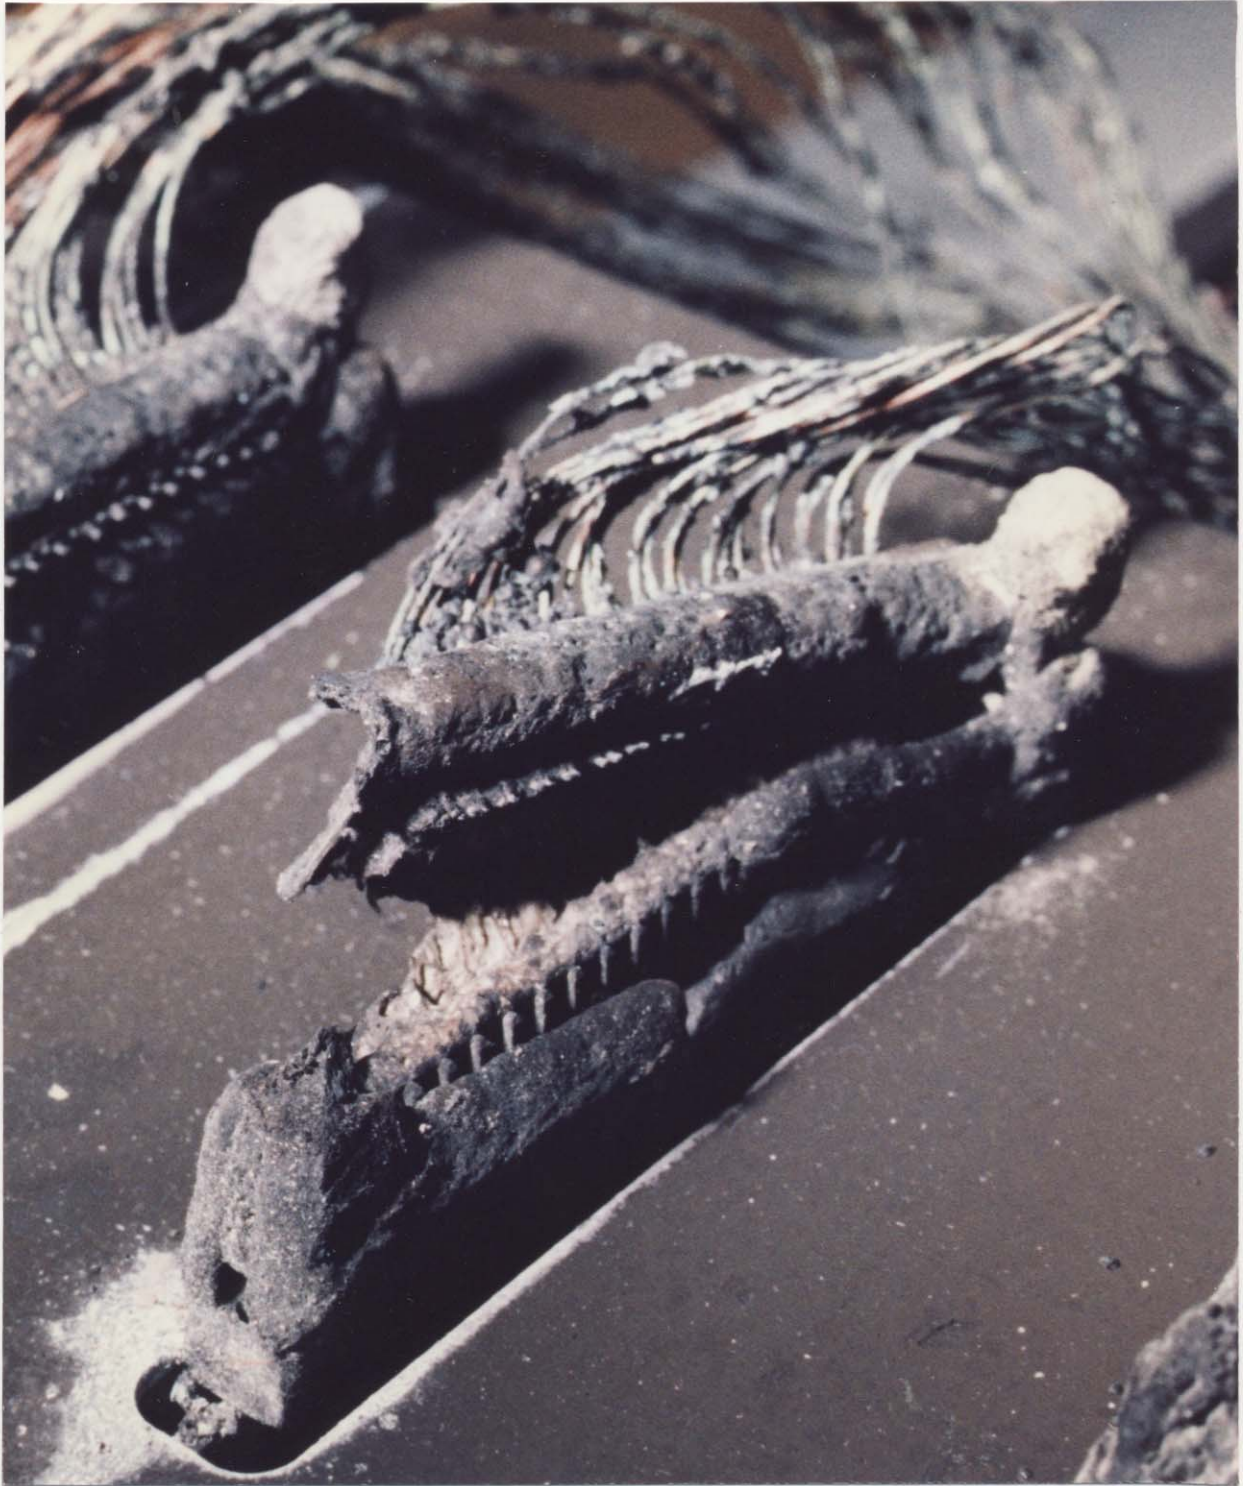
Figure 28. Closeup of suspect connector on lower upstream chassis box. Note lack of plastic on right side of pins.

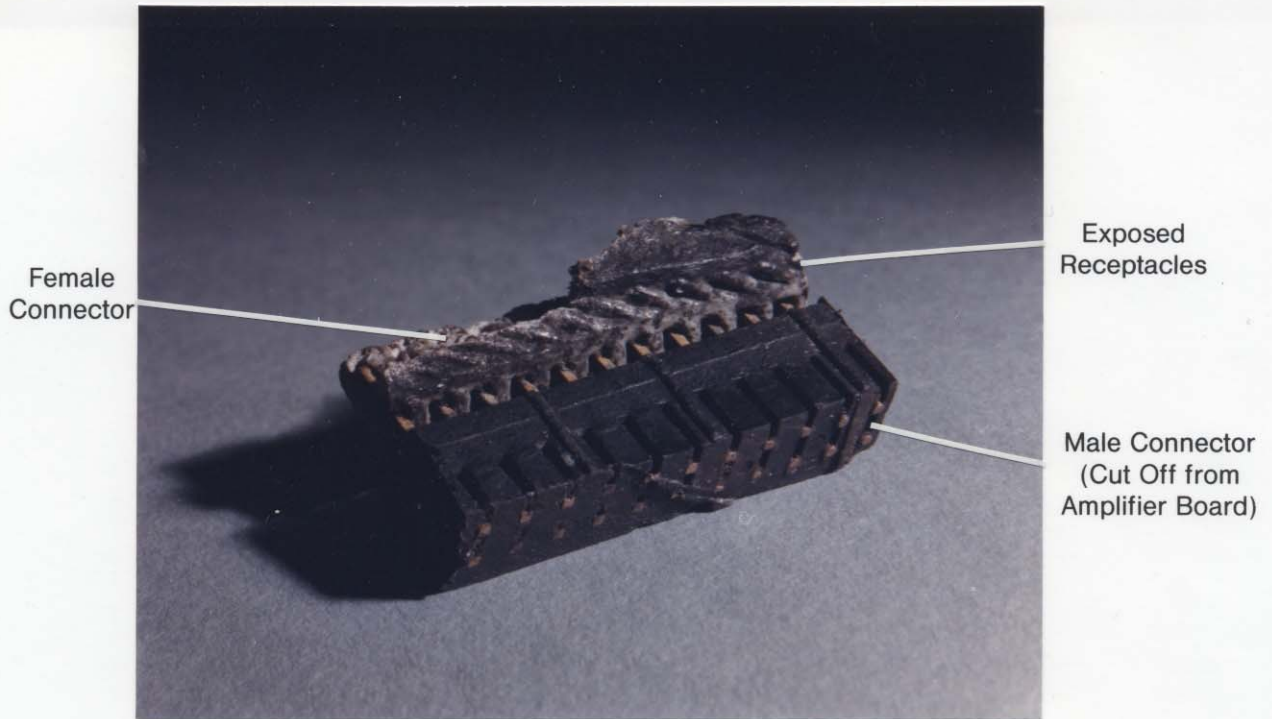
Figure 29a. External view, section of suspect 34-pin connectors. Note exposed row of female receptacles; deformed by partial melting of female connector.

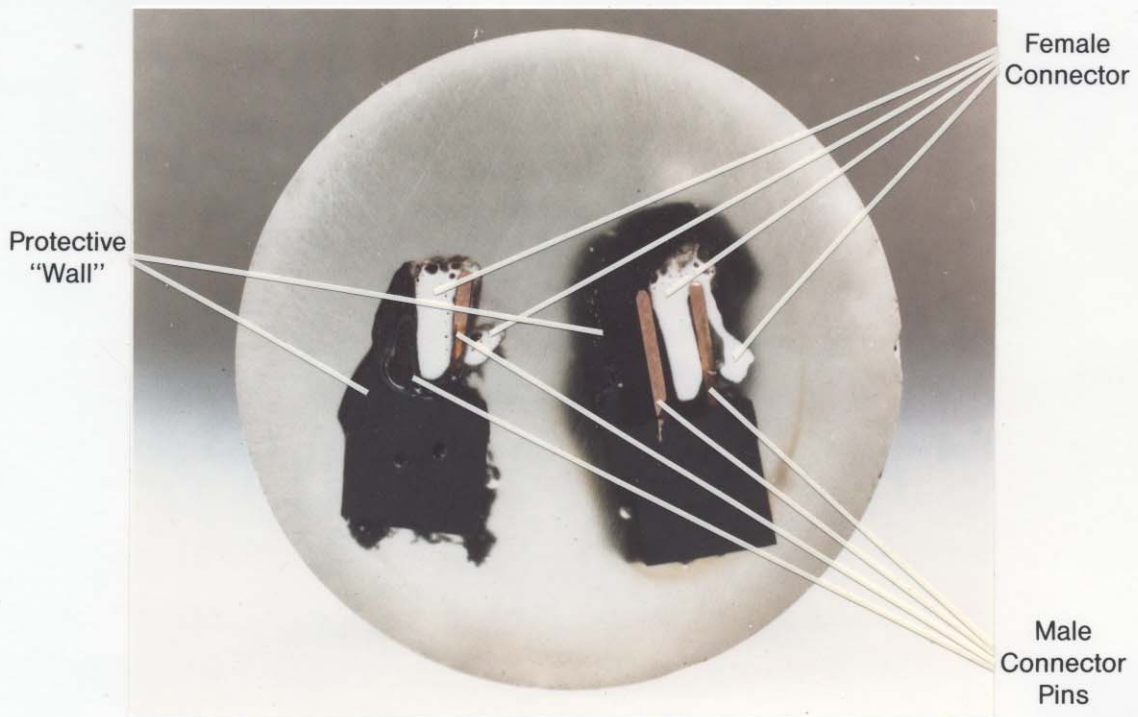
Fig. 29b. Cross-sectional views of suspect connectors. Note absence of gray plastic (female connector) on left side of pins.
