**Technology Report 77-2**

**THE BROWNS FERRY NUCLEAR PLANT FIRE**

ANDREW J. PRYOR  
U.S. Energy Research  
and Development Administration  
Albuquerque, New Mexico

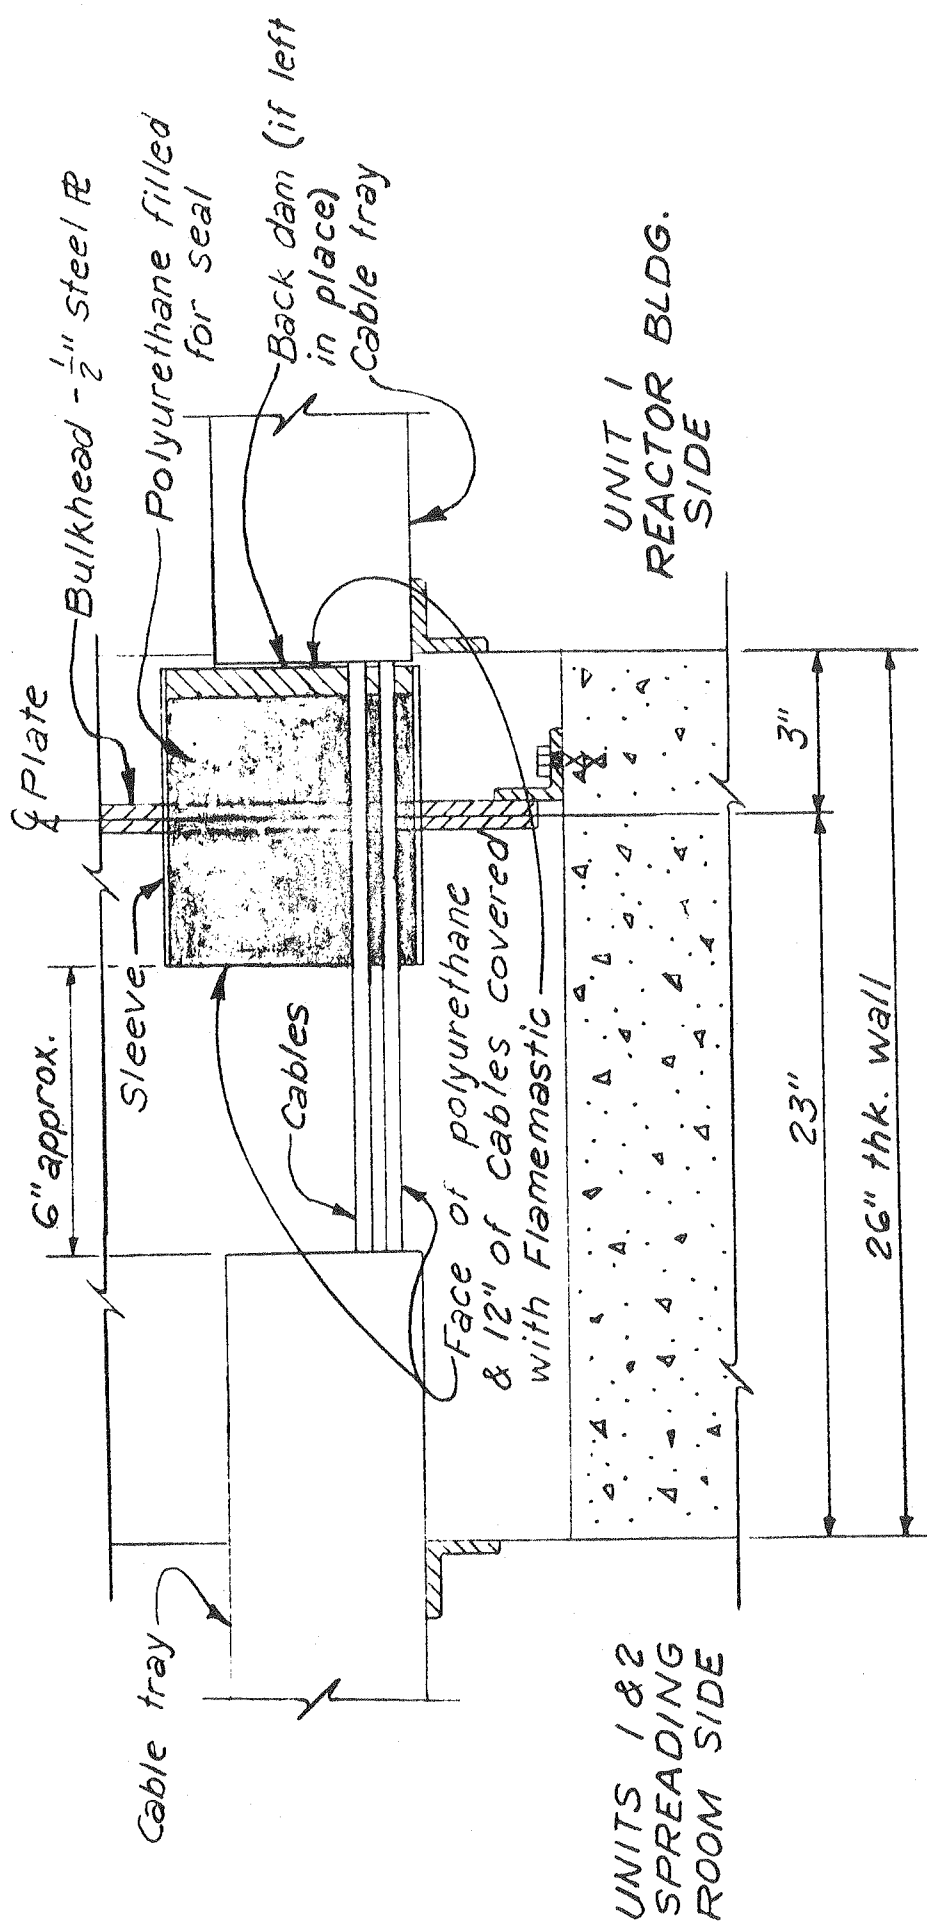
FIGURE 10  
 PARTIAL CROSS SECTION OF PENETRATIONS  
 (TO SHOW BULKHEAD LOCATION IN WALL AS CONSTRUCTED)

The cable penetration of concern is an array of 10 trays, two stacks of five. These 10 trays pass through a 1.22m x 1.22m (4'x4') opening in the 66cm (2') thick reinforced concrete wall between the Cable Spreading Room and the Reactor Building. Design for the pressure differential seal and firestop consisted of a steel plate having 10 sleeves measuring 13cm x 46cm (5"x18"), one for each tray. The cable tray stops at the wall, the cables span a short distance, about 25cm (10") pass through the sleeve, span another 25cm distance, then back into the tray on the other side. The sleeve was then filled with foamed-in-place polyurethane. A fire retardant or protective material was then applied on each of the exposed polyurethane faces. As installed, however, the seal/firestop was placed at the Reactor Building side of the wall rather than the center of the wall. Also, at the time of concern, the protective coating was not in place as designed.

*The cable trays and seal/firestop installation did not meet design criteria; some of the trays were overloaded, not installed in accord with design, nor maintained in accord with design.*

NOTE: FIRE STARTED IN SECOND PENETRATION FROM BOTTOM - TRAY VE

Removal of the urethane foam fire-stops and replacement with a silicone seal which has been tested and proved adequate for the purpose.

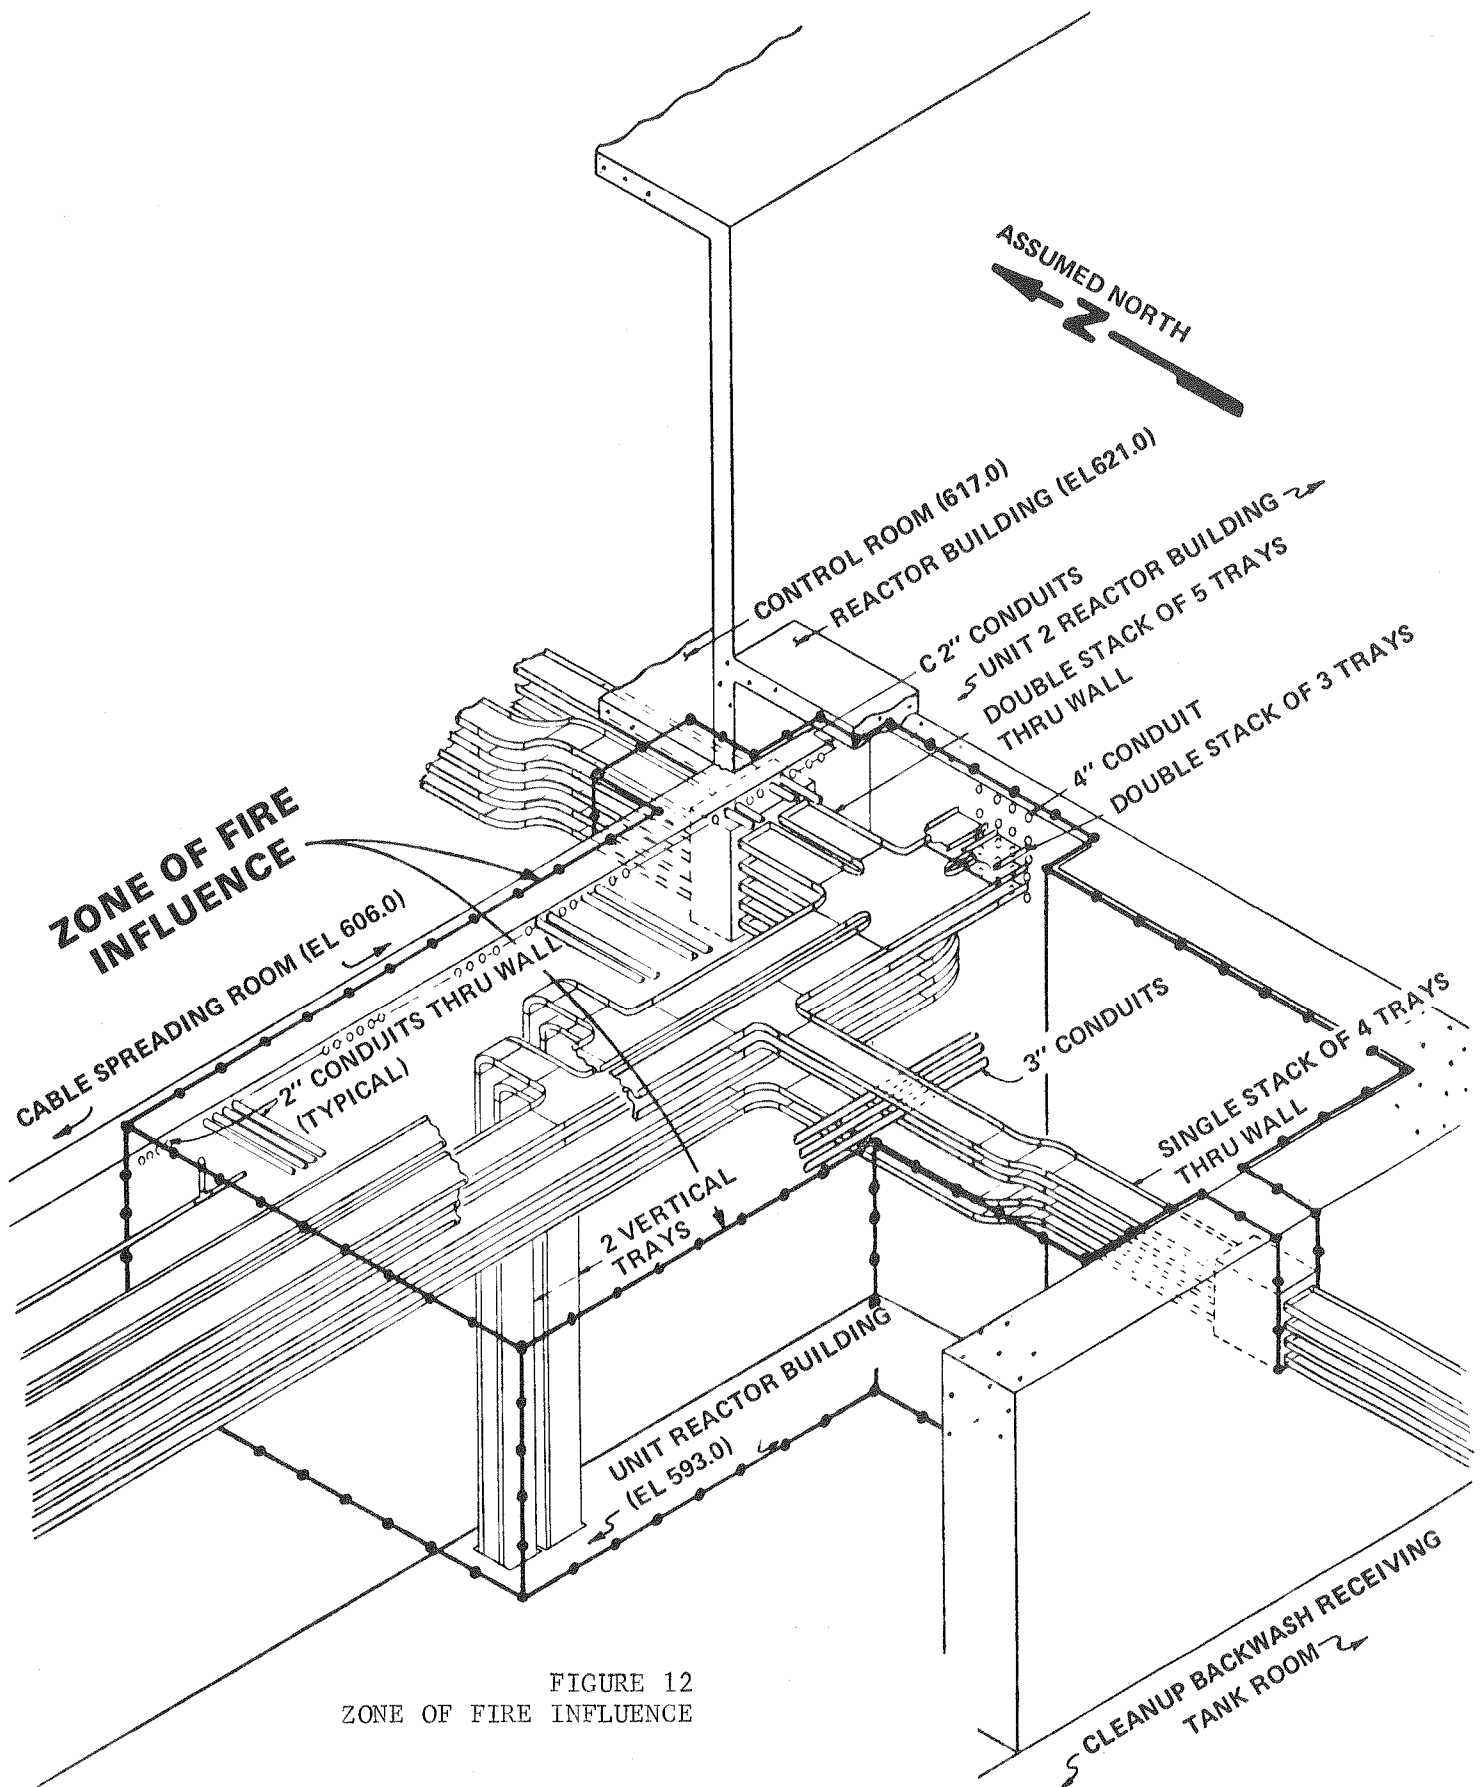
FIGURE 12  
ZONE OF FIRE INFLUENCE

The fire originated at the seal/firestop on the Cable Spreading Room side, passed through the seal and then burned along cables to cover an area roughly 9m x 12m (30' x 40'). A total of approximately 2,000 individual control, signal or power cables were burned. It is estimated that about 1815 kg (4,000 pounds) of polyvinyl chloride insulated cable burned releasing an estimated 635 kg (1,400 pounds) of chloride to the Reactor Building.

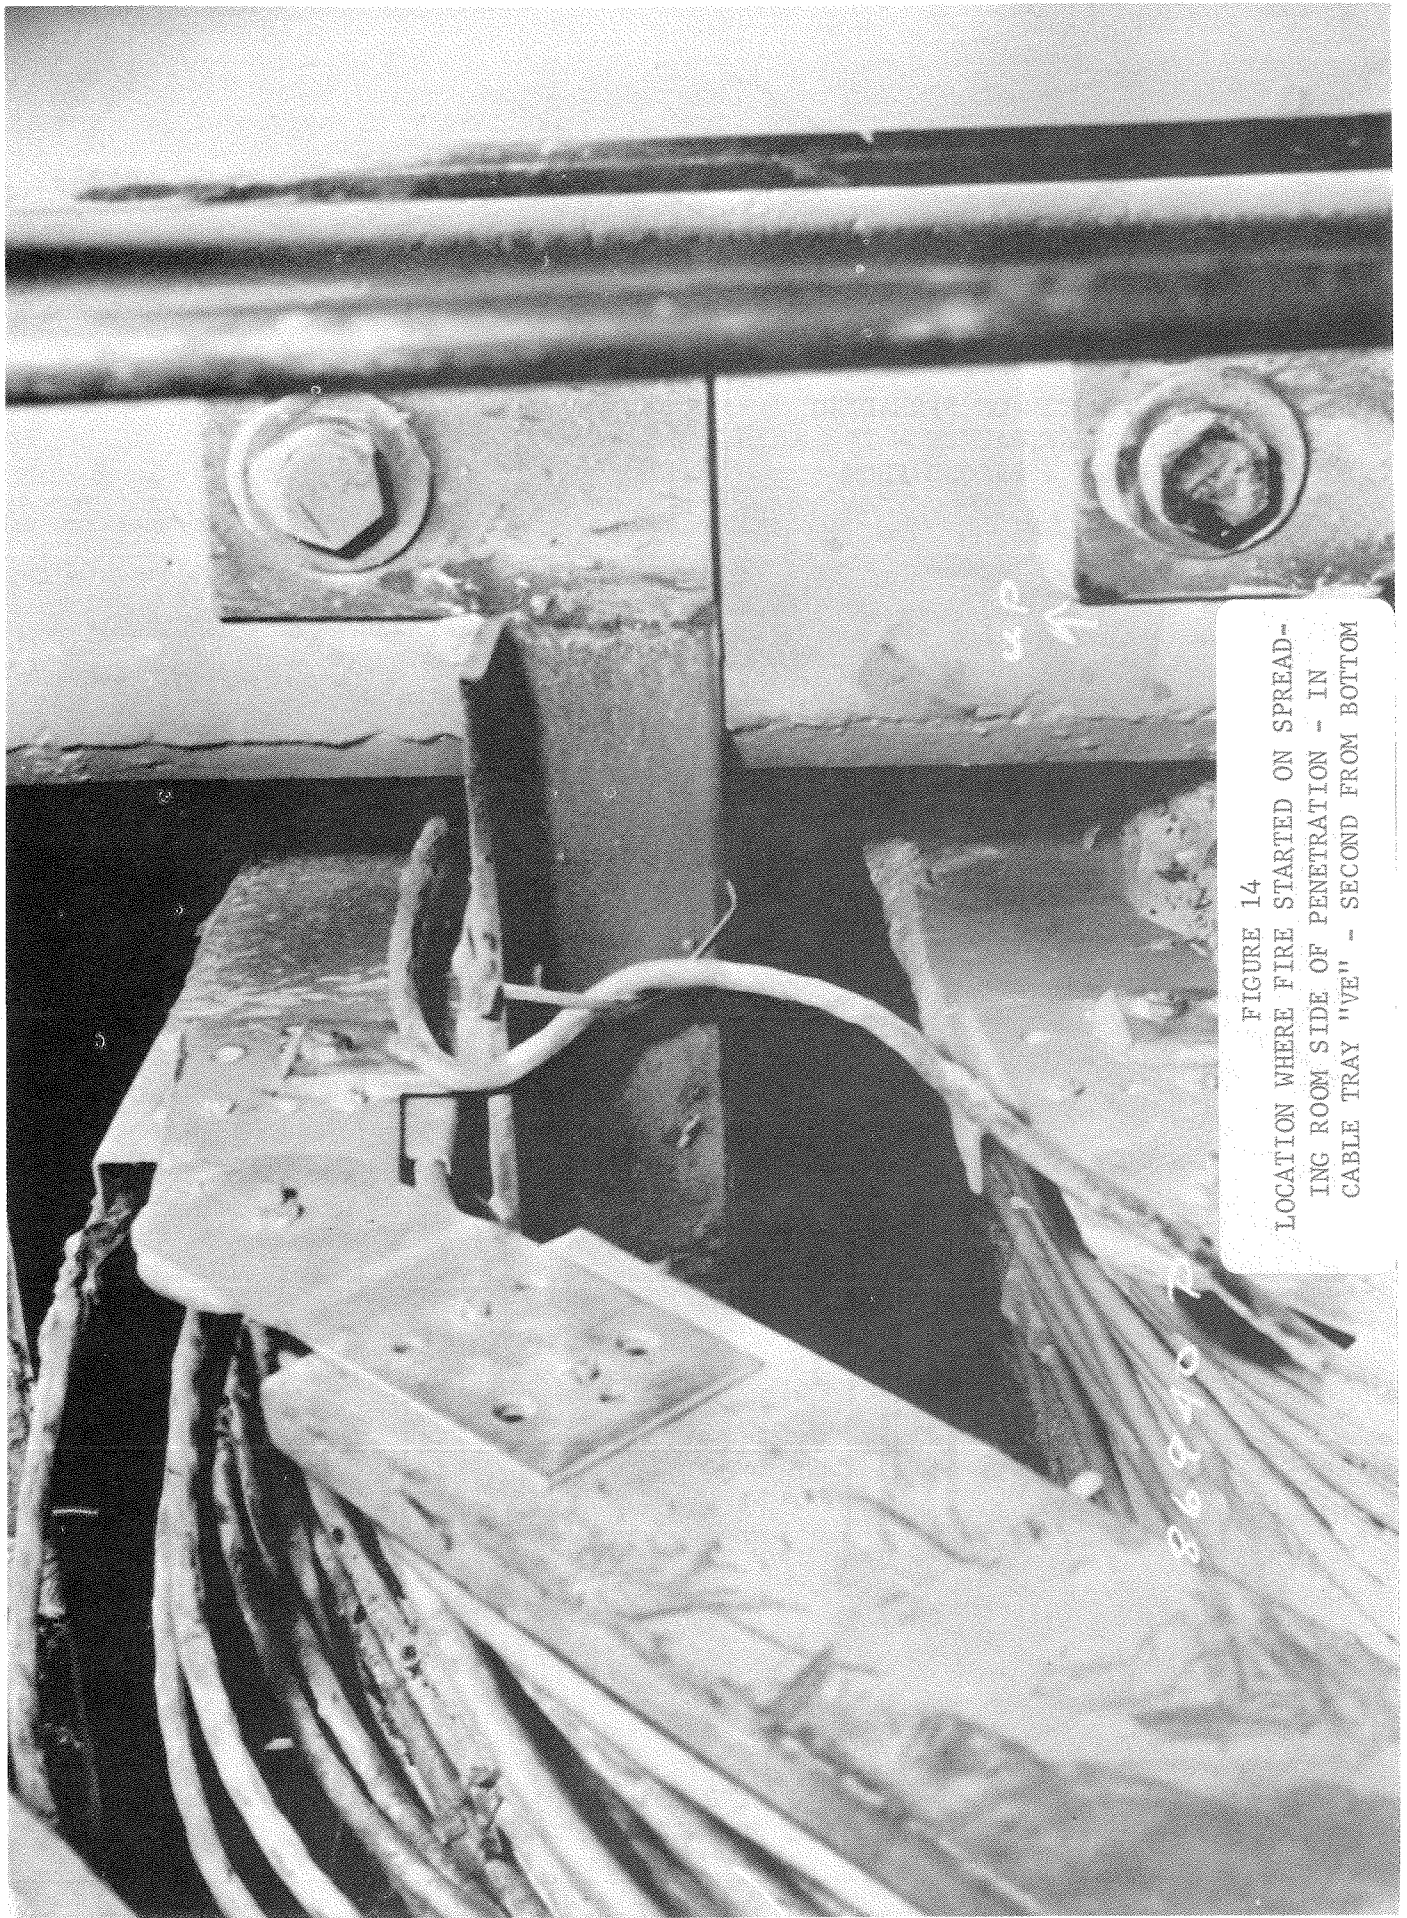
The candle flame was drawn toward the seal/firestop because of the airflow and the sheet-foam material ignited.

WHERE FIRE STARTED ON SPREADING ROOM SIDE OF PENETRATION - IN CABLE TRAY "VE" - SECOND FROM BOTTOM

FIGURE 14  
LOCATION WHERE FIRE STARTED ON SPREADING ROOM SIDE OF PENETRATION - IN CABLE TRAY "VE" - SECOND FROM BOTTOM

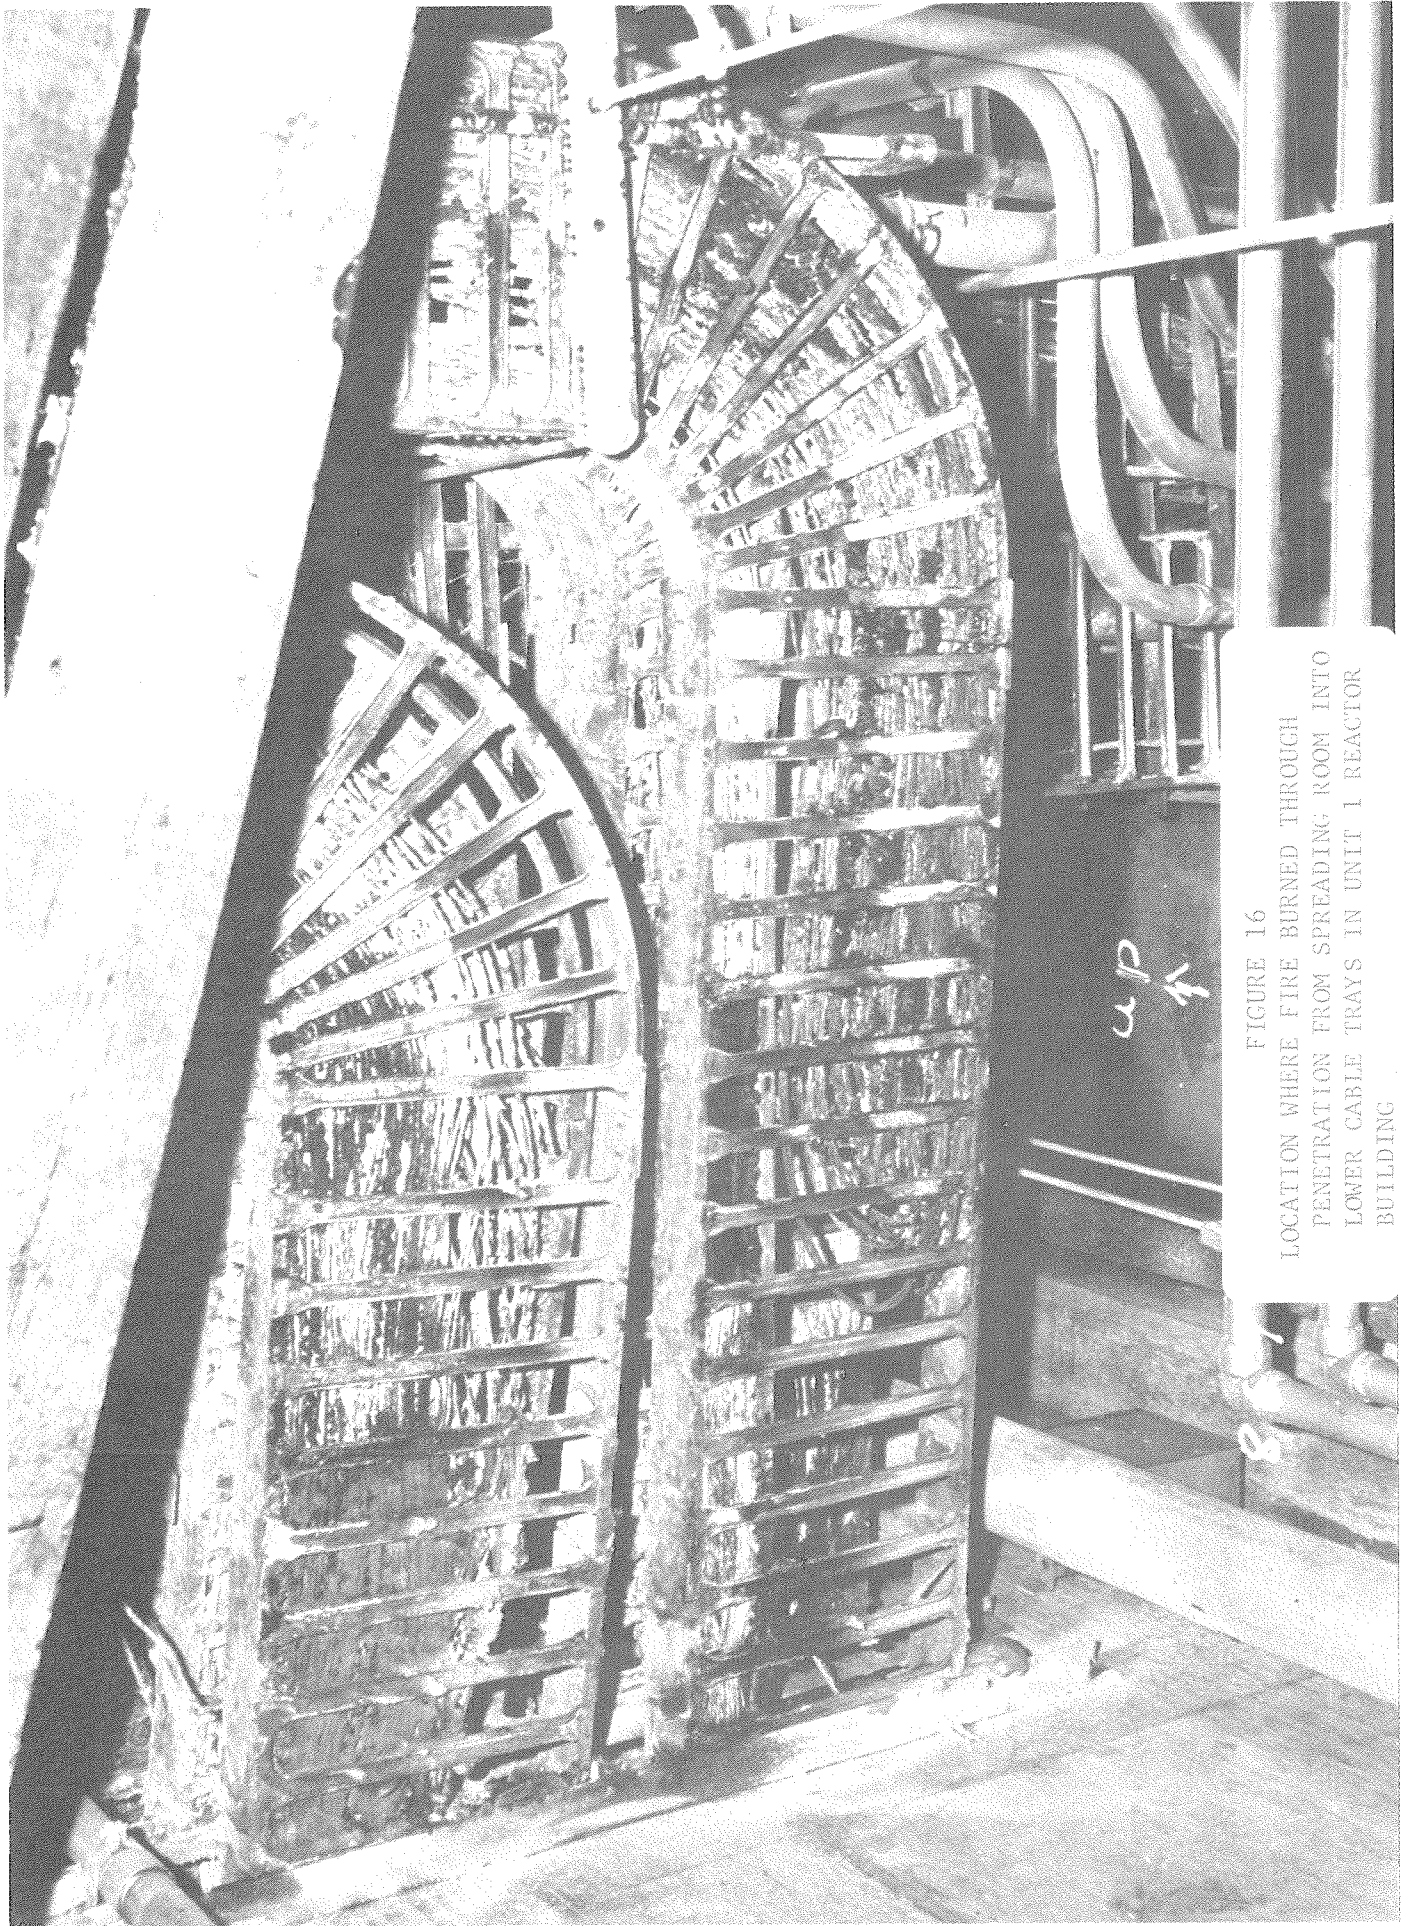
WHERE FIRE BURNED THROUGH  
PENETRATION FROM SPREADING ROOM  
INTO LOWER CABLE TRAYS IN UNIT 1  
REACTOR BUILDING

FIGURE 16  
LOCATION WHERE FIRE BURNED THROUGH  
PENETRATION FROM SPREADING ROOM INTO  
LOWER CABLE TRAYS IN UNIT 1 REACTOR  
BUILDING

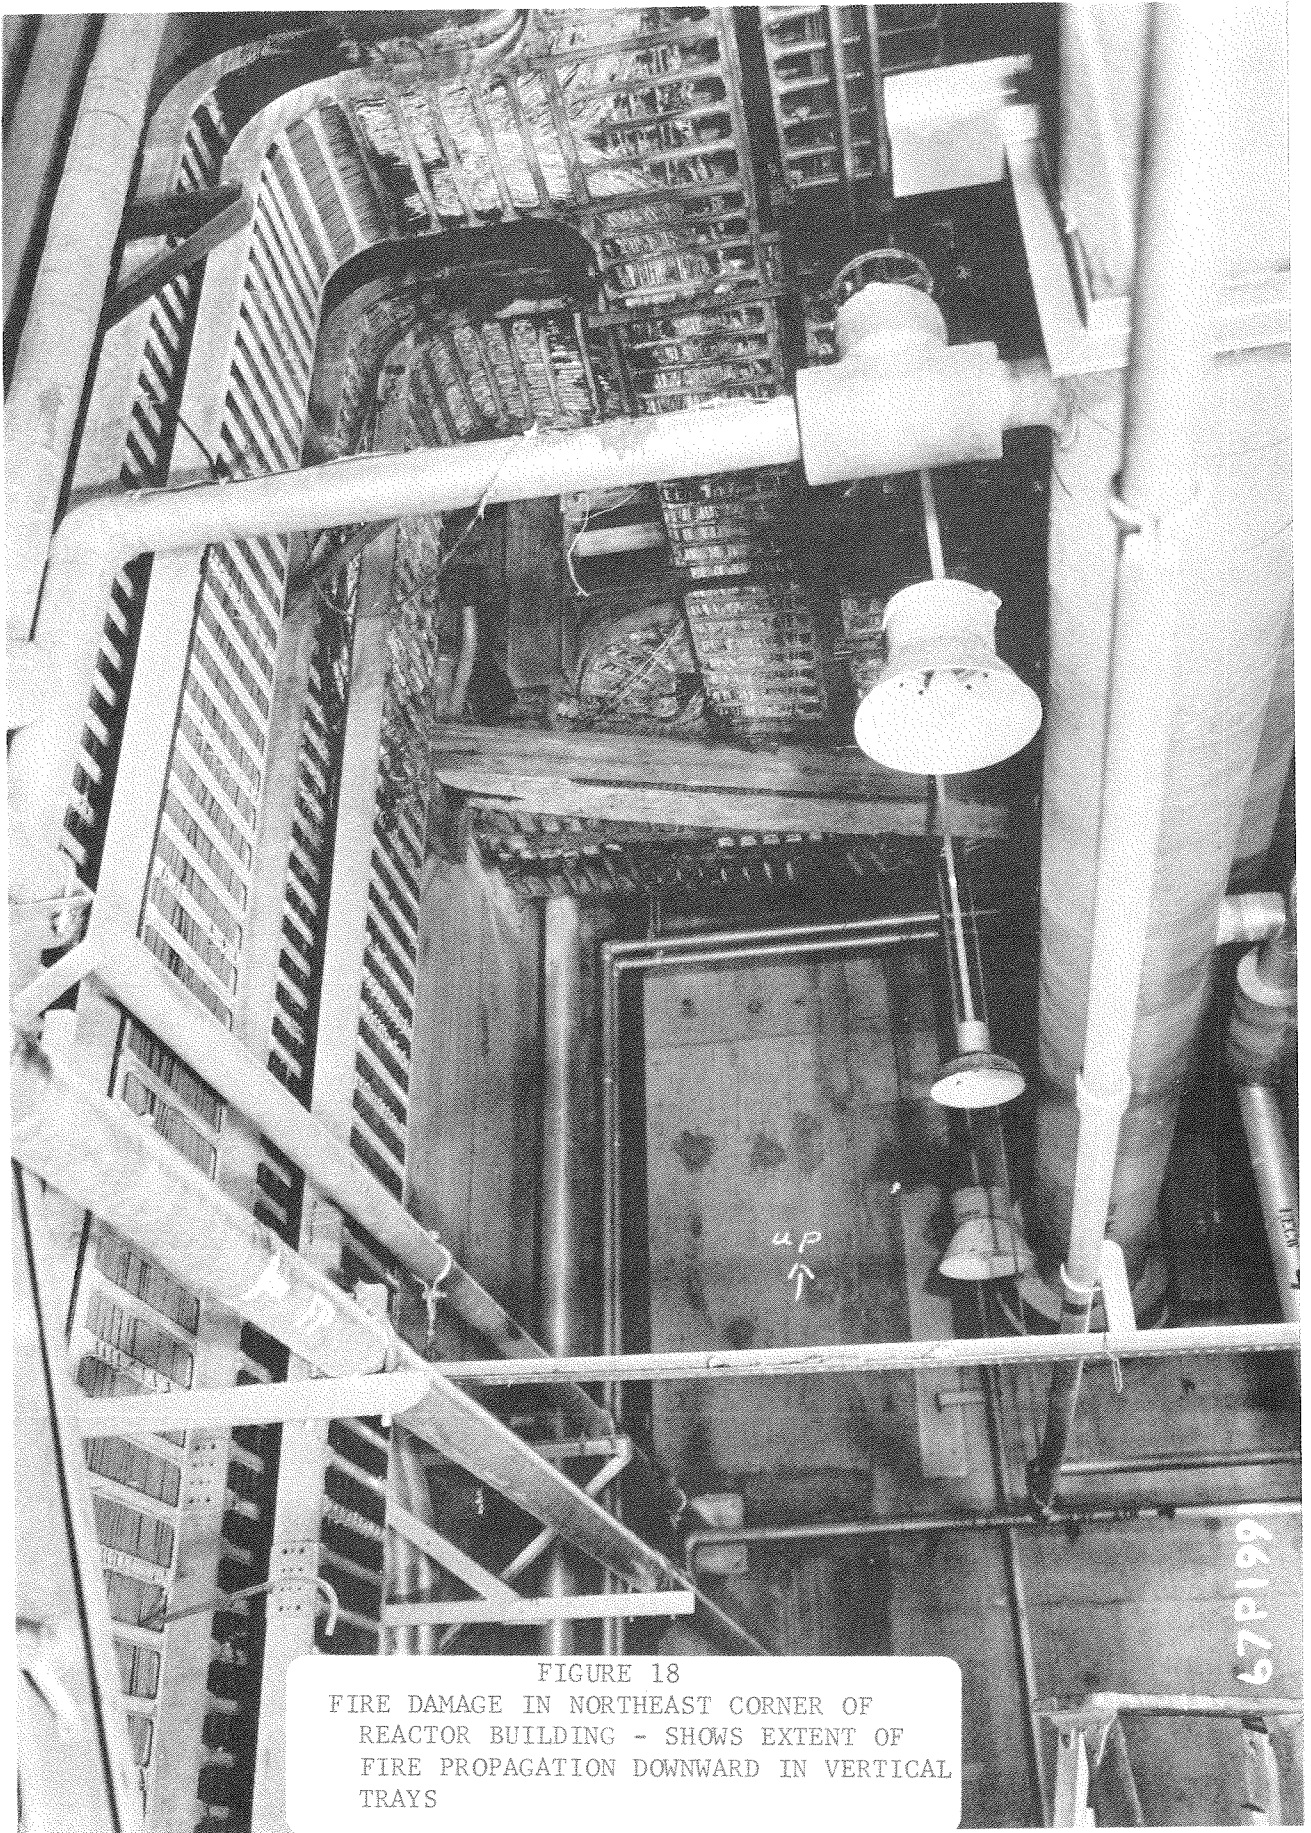
GENERAL VIEW OF FIRE DAMAGE IN  
NORTHEAST CORNER OF REACTOR  
BUILDING - SHOWS EXTENT OF FIRE  
PROPAGATION DOWNWARD IN VERTICAL  
TRAYS

FIGURE 18  
FIRE DAMAGE IN NORTHEAST CORNER OF  
REACTOR BUILDING - SHOWS EXTENT OF  
FIRE PROPAGATION DOWNWARD IN VERTICAL  
TRAYS

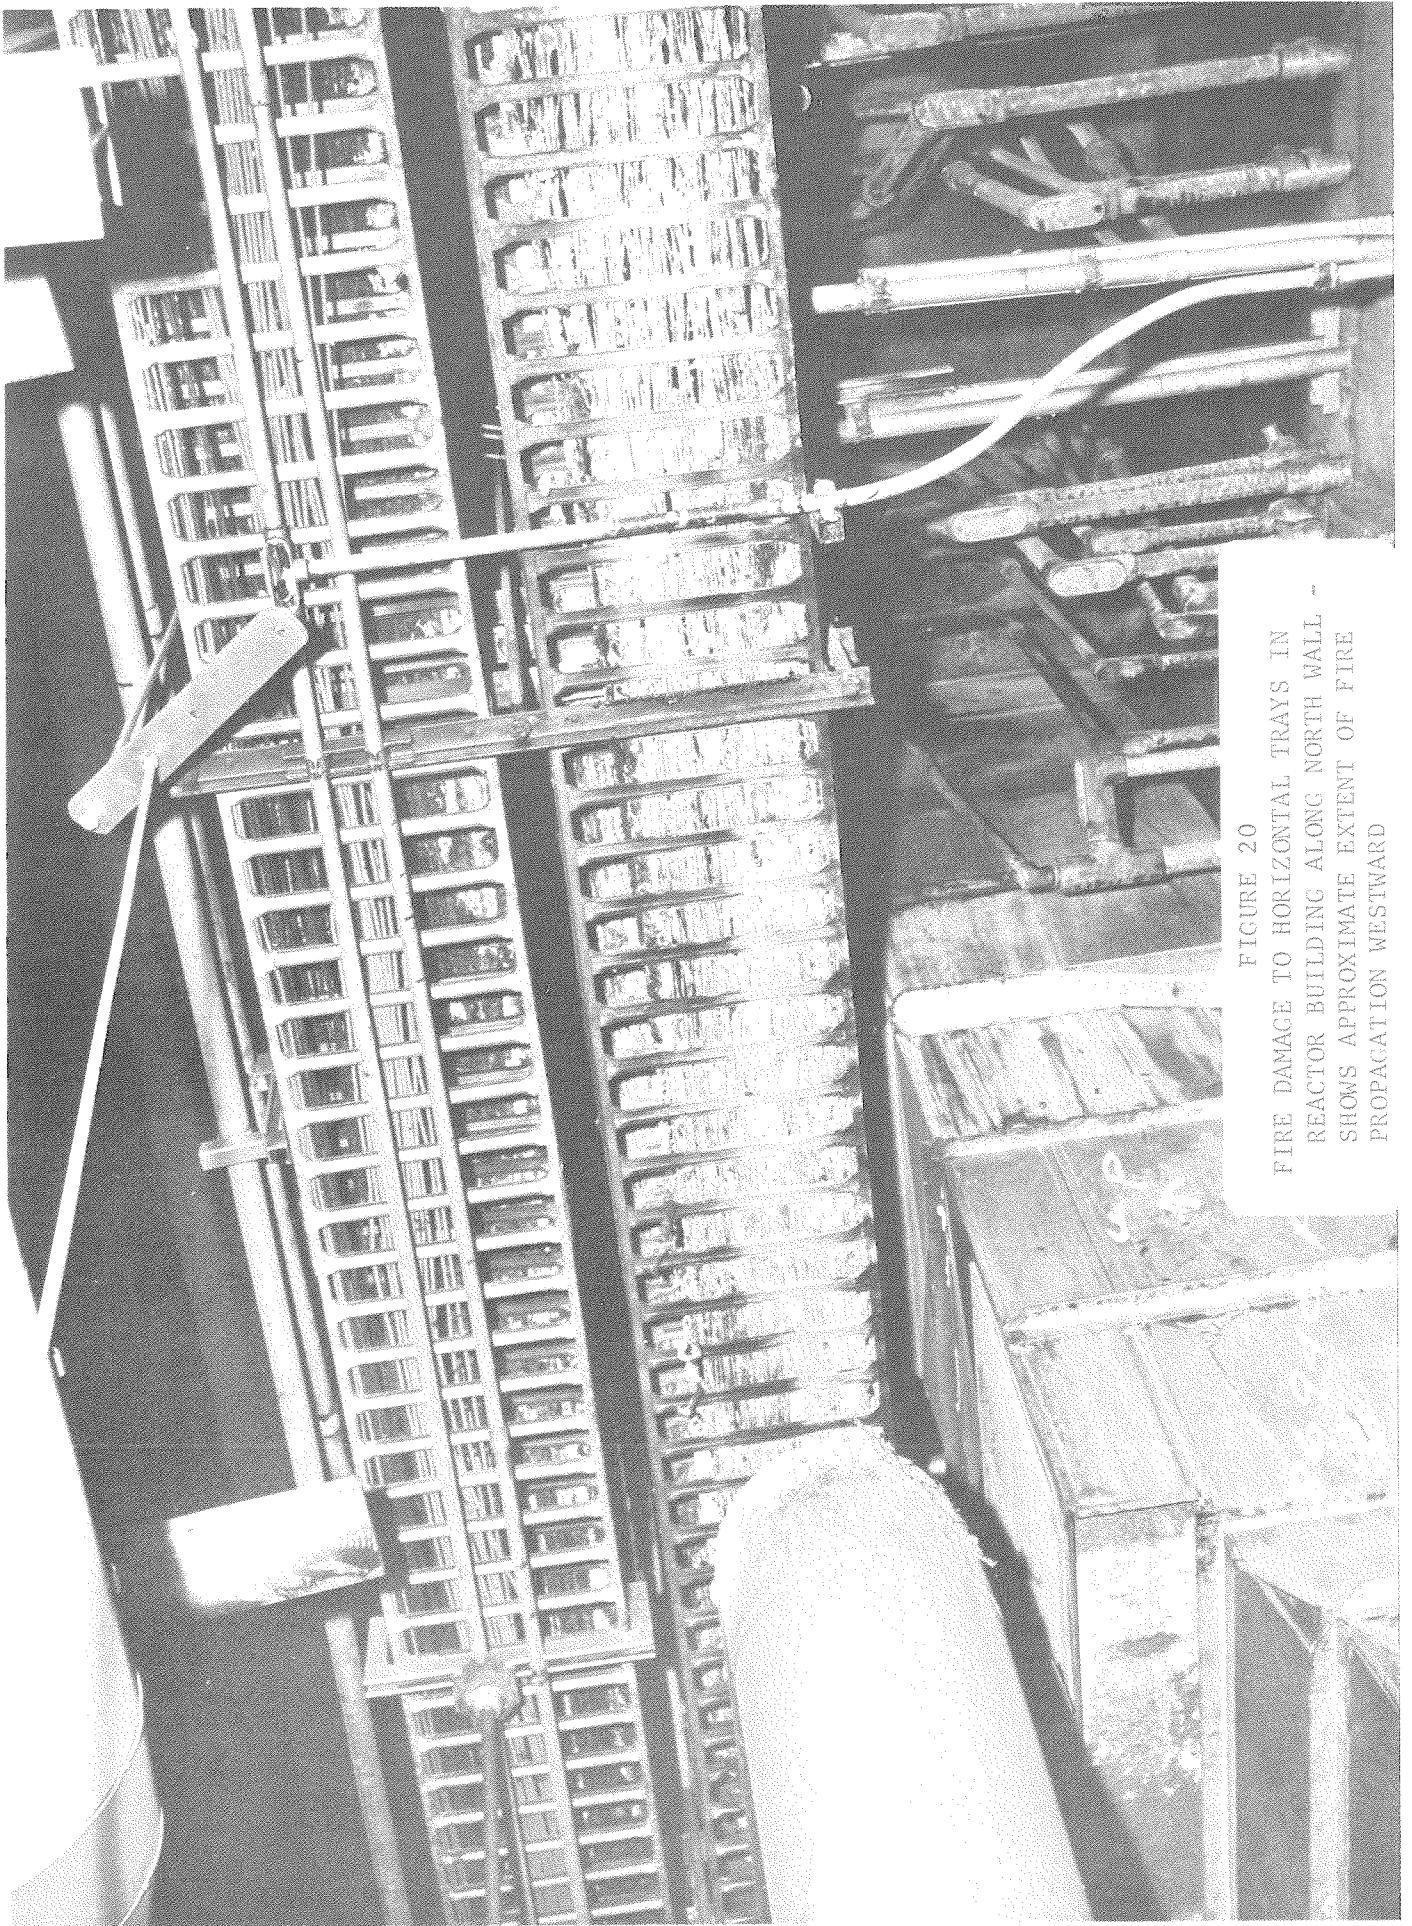
VIEW OF FIRE DAMAGE TO HORIZONTAL TRAYS IN REACTOR BUILDING ALONG NORTH WALL - SHOWS APPROXIMATE EXTENT OF FIRE PROPAGATION WESTWARD

FIGURE 20  
FIRE DAMAGE TO HORIZONTAL TRAYS IN  
REACTOR BUILDING ALONG NORTH WALL -  
SHOWS APPROXIMATE EXTENT OF FIRE  
PROPAGATION WESTWARD

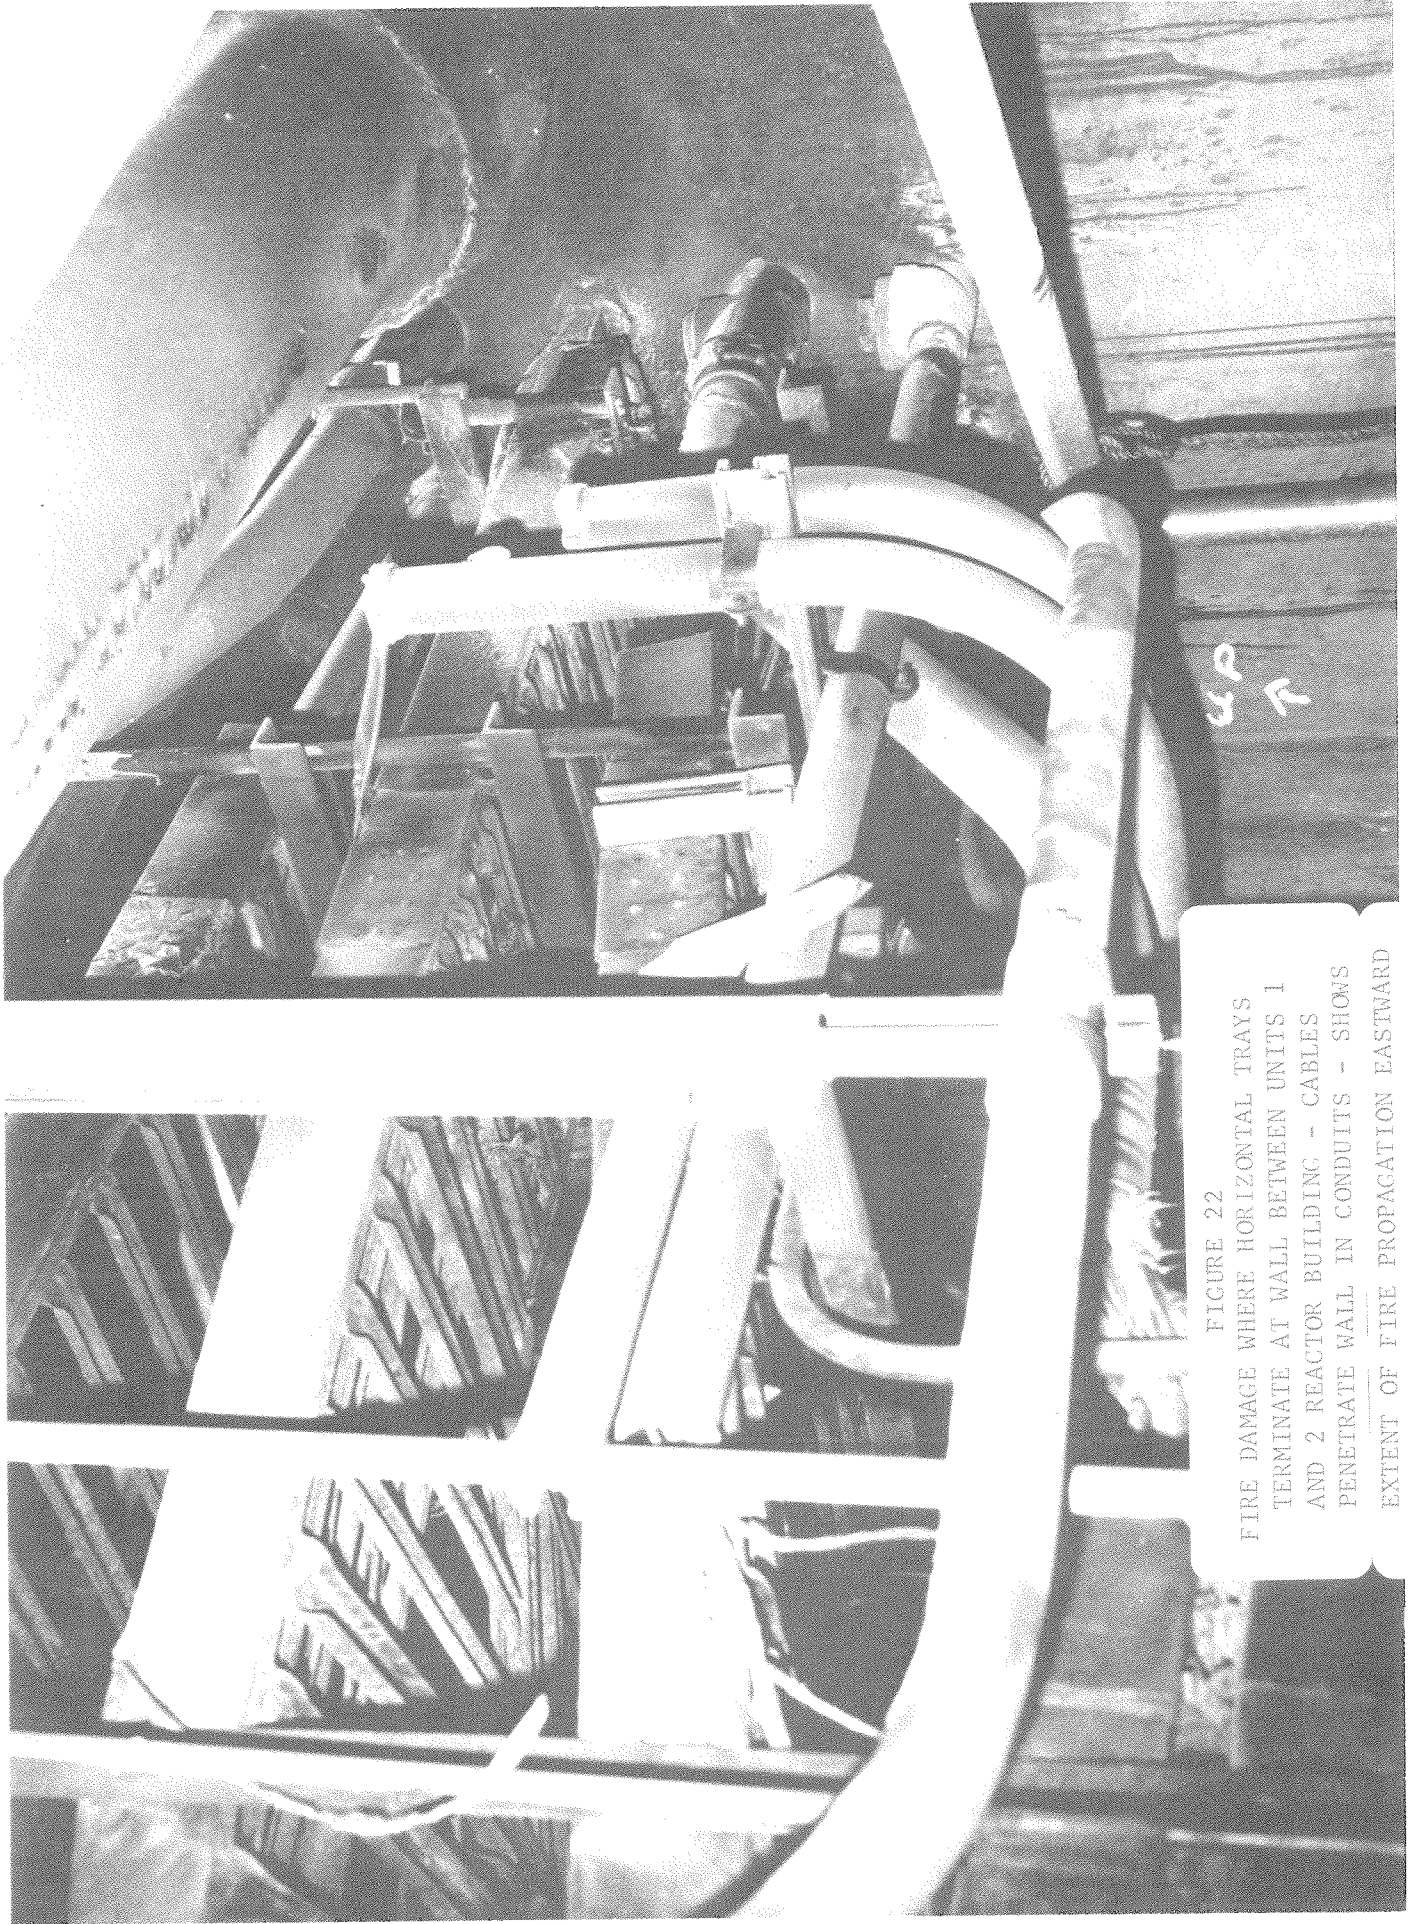
FIGURE 22  
FIRE DAMAGE WHERE HORIZONTAL TRAYS  
TERMINATE AT WALL BETWEEN UNITS 1  
AND 2 REACTOR BUILDING - CABLES  
PENETRATE WALL IN CONDUITS - SHOWS  
EXTENT OF FIRE PROPAGATION EASTWARD

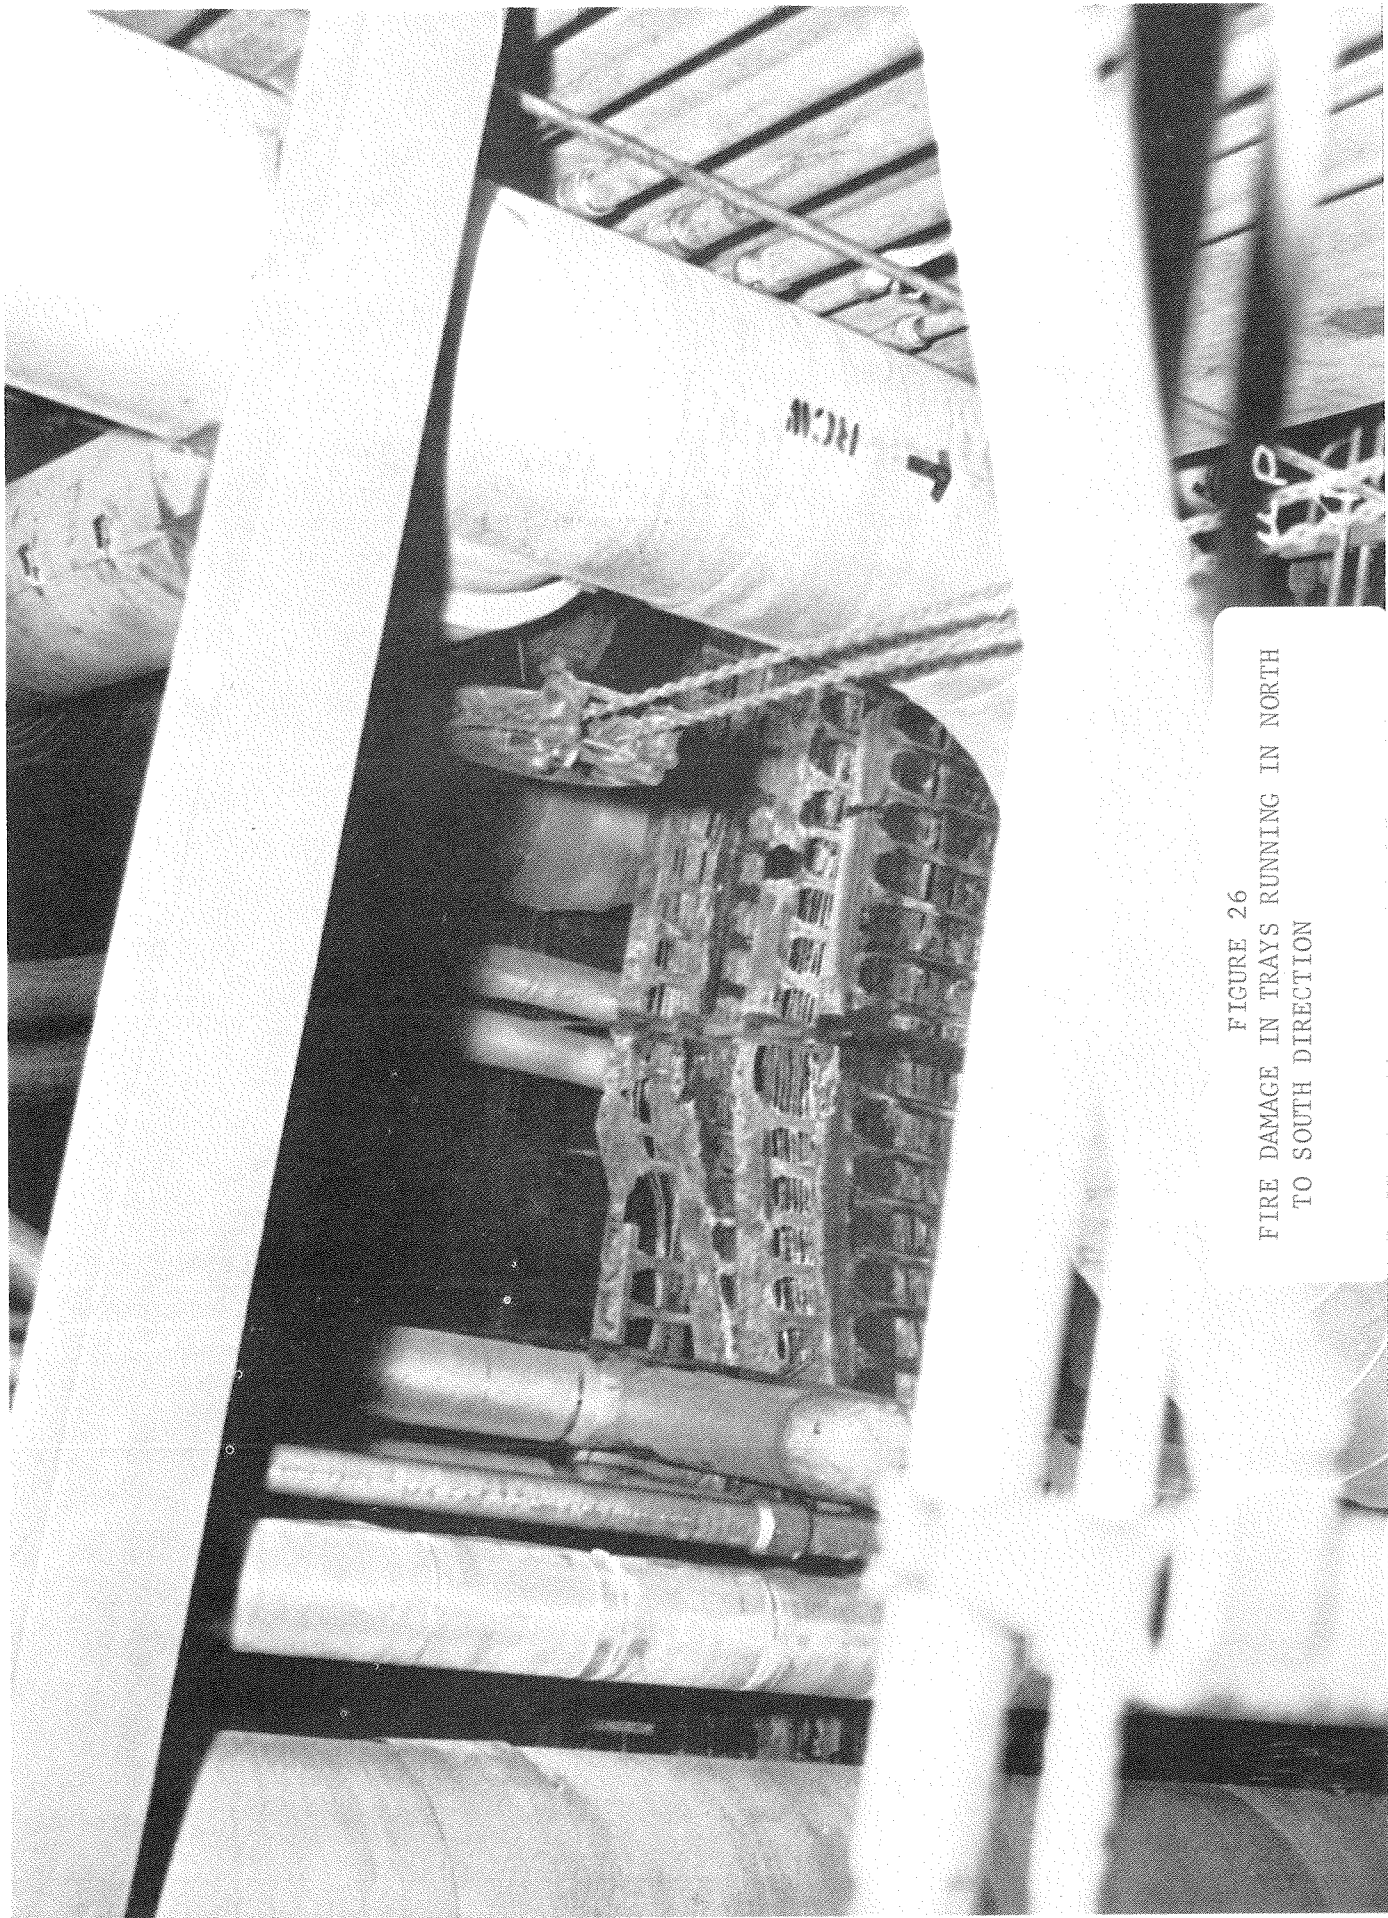
VIEW OF FIRE DAMAGE IN TRAYS  
 RUNNING IN NORTH TO SOUTH  
 DIRECTION

FIGURE 26  
FIRE DAMAGE IN TRAYS RUNNING IN NORTH  
TO SOUTH DIRECTION
