**Technology Report 77-2**

**THE BROWNS FERRY NUCLEAR PLANT FIRE**

ANDREW J. PRYOR  
U.S. Energy Research  
and Development Administration  
Albuquerque, New Mexico

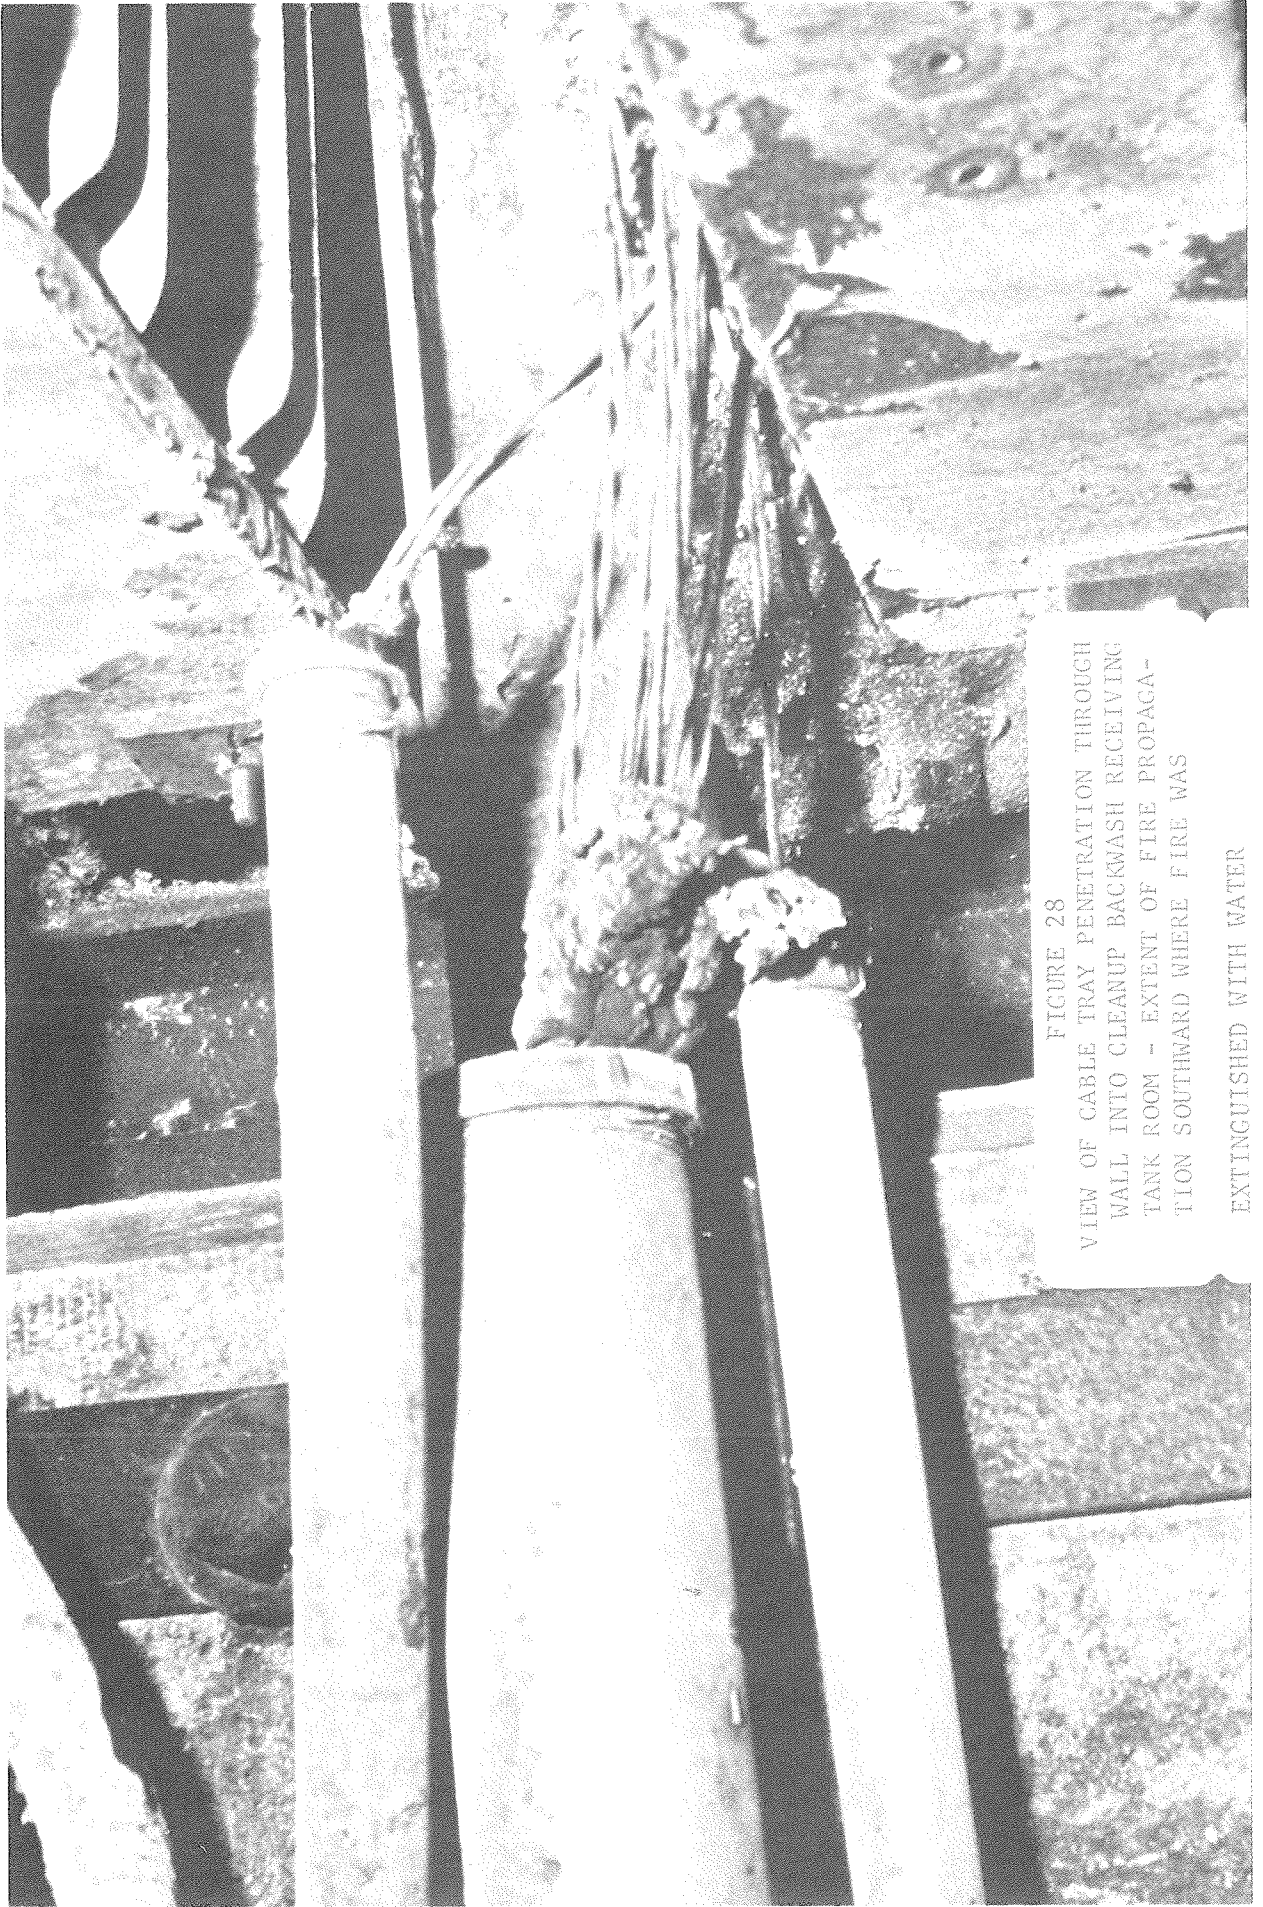
VIEW OF CABLE TRAY PENETRATION  
THROUGH WALL INTO CLEANUP  
BACKWASH RECEIVING TANK ROOM -  
EXTENT OF FIRE PROPAGATION  
SOUTHWARD WHERE FIRE WAS  
EXTINGUISHED WITH WATER

FIGURE 28  
VIEW OF CABLE TRAY PENETRATION THROUGH  
WALL INTO CLEANUP BACKWASH RECEIVING  
TANK ROOM - EXTENT OF FIRE PROPAGA-  
TION SOUTHWARD WHERE FIRE WAS  
EXTINGUISHED WITH WATER

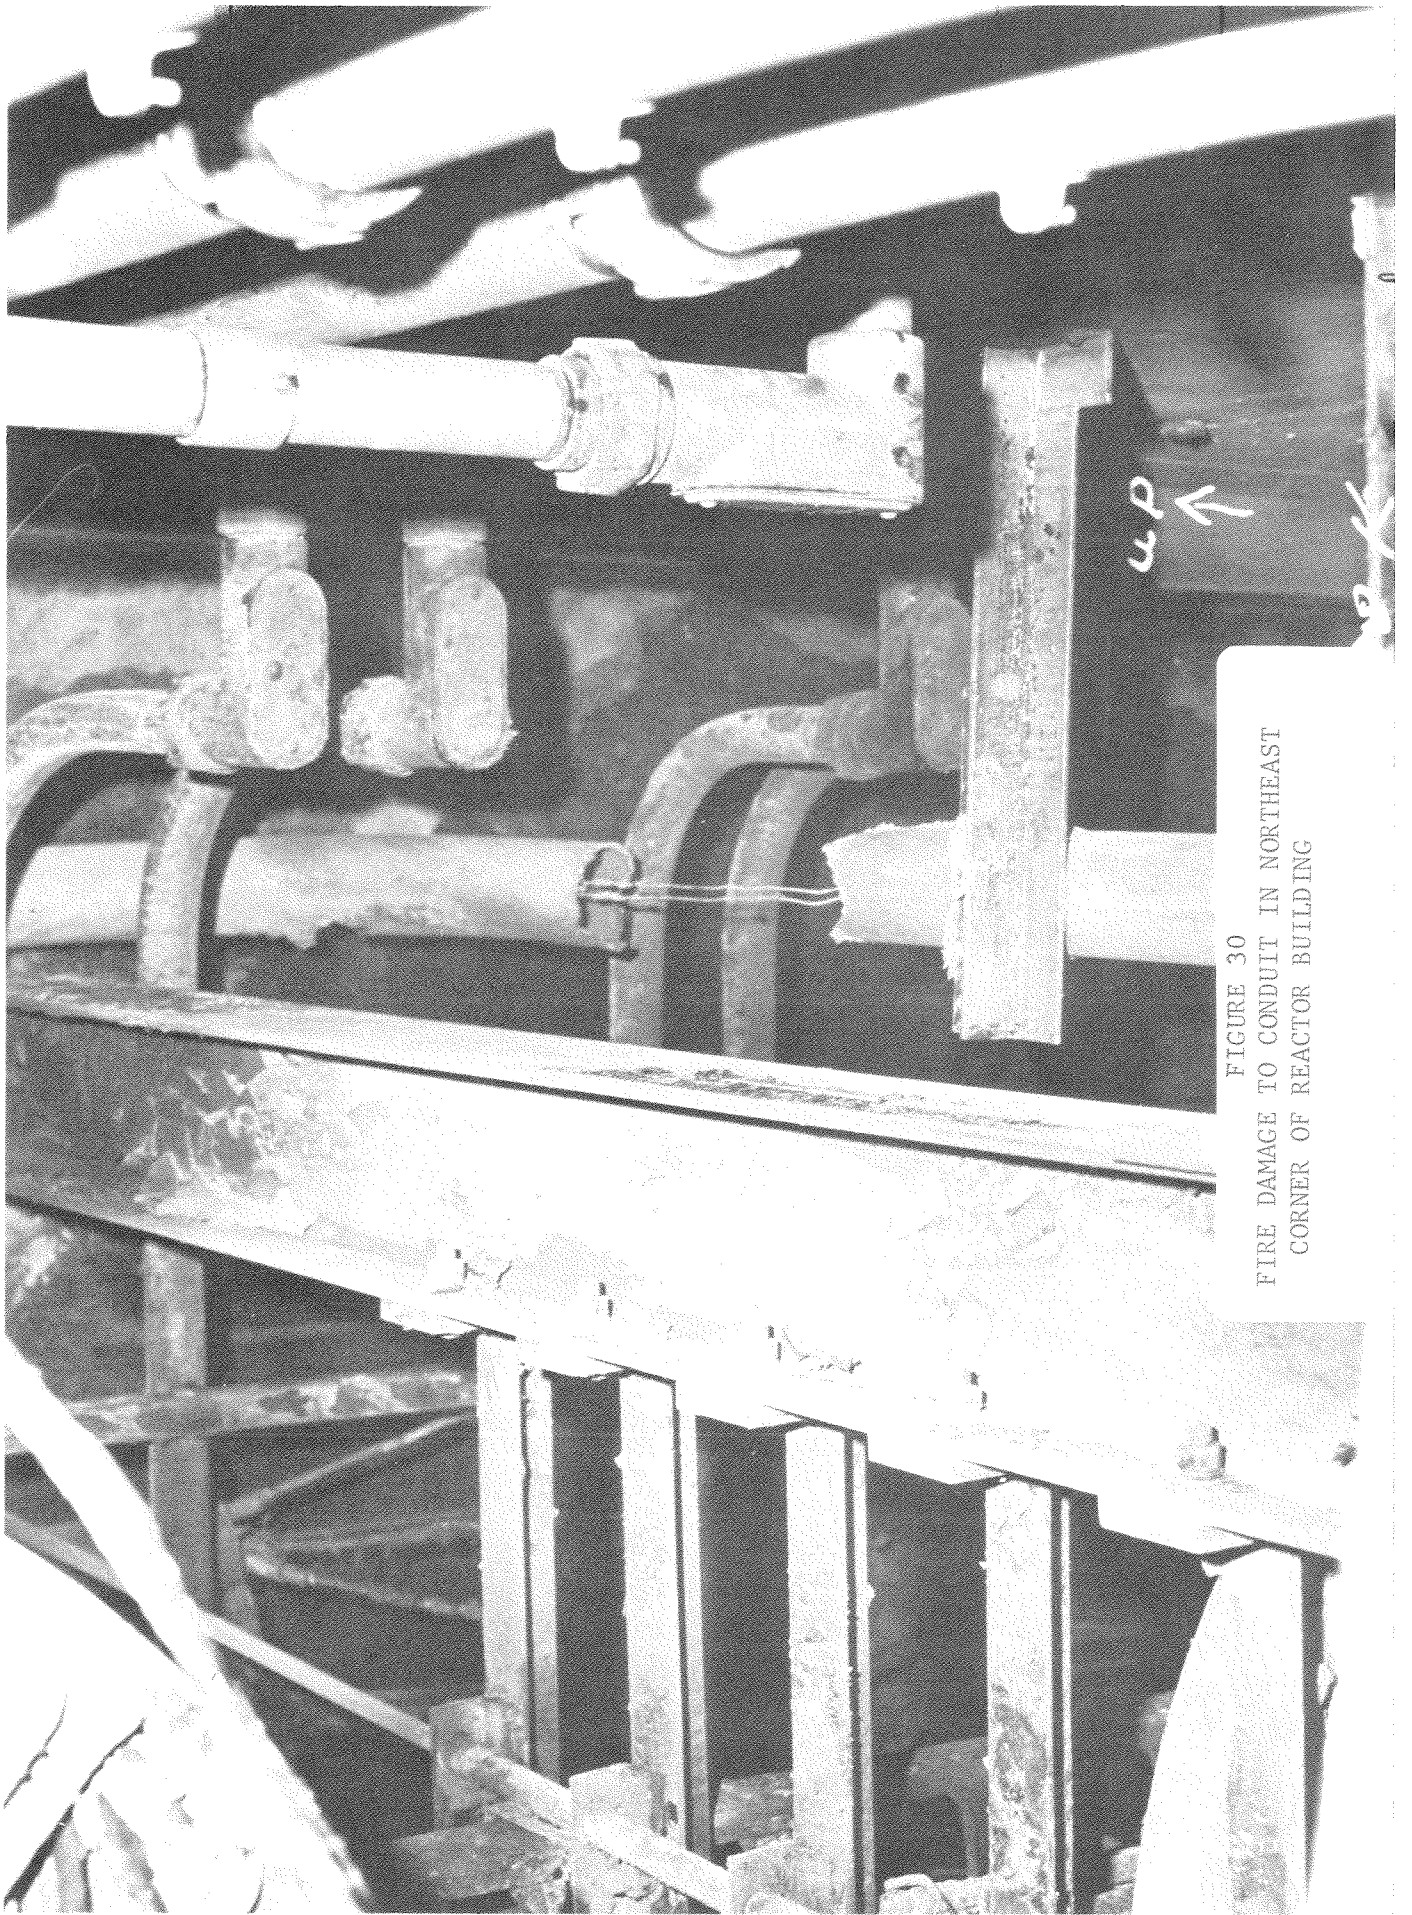
VIEW OF FIRE DAMAGE TO CONDUIT  
IN NORTHEAST CORNER OF REACTOR  
BUILDING

FIGURE 30  
FIRE DAMAGE TO CONDUIT IN NORTHEAST  
CORNER OF REACTOR BUILDING
