## Cable Fire At Browns Ferry Nuclear Power Plant

**ROBERT G. SAWYER**, Staff Property Engineer  
**JAMES A. ELSNER, P.E.**, Staff Nuclear Engineer  
*Nuclear Energy Liability - Property Insurance Association (NEL-PIA)*

*March 22, 1975 was the date of a major electrical cable system fire at the Browns Ferry Nuclear Power Plant of the Tennessee Valley Authority (TVA). The fire was accidentally started by an employee who was using a candle to check for air leaks through a fire wall penetration seal. The fire was not extinguished until seven hours after ignition and caused the shutdown of two nuclear generating units for over one year. Property damage at this self-insured facility is estimated at about \$10 million, and the cost of replacement power was approximately \$10 million per month. There was no release of radioactivity as a result of the fire.*

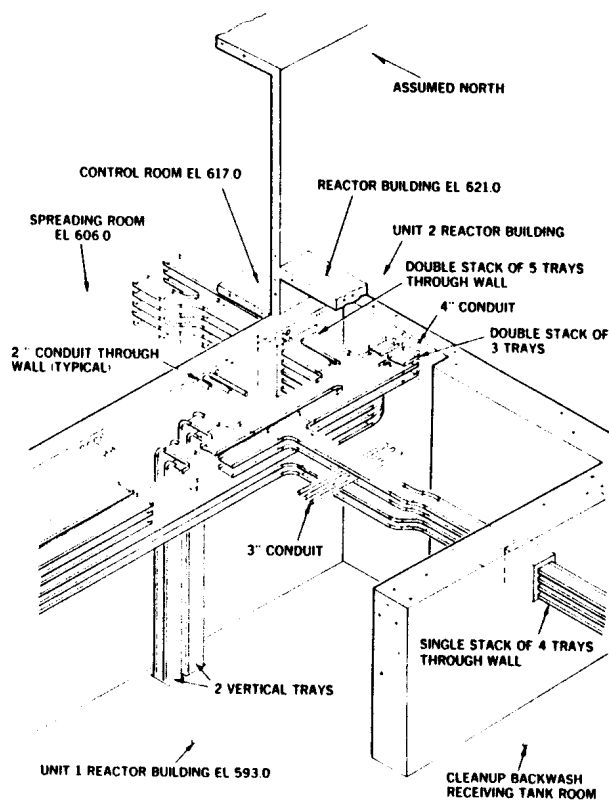
Figure 3. General area of the incident.

from the Cable Spreading Room to the Reactor Building butted up to either side of the wall (see Figure 3). Sleeves passed through a steel plate in the wall. To provide an air and fire seal in the sleeves, a polyurethane foam material was stuffed in around the cables. Foamed-in-place polyurethane was used to fill the sleeve; this was followed by application of a fire-retardant mass to cover the foam and provide a fire seal.

The fire started at approximately 12:20 pm when the flame from the candle was sucked into the penetration seal by the pressure differential, igniting the foam plastic sheeting. It should be noted that the actual seal was set back into the wall several inches, and was a difficult area to reach because of the congested cable trays. Immediate attempts to extinguish the flames by beating them out with a flashlight and smothering them with rags failed, and the first major fire in an operating nuclear power plant in the United States was under way.
