**INVESTIGATION REPORT
OF THE
FIRE IN THE
WIDE BAND LABORATORY
AT
FERMI NATIONAL ACCELERATOR
LABORATORY
BATAVIA, ILLINOIS
OCTOBER 3, 1987**

**U.S. DEPARTMENT OF ENERGY
Chicago Operations Office**

FIRE IN THE WIDE BAND LABORATORY

OCTOBER 3, 1987

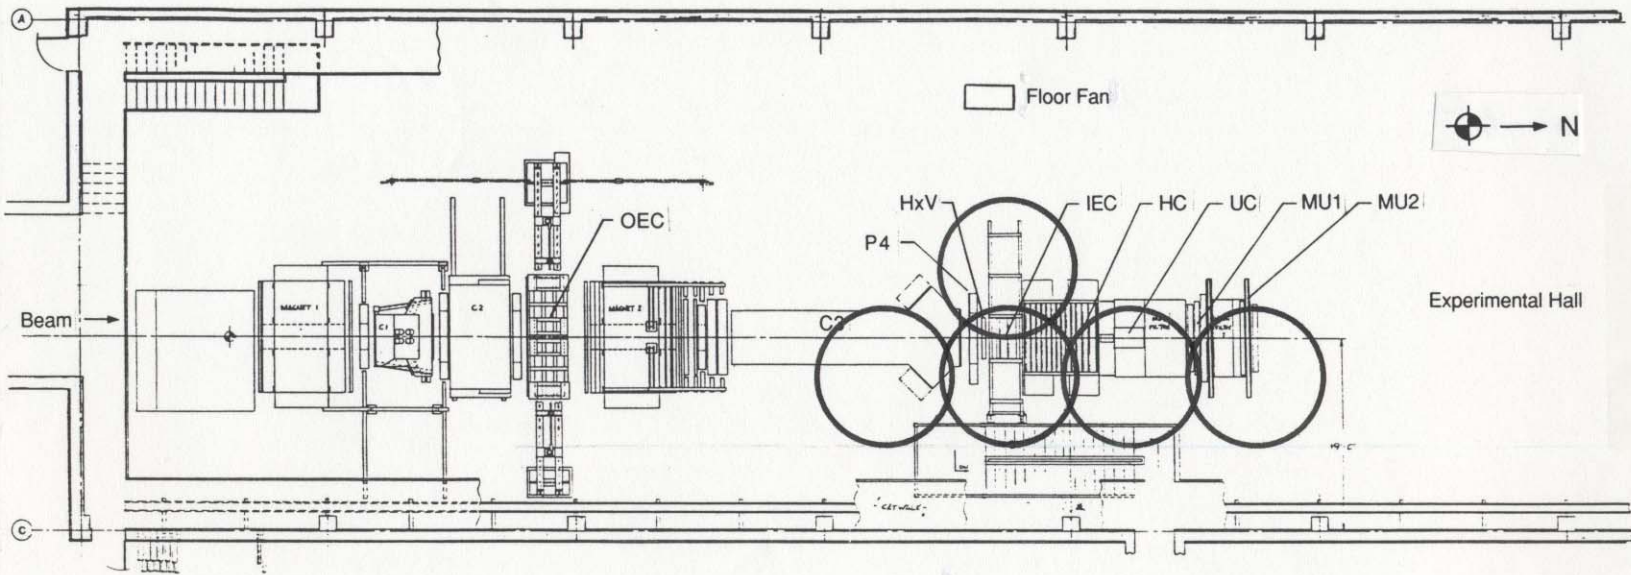
Operation of the automatic sprinklers was delayed by the distance between the fire and the sprinklers (approximately 43 ft). A total of five heads operated during the fire (see Figure 30). The pattern indicates an apparent heat gradient toward the east; this may have been enhanced by the operating floor fan west of P4. The FFD maintained input pressure at 150 psig on the fire department connection, which resulted in a combined flow of 288 gpm from the operating sprinklers. Analysis has shown that this pressure and flow are adequate. The most effective height (above a fire) for sprinkler protection is approximately 7 ft. Distances above 10 ft significantly reduce the effectiveness of the sprinkler discharge. In this case, the large distance, along with the amount of combustible material available, not only delayed the sprinklers' operation but also limited their ability to extinguish the fire. However, they did serve to confine the fire and prevent major involvement of the second and third IEC modules. They also prevented involvement of the cables on the east side of the IEC and ribbon cables attached to P4. Given the amount of combustible material still available (about 2000 lbs of PMMA and hundreds of feet of cables), if the fire had spread uncontrolled the building structure would have failed, causing more extensive damage.

Figure 30. Discharge pattern for the five operated sprinklers in the experimental hall.
