**Technology Report 77-2**

**THE BROWNS FERRY NUCLEAR PLANT FIRE**

ANDREW J. PRYOR  
U.S. Energy Research  
and Development Administration  
Albuquerque, New Mexico

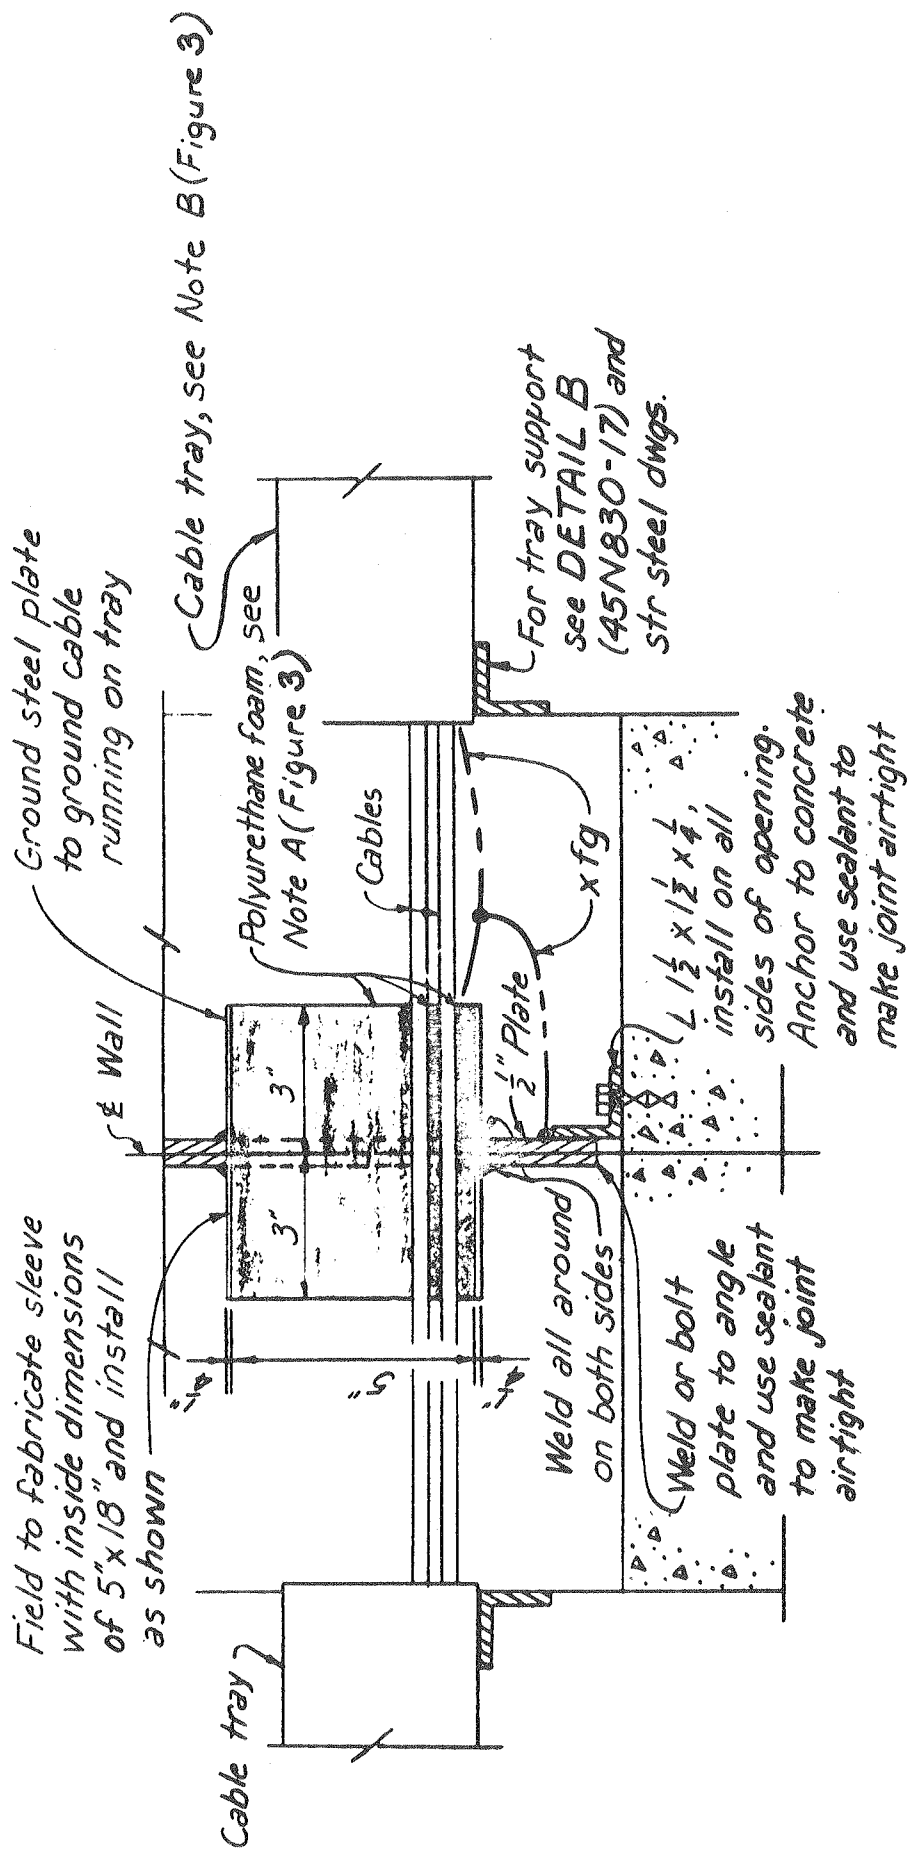
FIGURE 9  
 SIDE VIEW OF WALL CABLE TRAY PENETRATION  
 DIFFERENTIAL PRESSURE SEAL AND FIRE-  
 STOP DESIGN

NOTE: FIRE STARTED IN SECOND PENETRATION FROM BOTTOM - TRAY VE

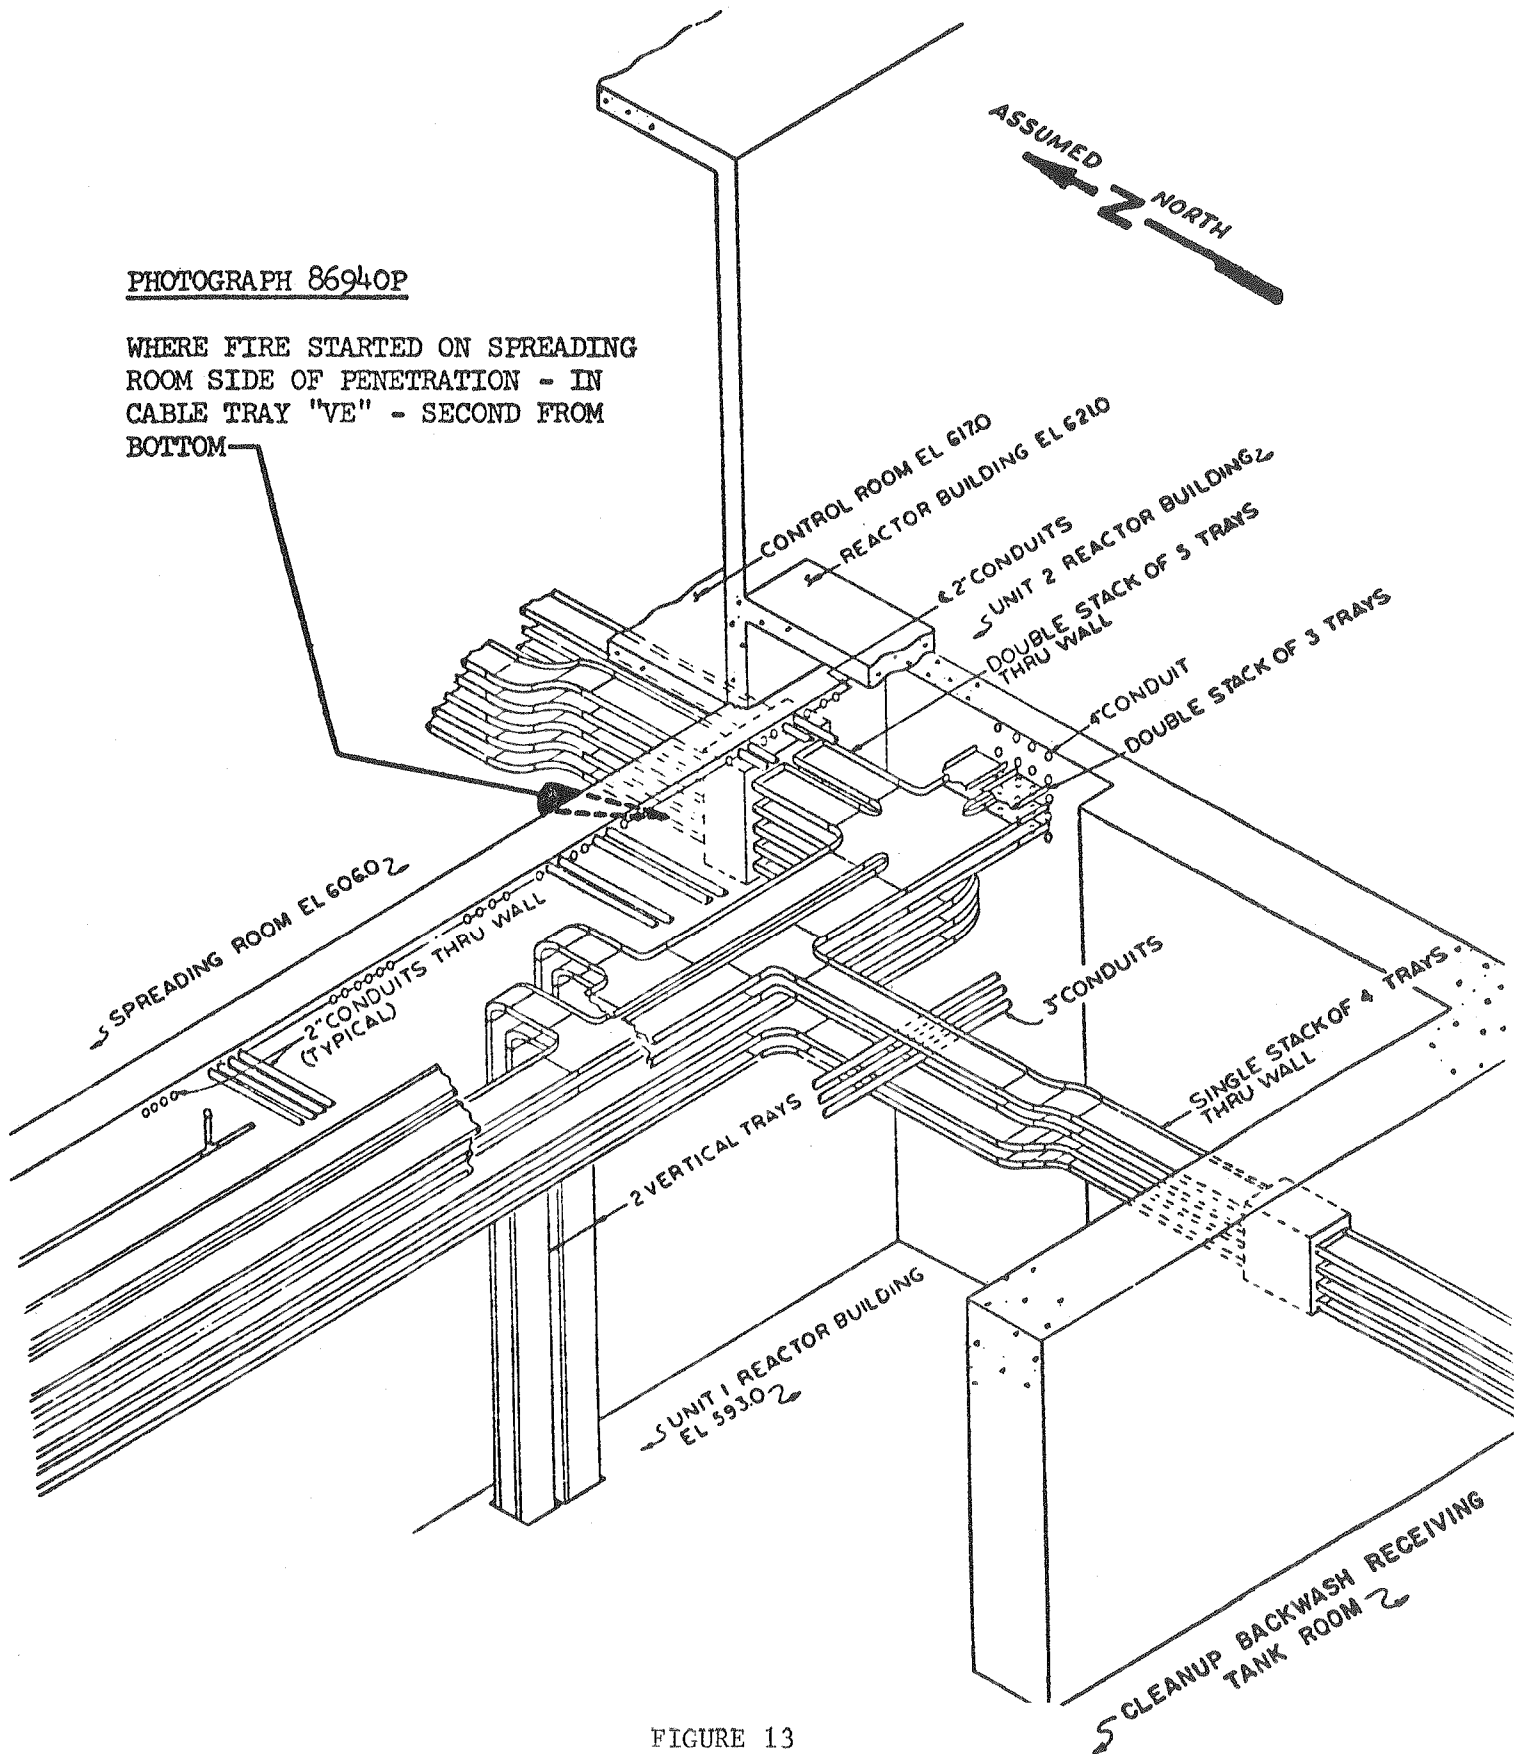
FIGURE 13  
 LOCATION WHERE PHOTOGRAPH 86940P WAS  
 TAKEN

PHOTOGRAPH 86940P

WHERE FIRE STARTED ON SPREADING ROOM SIDE OF PENETRATION - IN CABLE TRAY "VE" - SECOND FROM BOTTOM

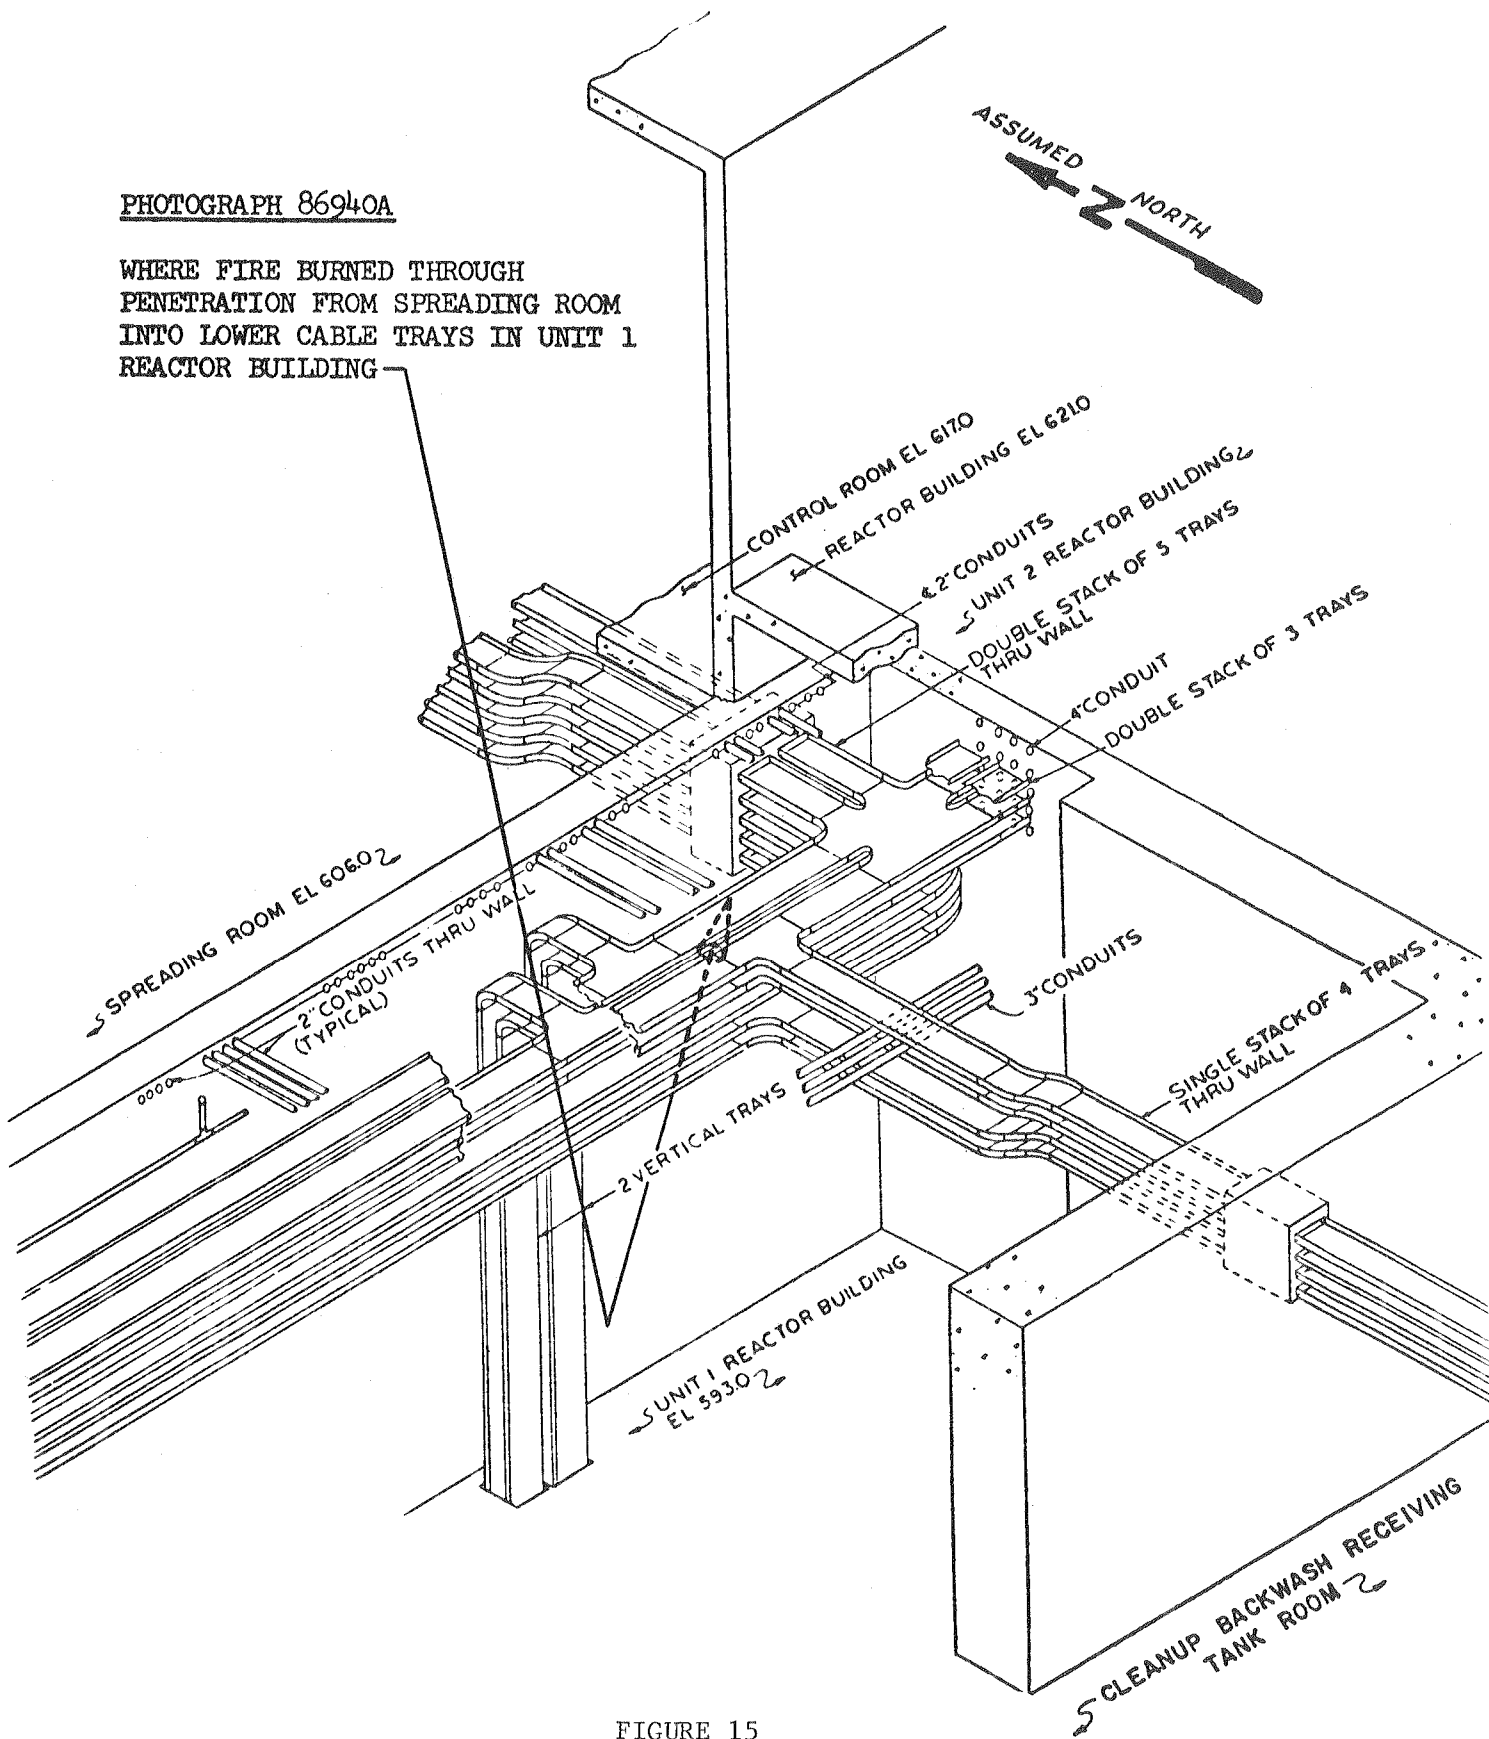
FIGURE 15  
LOCATION WHERE PHOTOGRAPH 86940A WAS  
TAKEN

PHOTOGRAPH 86940A

WHERE FIRE BURNED THROUGH  
PENETRATION FROM SPREADING ROOM  
INTO LOWER CABLE TRAYS IN UNIT 1  
REACTOR BUILDING

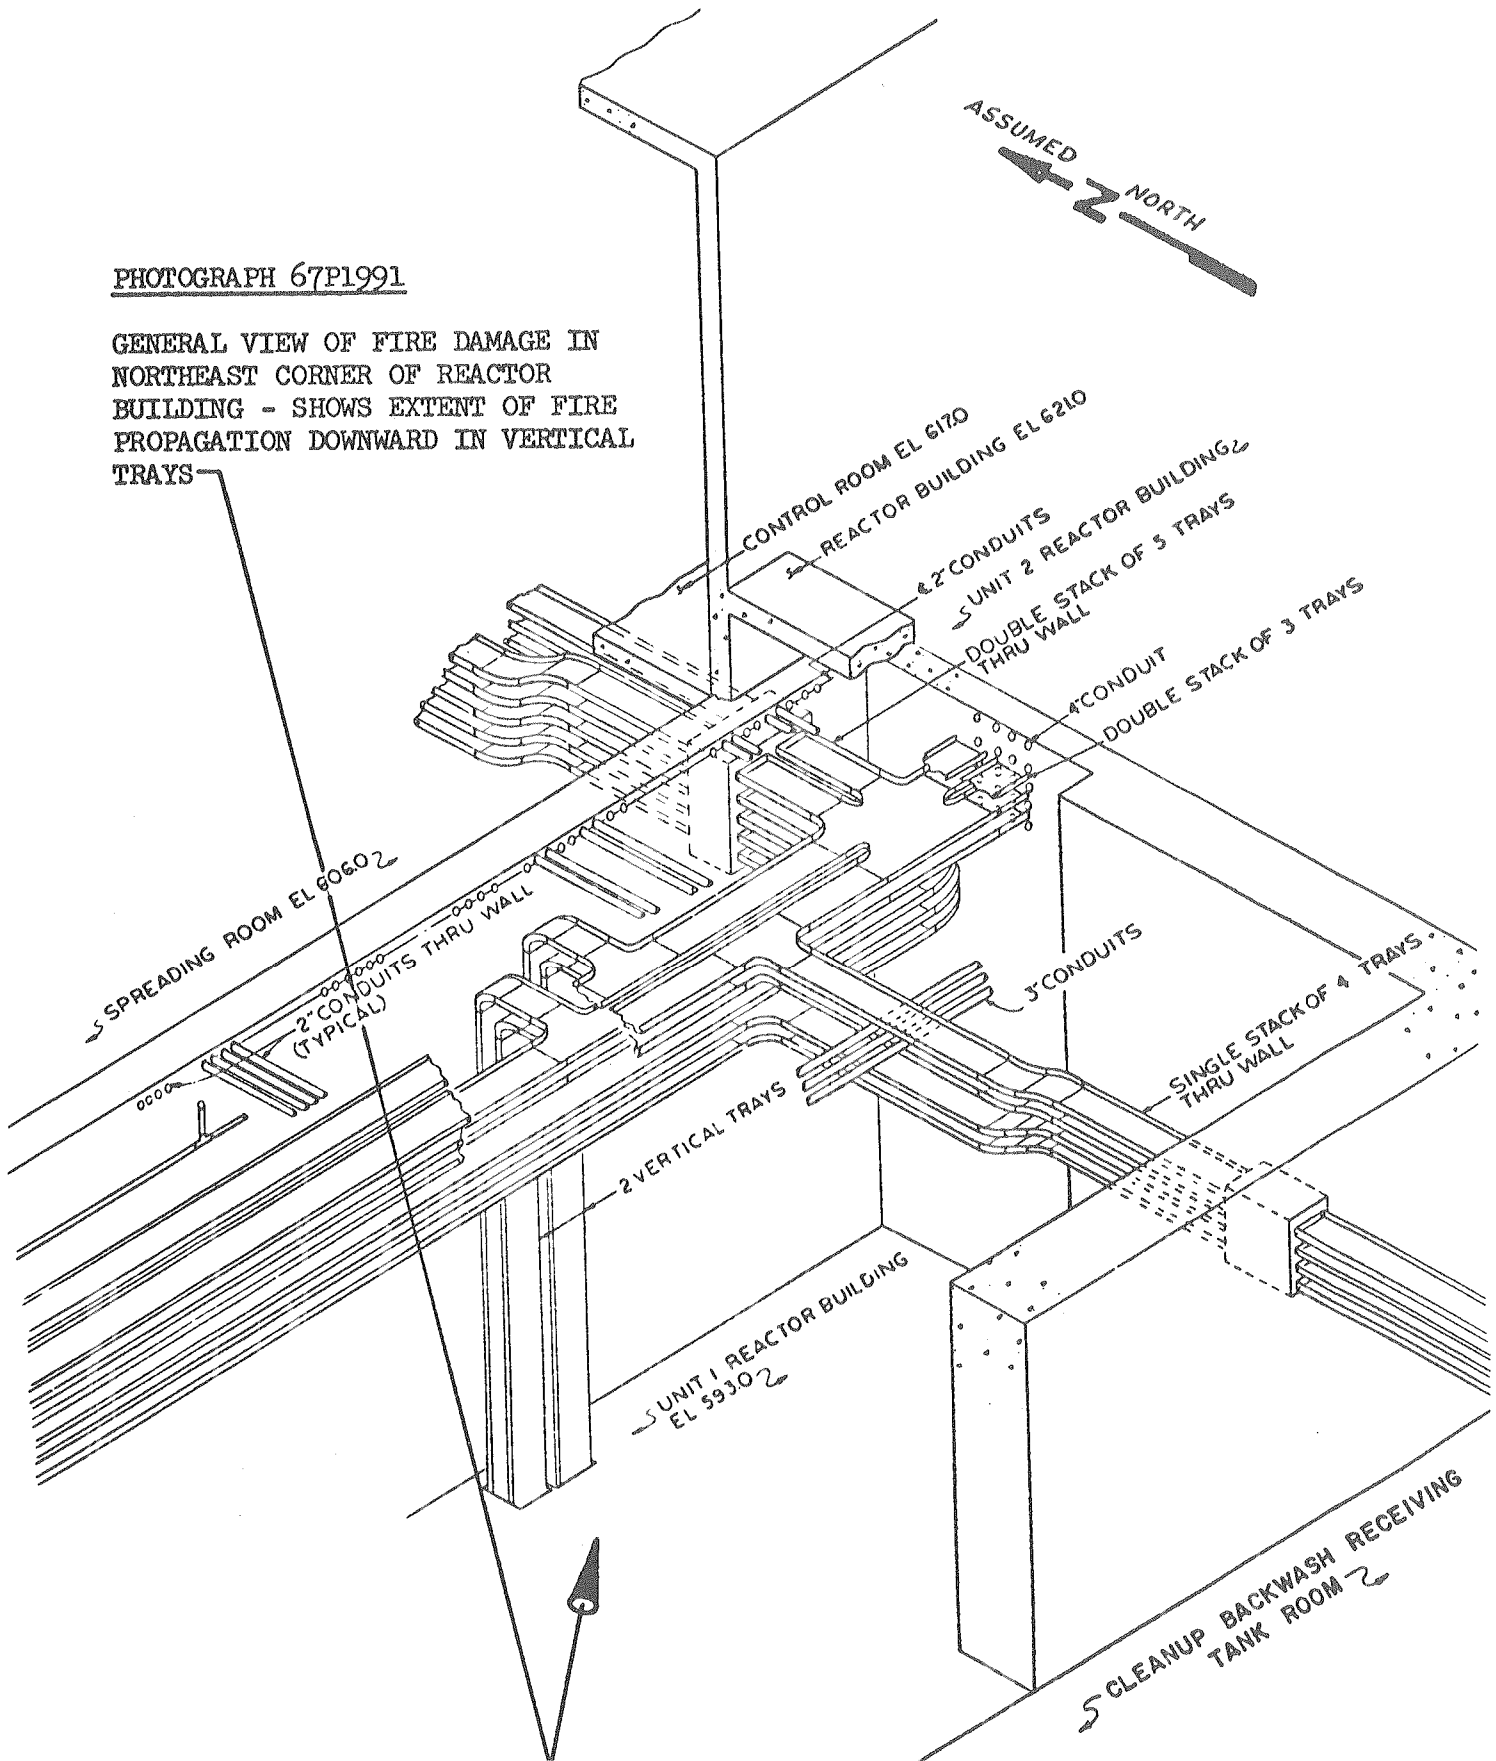
FIGURE 17  
LOCATION WHERE PHOTOGRAPH 67P1991 WAS  
TAKEN

PHOTOGRAPH 67P1991

GENERAL VIEW OF FIRE DAMAGE IN  
NORTHEAST CORNER OF REACTOR  
BUILDING - SHOWS EXTENT OF FIRE  
PROPAGATION DOWNWARD IN VERTICAL  
TRAYS

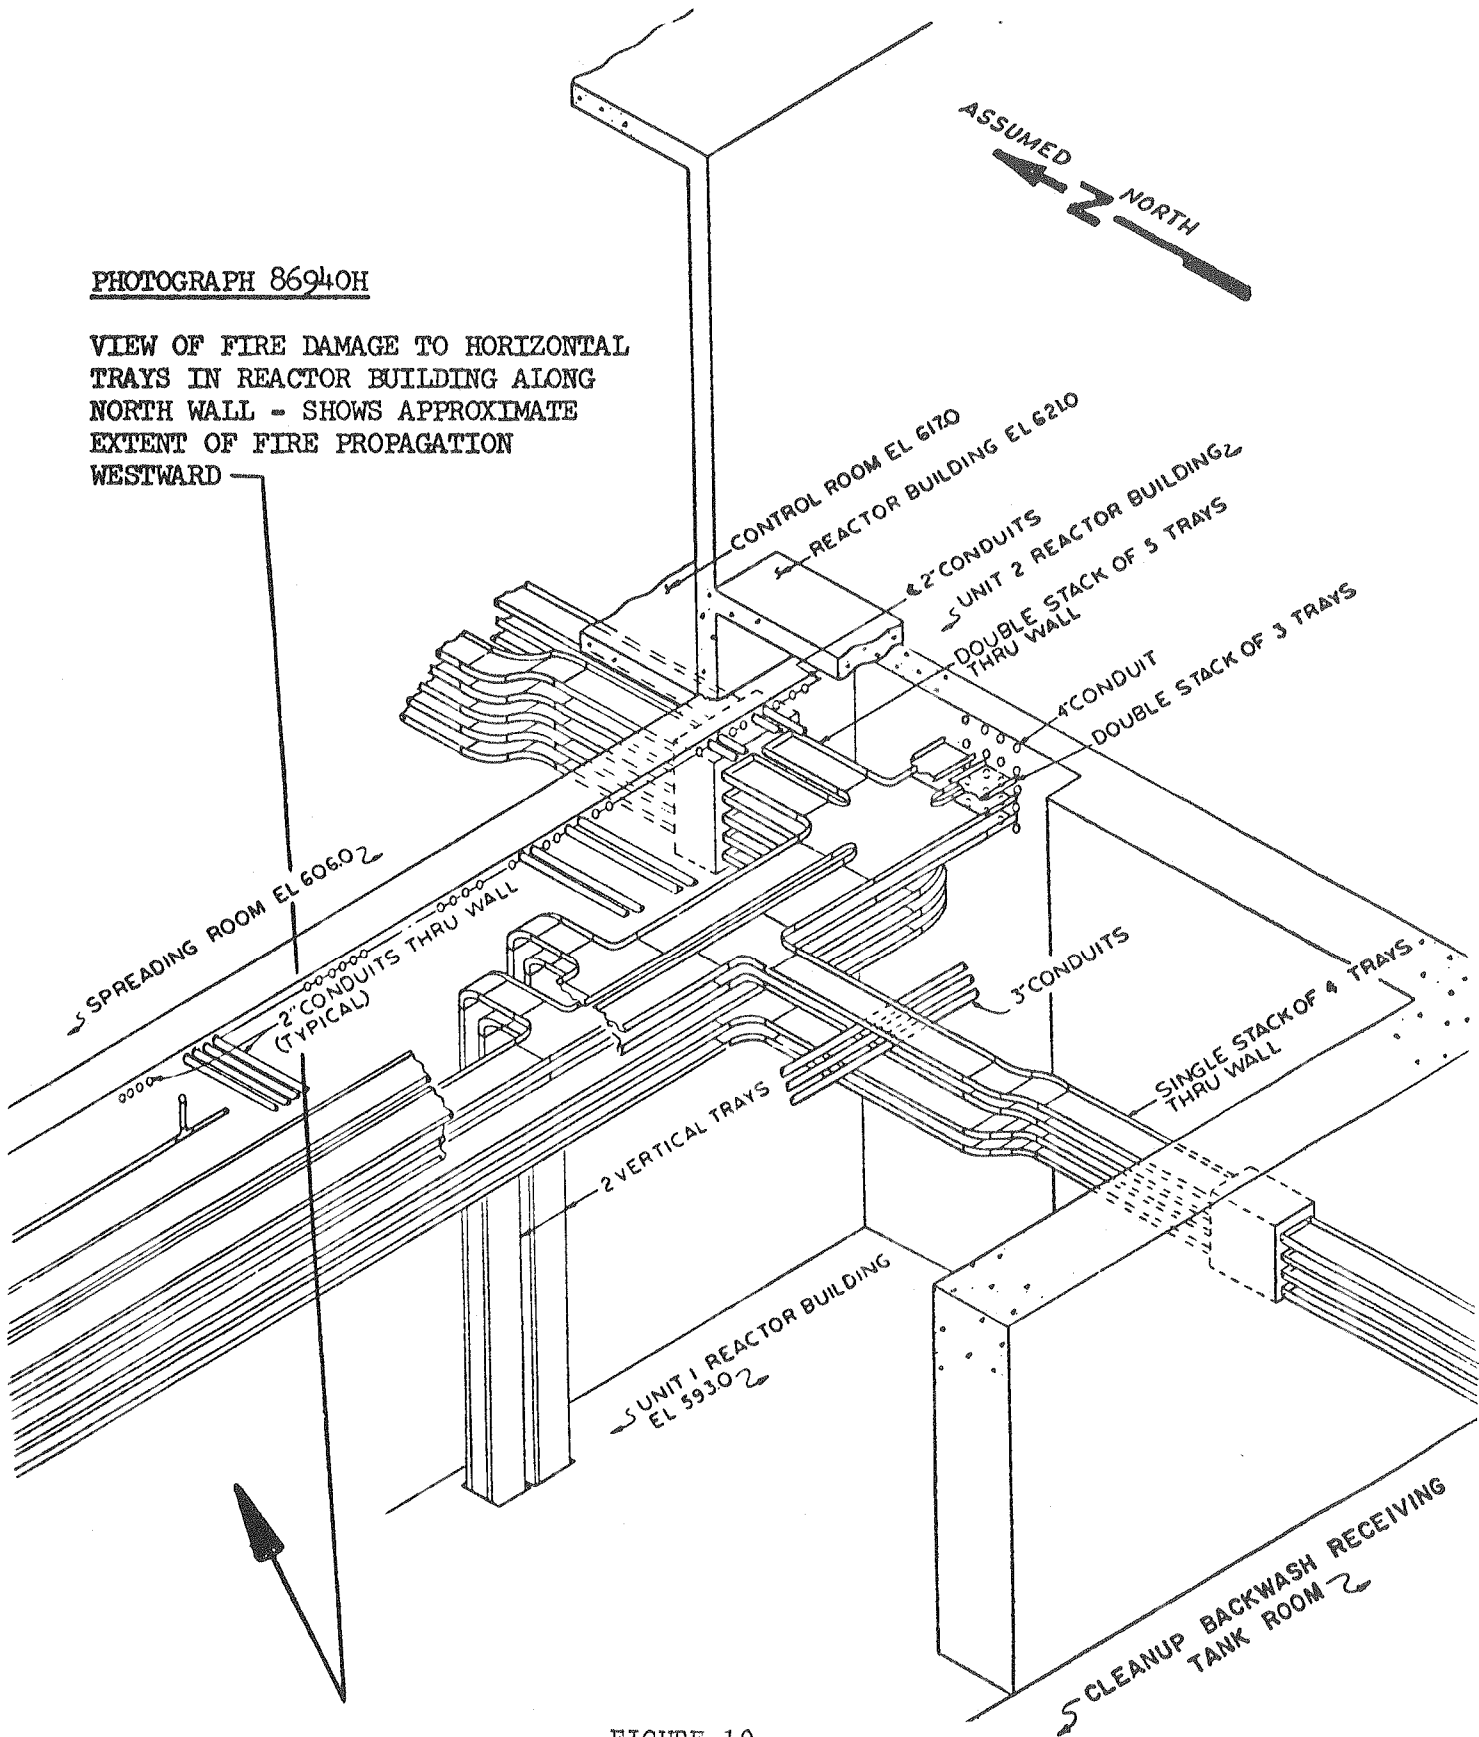
FIGURE 19  
LOCATION WHERE PHOTOGRAPH 86940H WAS  
TAKEN

PHOTOGRAPH 86940H

VIEW OF FIRE DAMAGE TO HORIZONTAL TRAYS IN REACTOR BUILDING ALONG NORTH WALL - SHOWS APPROXIMATE EXTENT OF FIRE PROPAGATION WESTWARD

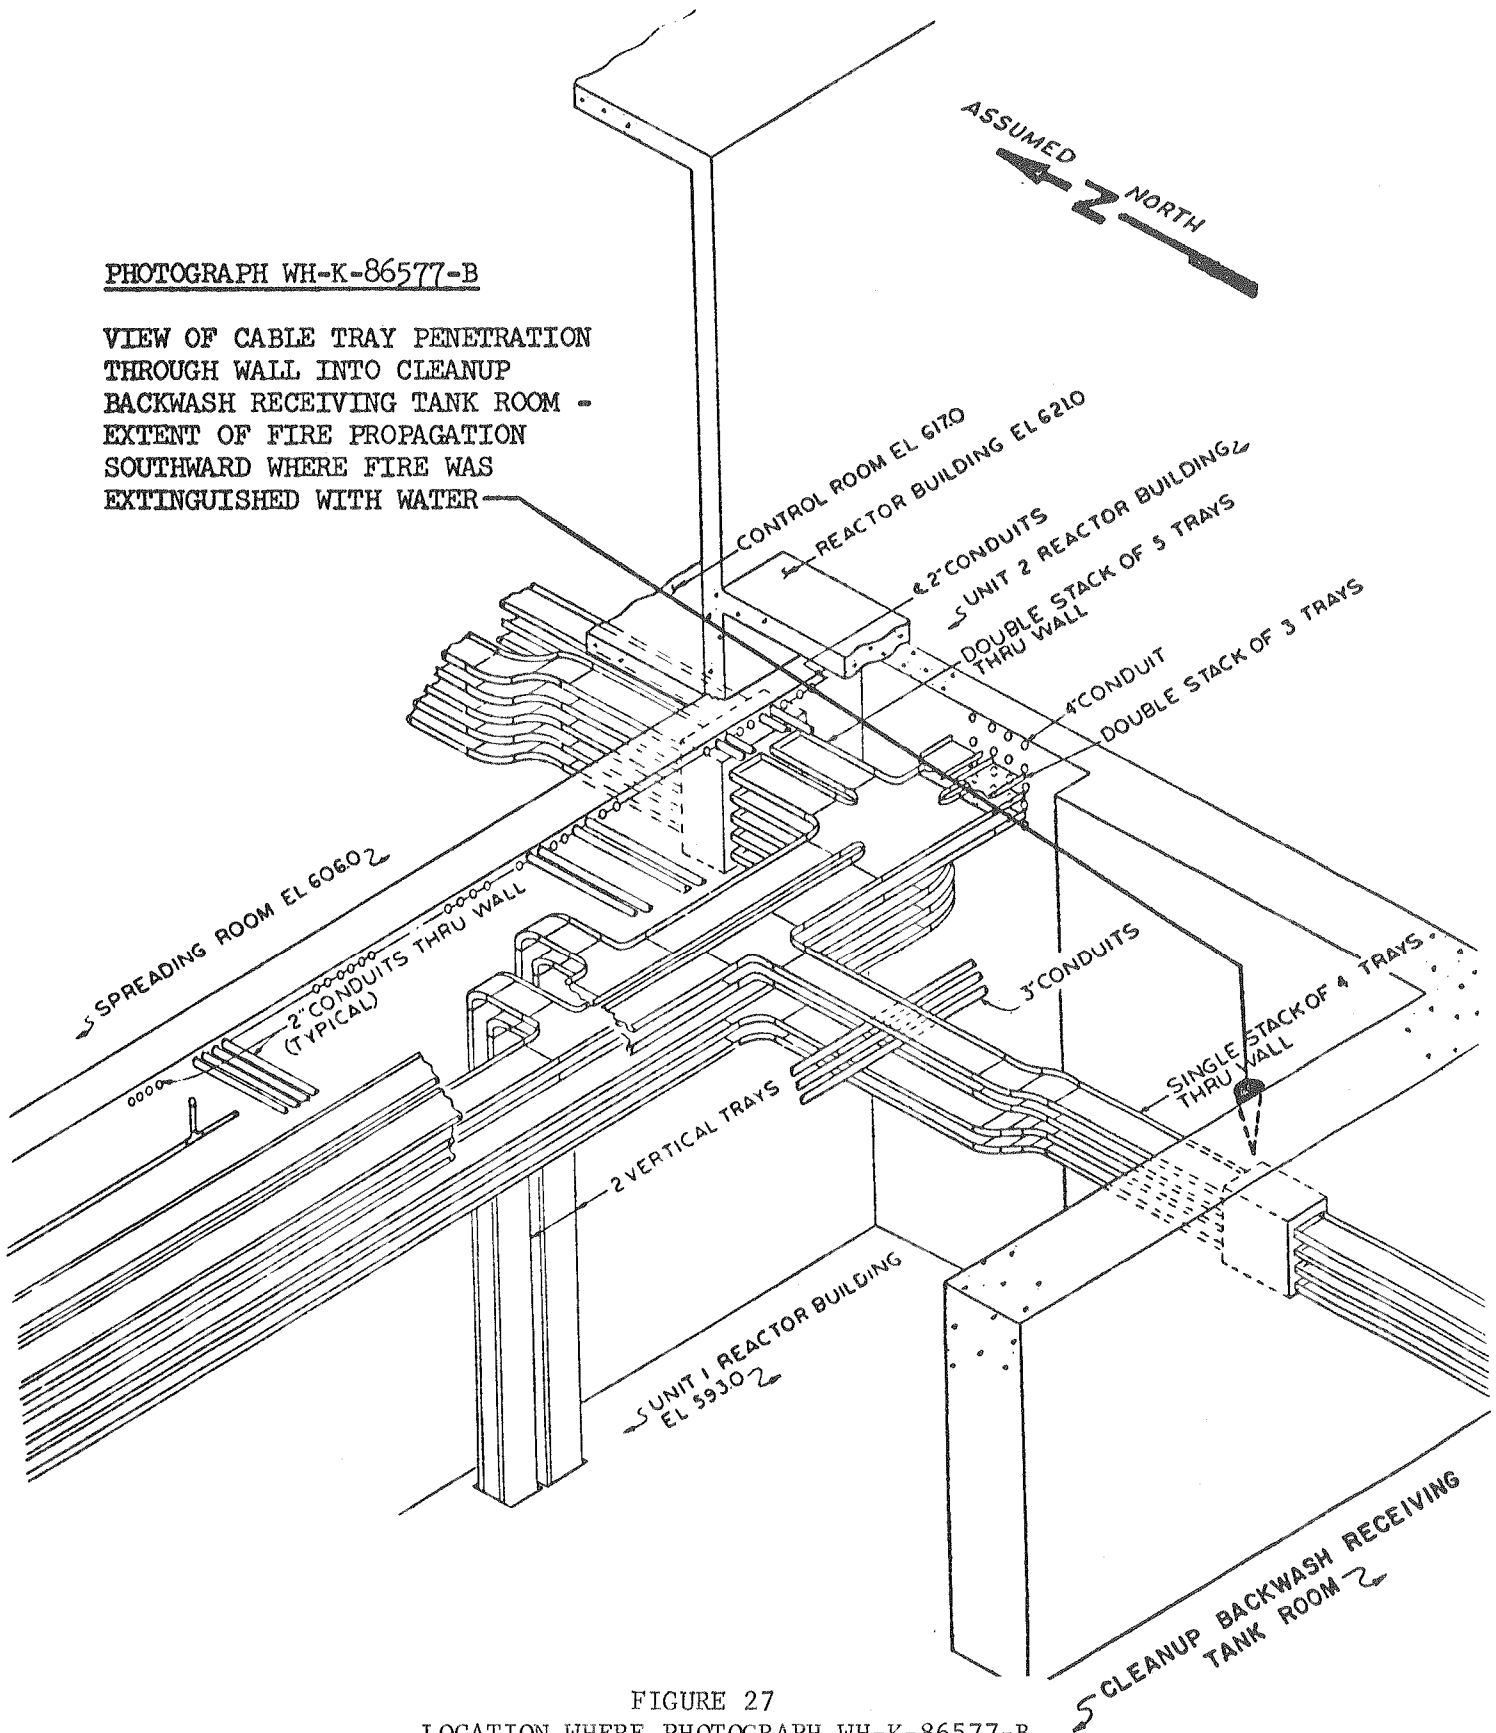
FIGURE 27  
LOCATION WHERE PHOTOGRAPH WH-K-86577-B  
WAS TAKEN

PHOTOGRAPH WH-K-86577-B

VIEW OF CABLE TRAY PENETRATION  
THROUGH WALL INTO CLEANUP  
BACKWASH RECEIVING TANK ROOM -  
EXTENT OF FIRE PROPAGATION  
SOUTHWARD WHERE FIRE WAS  
EXTINGUISHED WITH WATER

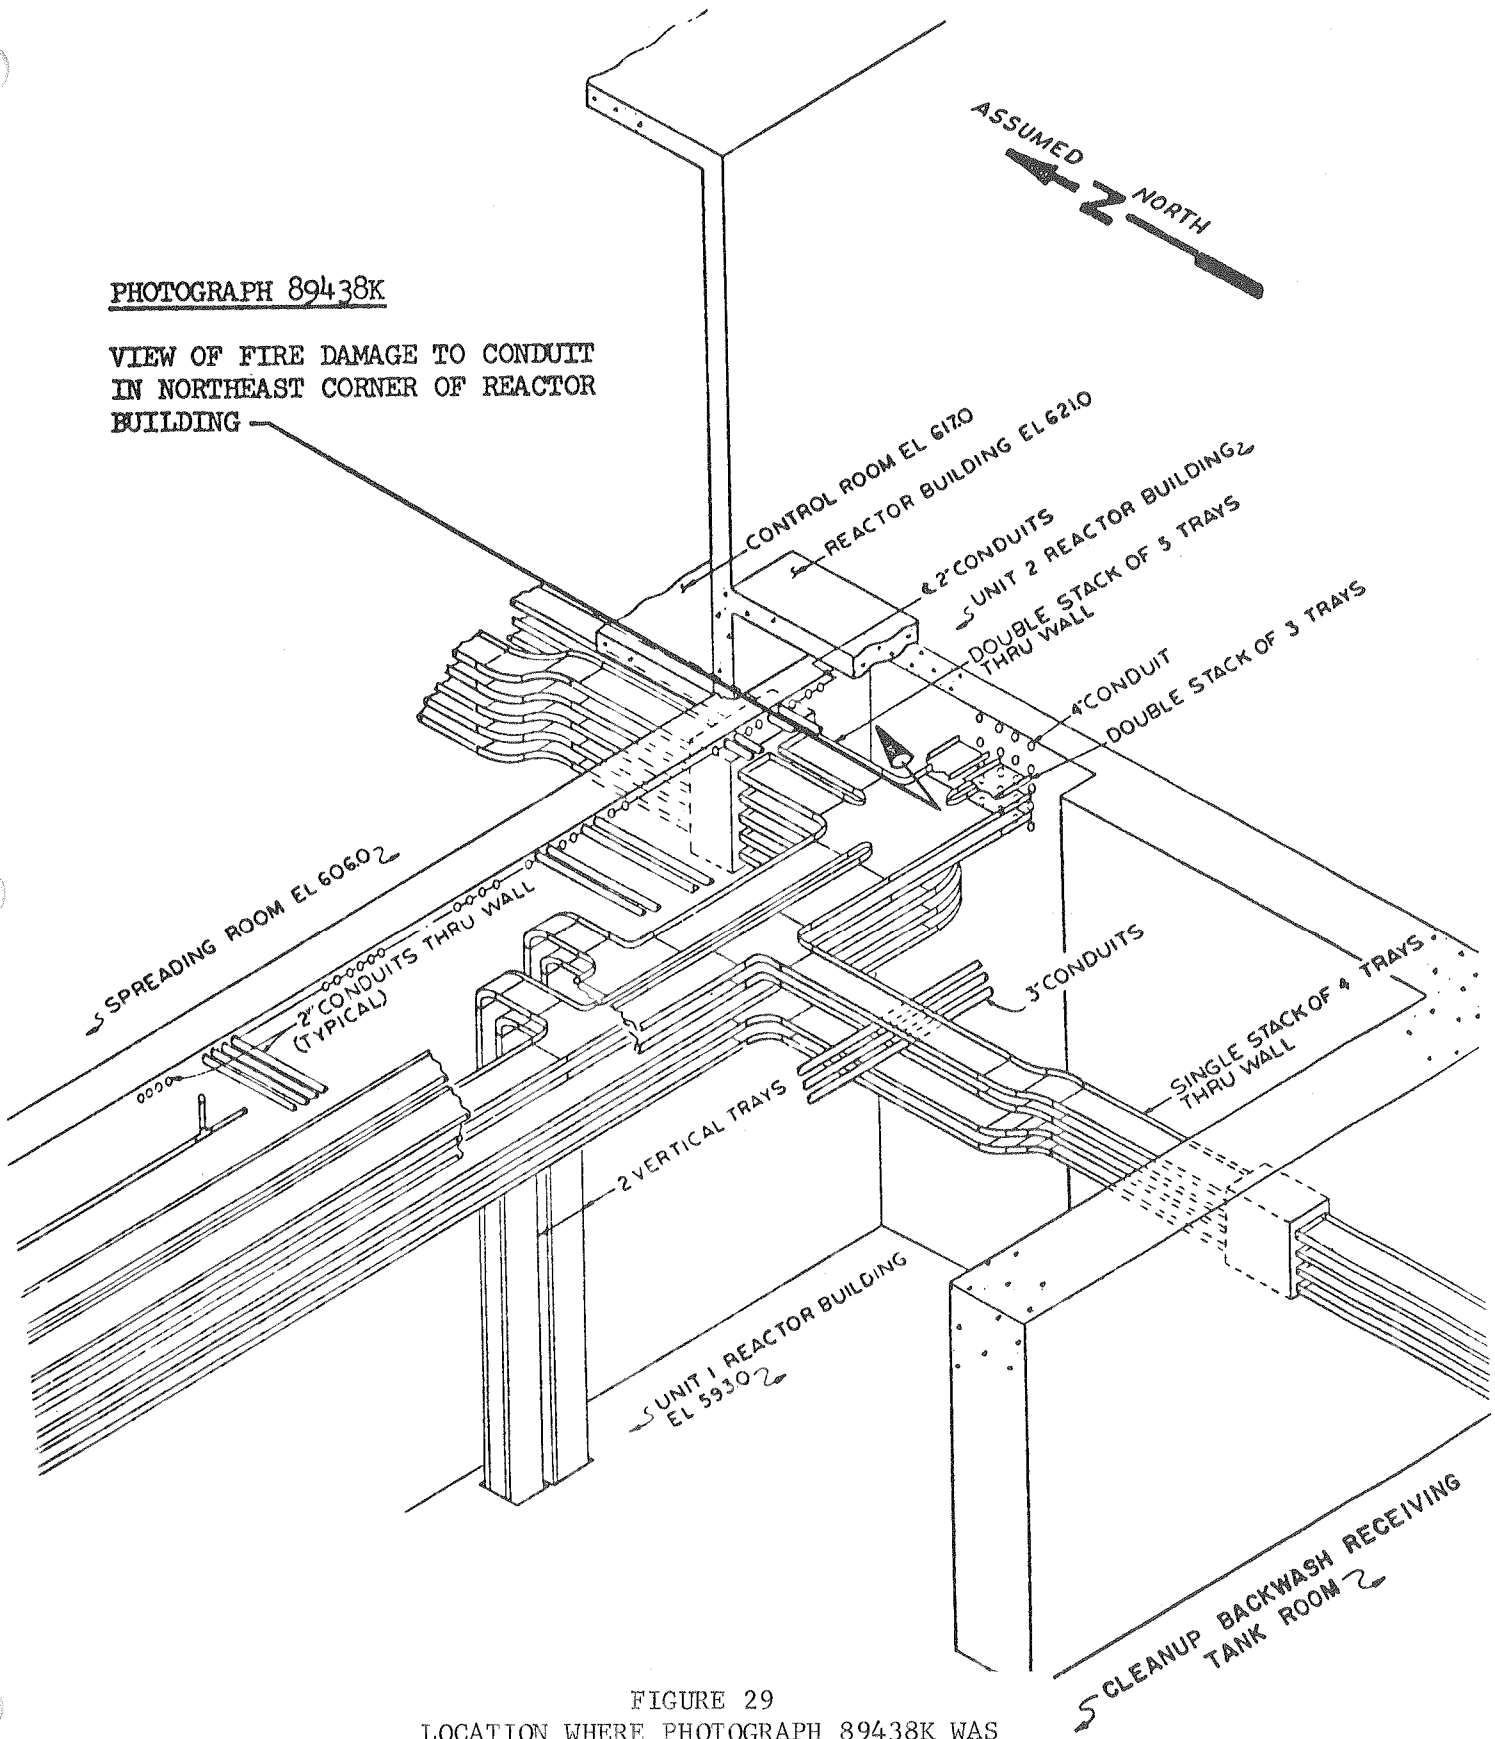
FIGURE 29  
LOCATION WHERE PHOTOGRAPH 89438K WAS  
TAKEN

PHOTOGRAPH 89438K

VIEW OF FIRE DAMAGE TO CONDUIT  
IN NORTHEAST CORNER OF REACTOR  
BUILDING
