## Cable Fire At Browns Ferry Nuclear Power Plant

**ROBERT G. SAWYER**, Staff Property Engineer  
**JAMES A. ELSNER, P.E.**, Staff Nuclear Engineer  
*Nuclear Energy Liability - Property Insurance Association (NEL-PIA)*

*March 22, 1975 was the date of a major electrical cable system fire at the Browns Ferry Nuclear Power Plant of the Tennessee Valley Authority (TVA). The fire was accidentally started by an employee who was using a candle to check for air leaks through a fire wall penetration seal. The fire was not extinguished until seven hours after ignition and caused the shutdown of two nuclear generating units for over one year. Property damage at this self-insured facility is estimated at about \$10 million, and the cost of replacement power was approximately \$10 million per month. There was no release of radioactivity as a result of the fire.*

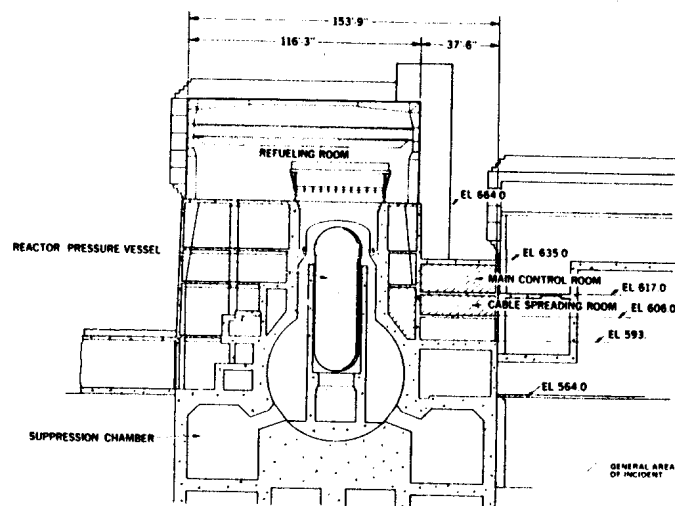
Figure 2. Reactor Building, Control Room, and Spreading Room.

The penetrations between the Cable Spreading Room, directly beneath the Control Room, and the Unit 1 Reactor Building were being checked for leakage. The wall between the Cable Spreading Room and the Reactor Building is of 26-inch-thick reinforced concrete. Cable trays carrying control and instrumentation wiring
